Memorandum

To	Erle Bencich
Copy	Mark Smith, Kathie Ragg
From	Rem Markland
Office	Greymouth
Date	19 June 2024
File/Ref	6-WWES5.02
Subject	Totara Rail Bridge - Summary Assessment 2024

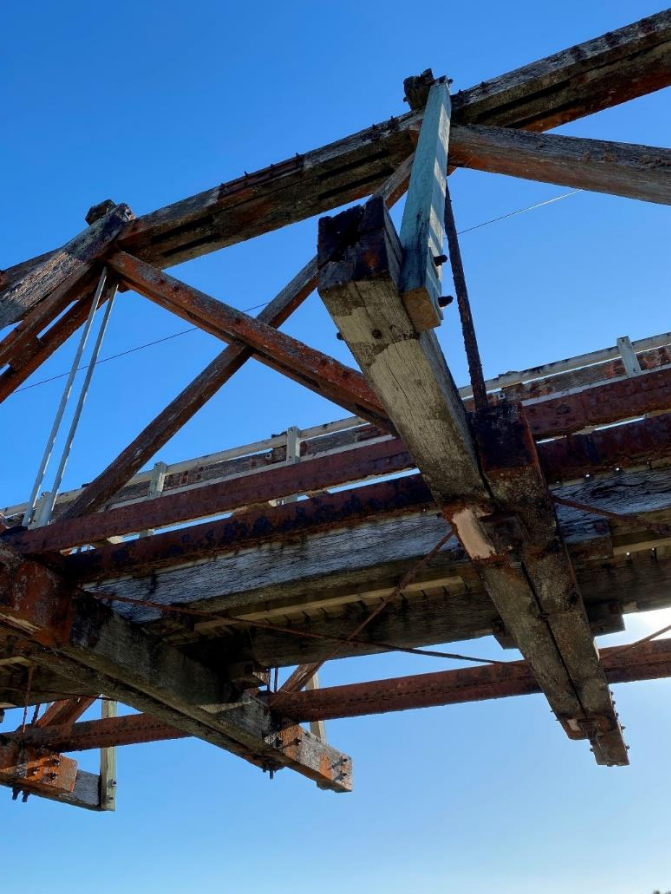
Transom end timber decay.

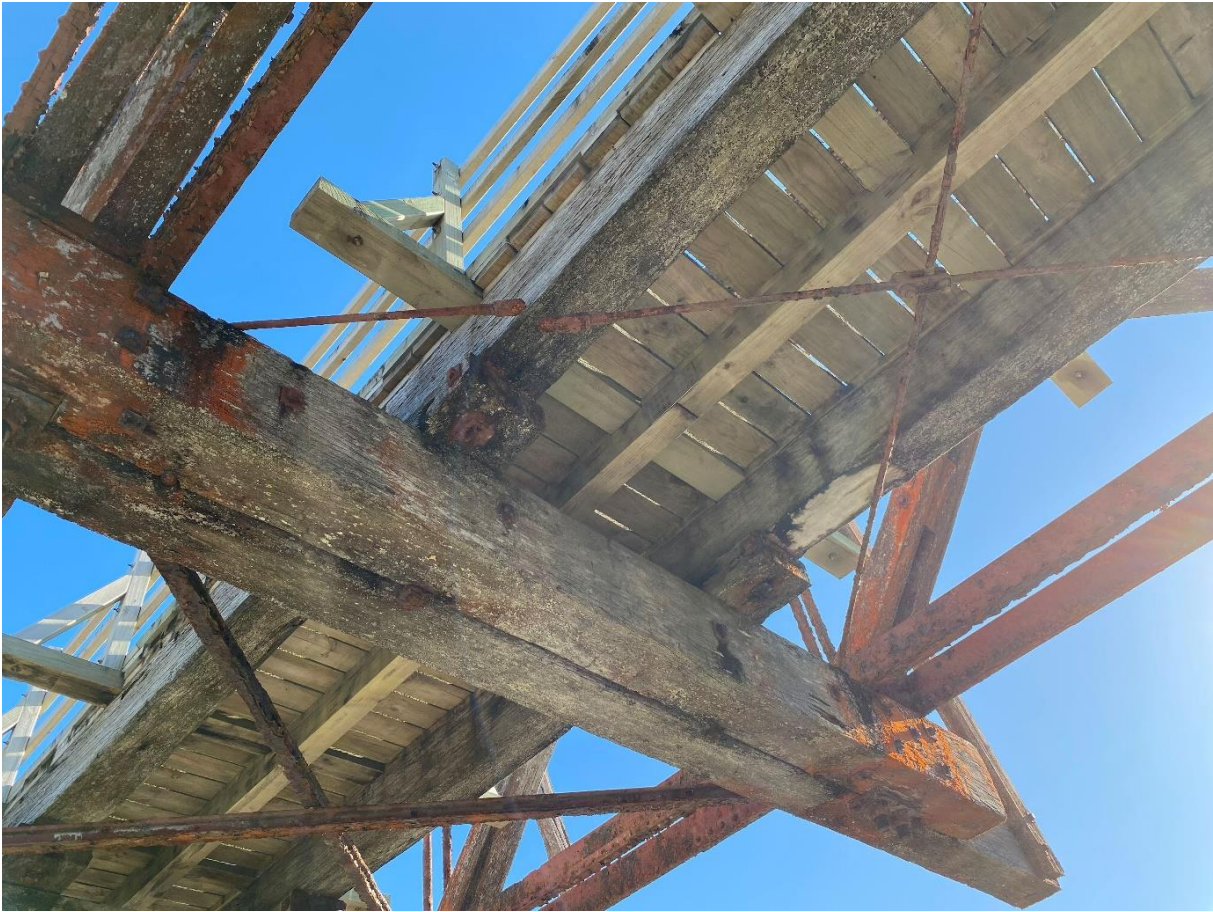
Cross bracing corroded away.

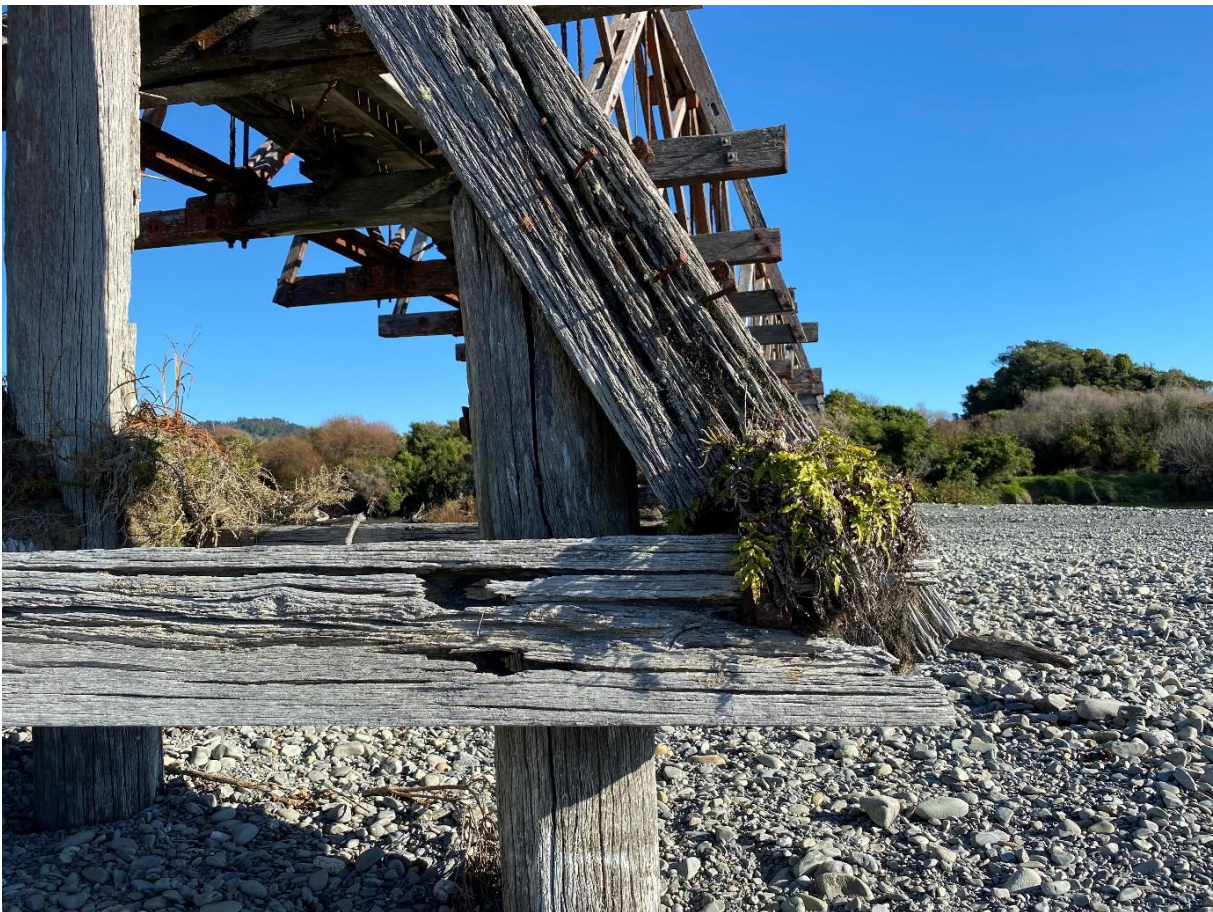
Timber loss and decay.

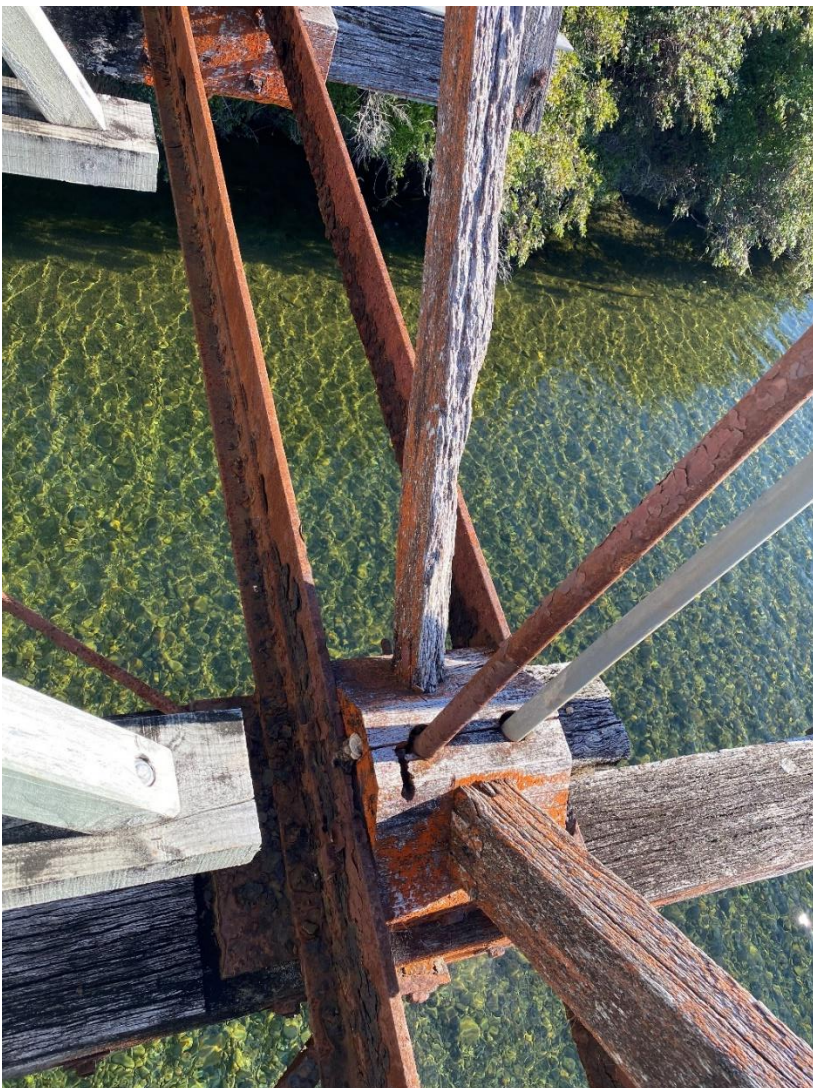
Loss of section on timber strut.

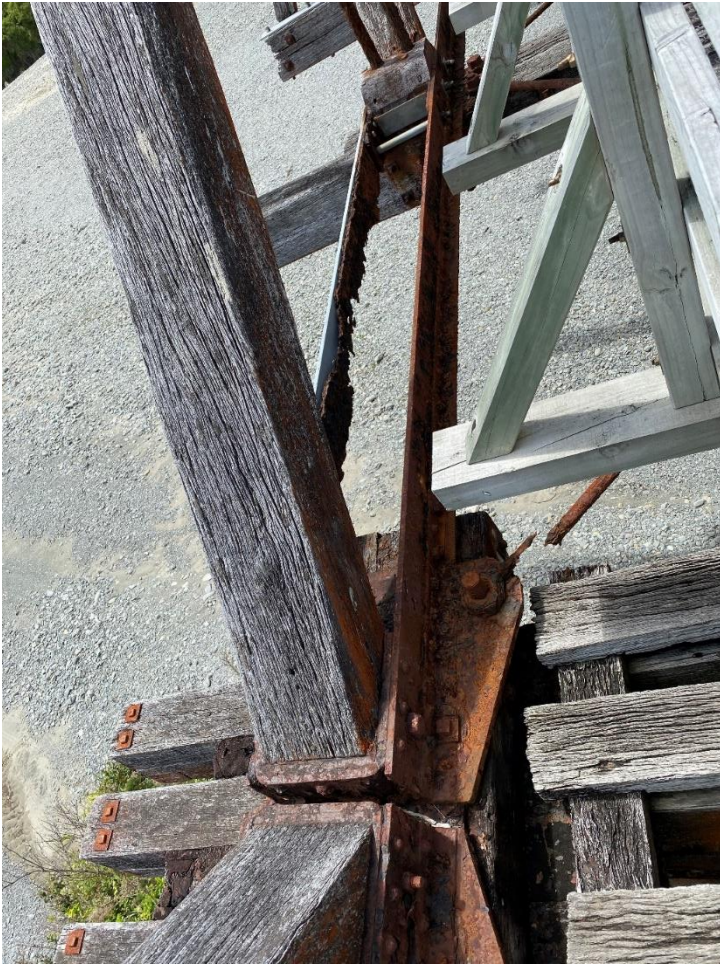
Bottom cord corroded, needs replacing.
Cross bracing corroded needs replacing

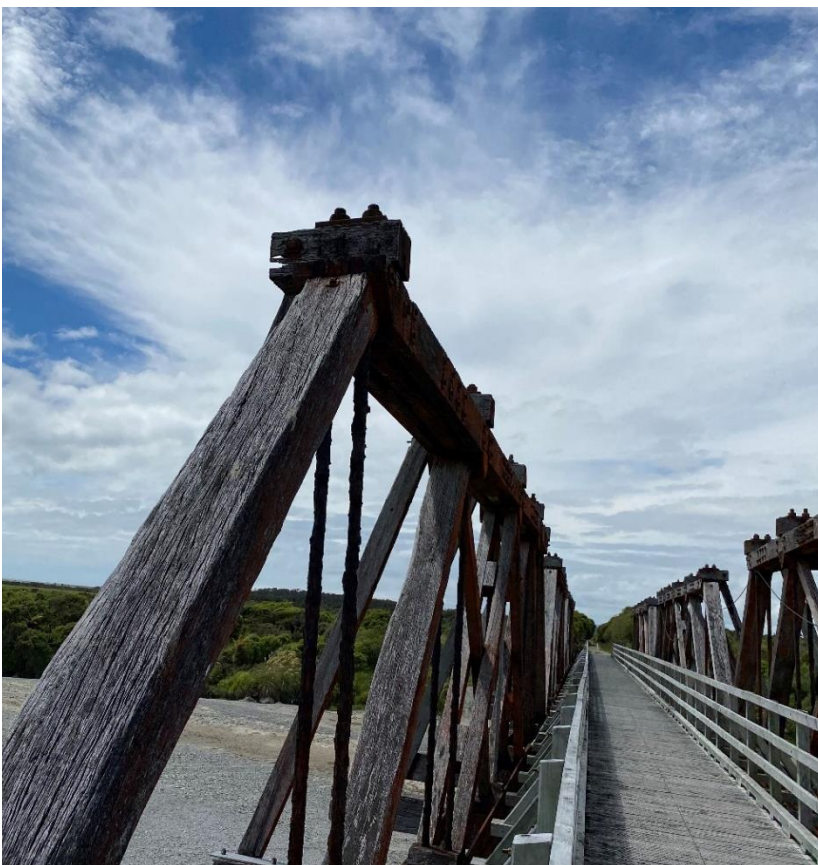
Saddle block decay and split.

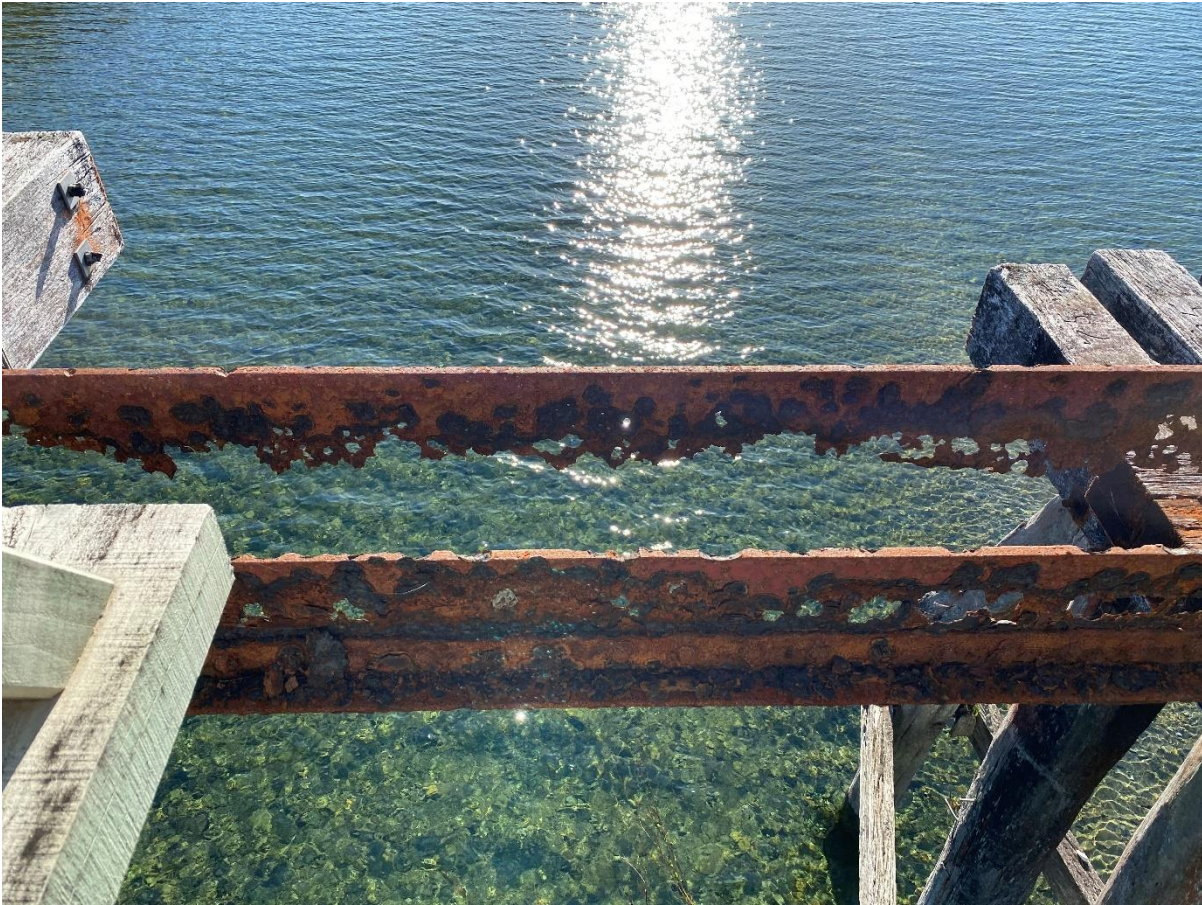
Bottom cord corroded. Needs replacing.

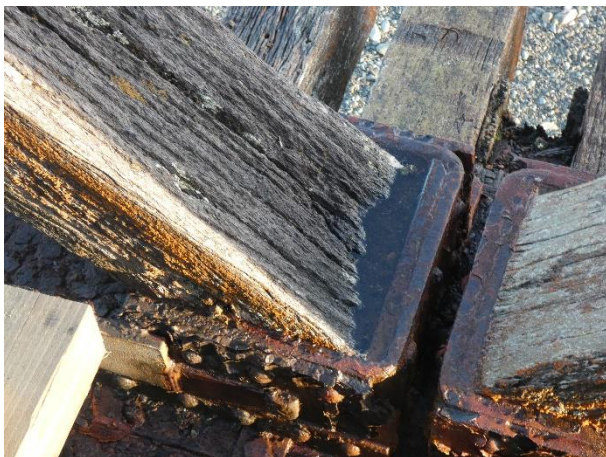
Typical Weathered Timber and Ponding Moisture.

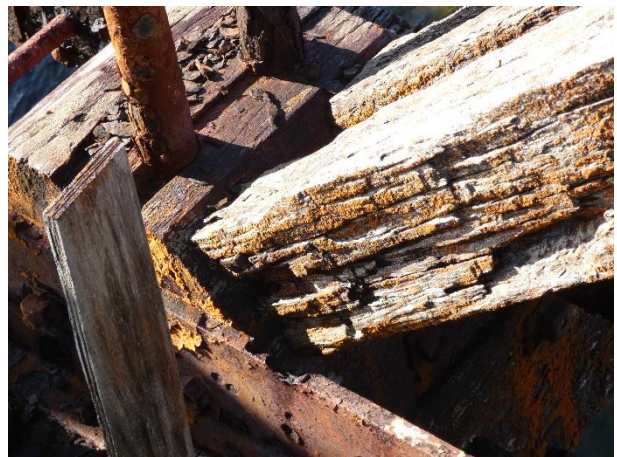
Typical Weathered Timber.

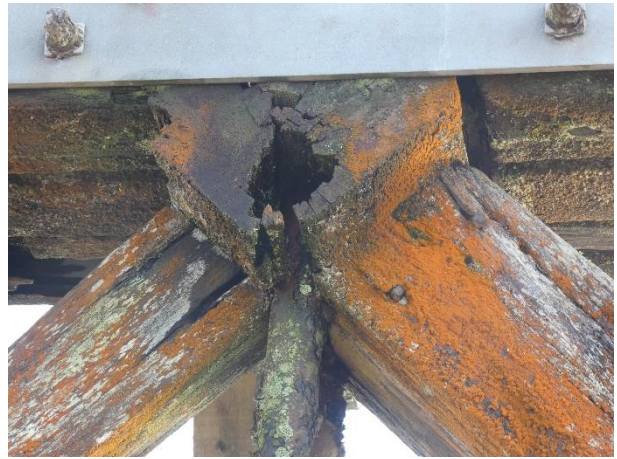
Typical Heavy to Critical Decay of 'A' Block.

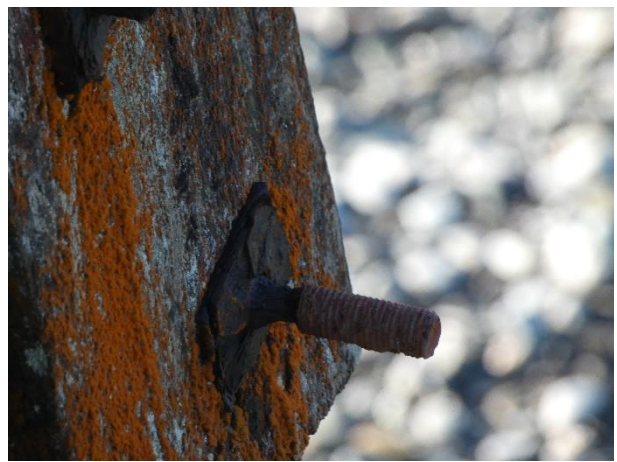
Corrosion and Loss of Fixing Components. Missing Nut and Necked Bolt Shown.

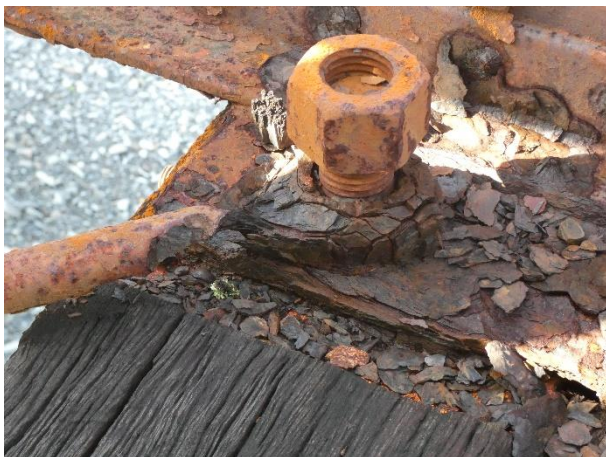
Typical Loose Fixings. Corroded Steel Components.

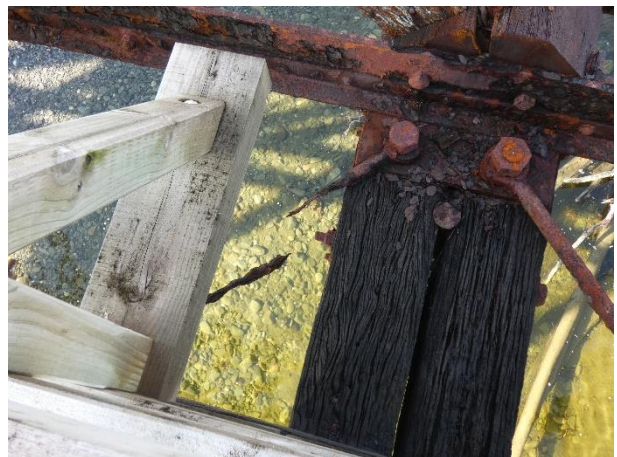
Widespread Loss of Deck Bracing Due to Corrosion.

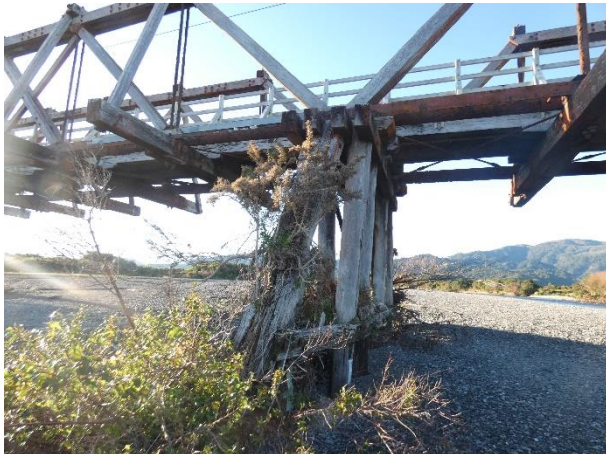
Vegetation Growth From Timber Decay Pockets

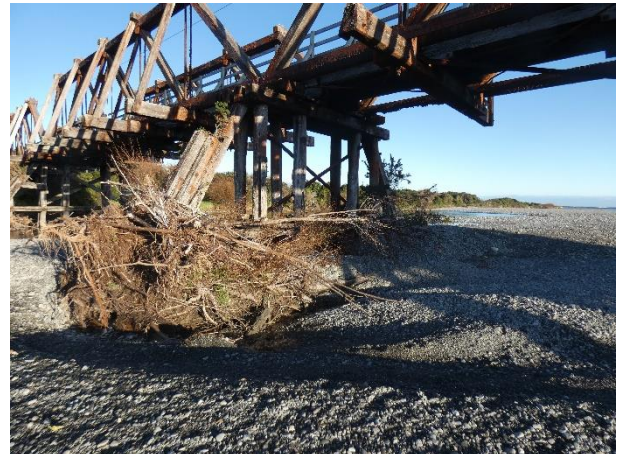
Debris Caught on Piers Causing Local Scour.
