Liddell
CONTRACTING

**WDC HOKITIKA
CENOTAPH
STRENGTHENING**

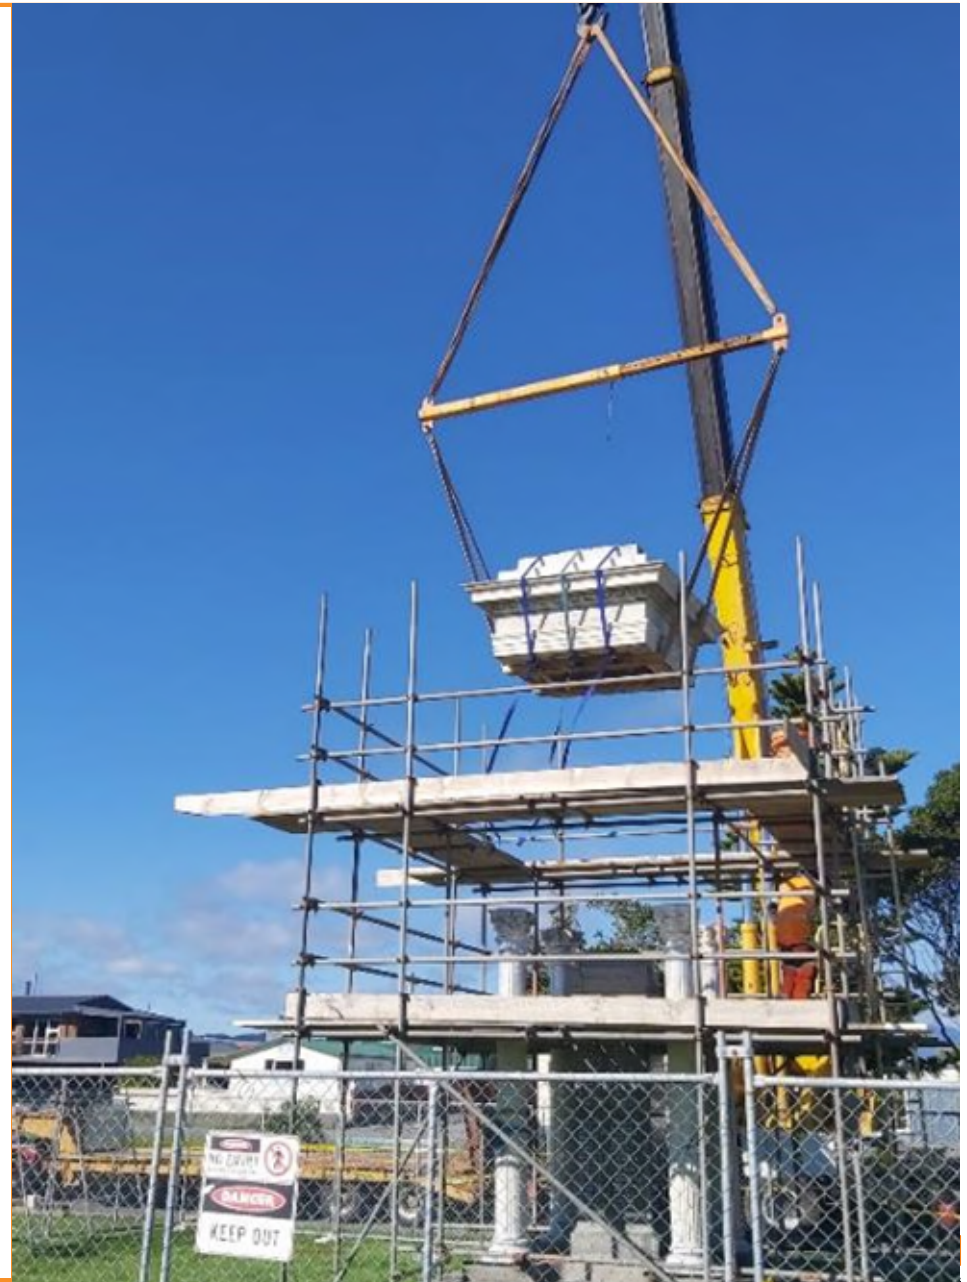
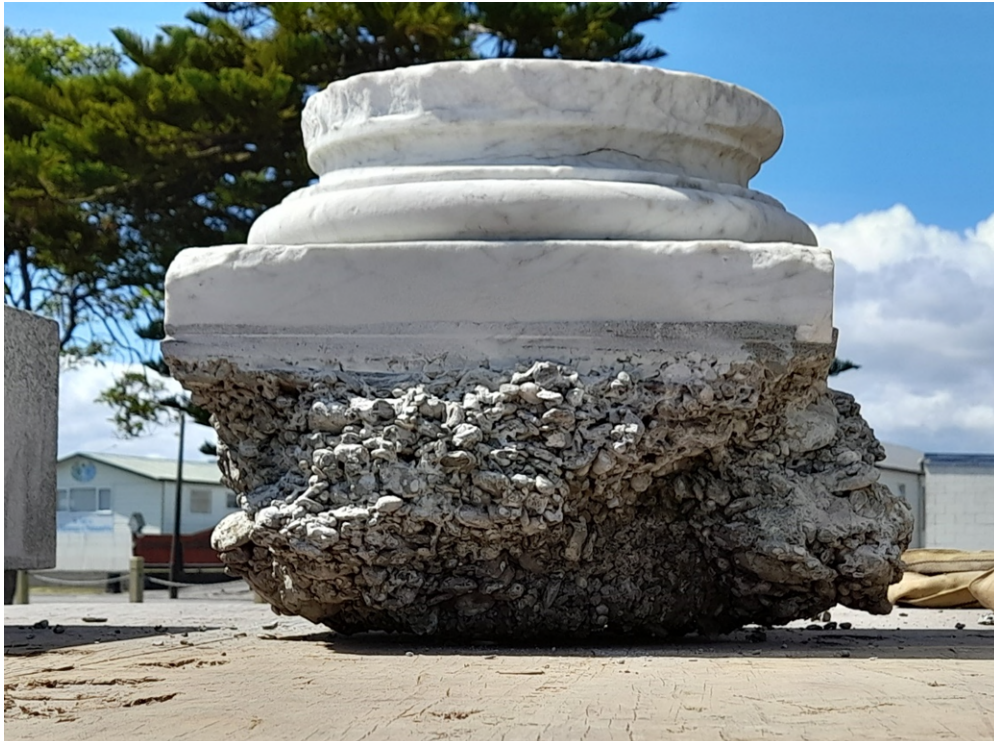
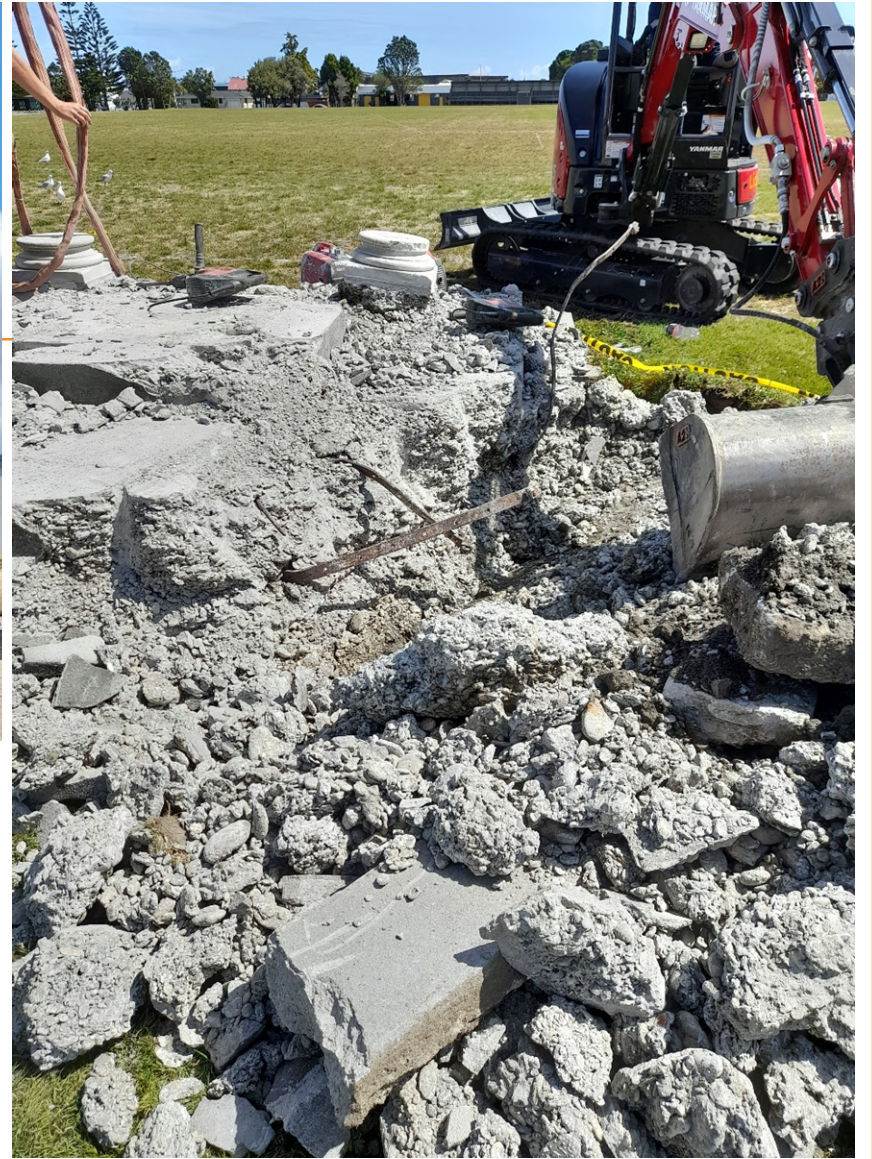
While cleaning the Cenotaph, it was determined that it was unstable. The decision was made to deconstruct the Cenotaph to prevent it from collapsing.

All the marble was removed and taken to the Liddell yard for storage.

We then had to break out and remove the concrete base and prep the site for the new concrete base.

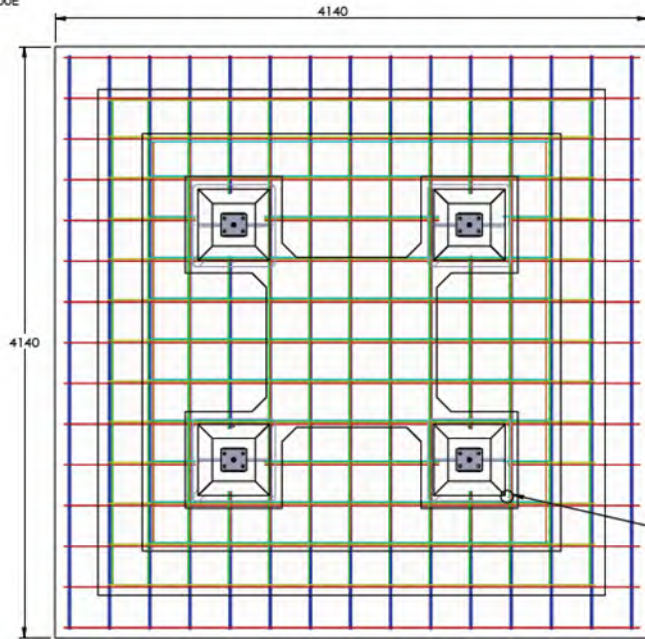
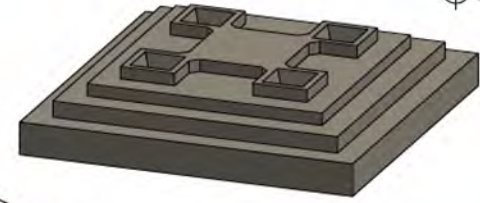
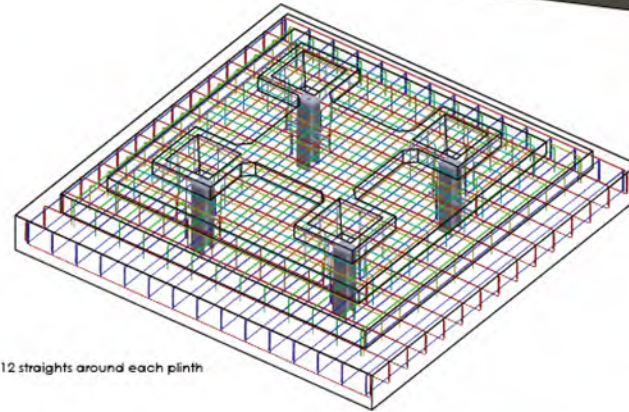
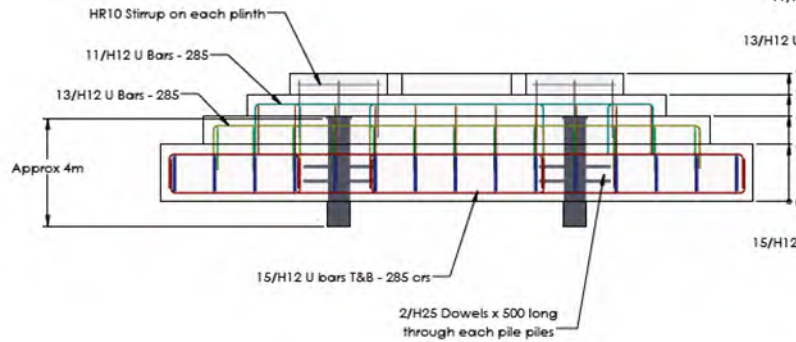
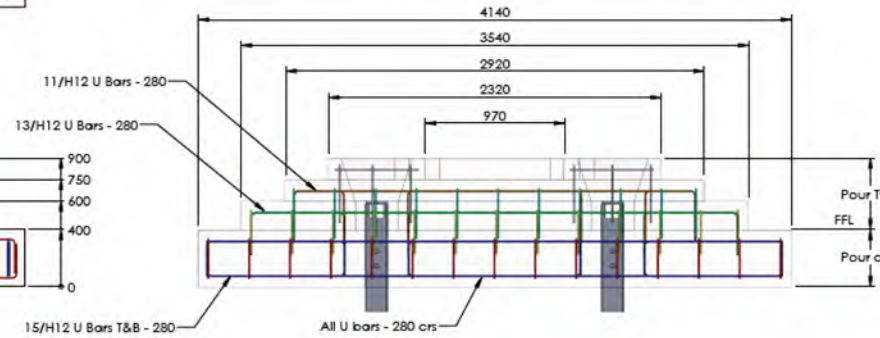
Liddell CONTRACTING		TITLE: Cenotaph Base Reinforcing	
REVISION	DATE	PROJECT:	Hokitika Cenotaph EQS
DESIGNED	DRAWN	MATERIAL:	DWS NO. 01- 694-2
JOB No. 694	MS	FINISH:	A3
CHECKED	ALL DIMENSIONS IN MILLIMETRES	WEIGHT: Kg	DO NOT SCALE DRAWING
CLIENT	WDC	TELEPHONE: 03 748 6990	EMAIL: martin@liddell.co.nz

Concrete 40 MPa
Min 50mm cover
All reinforcing grade 500E

8/H12 straights around each plinth

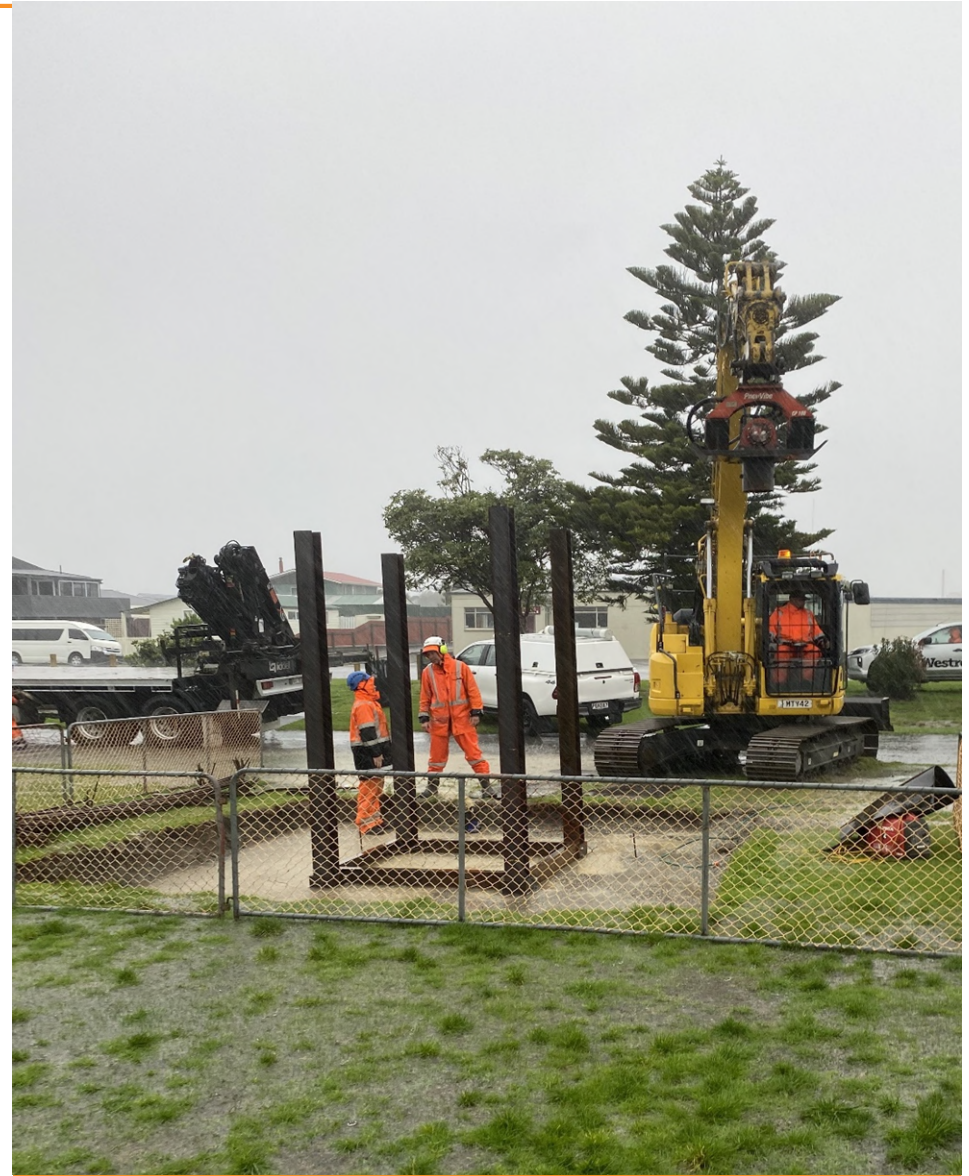
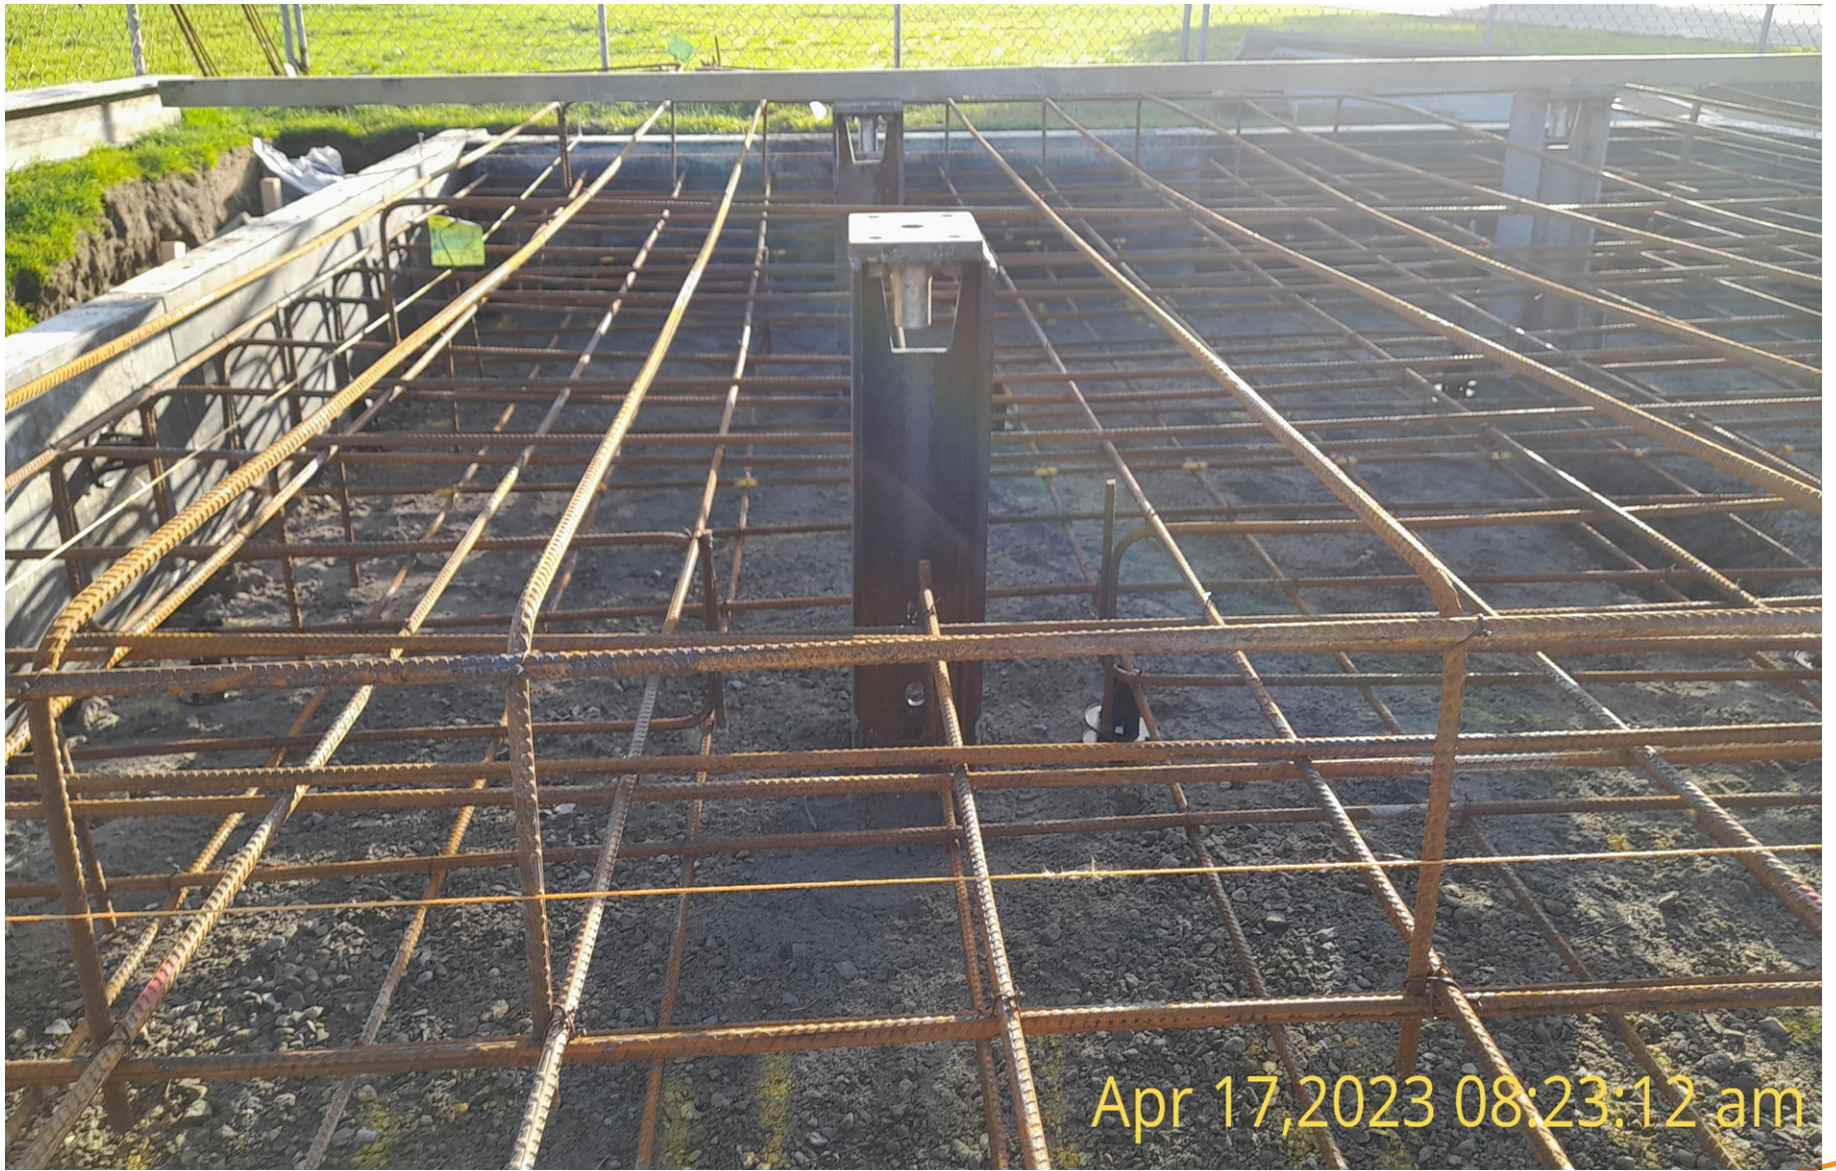
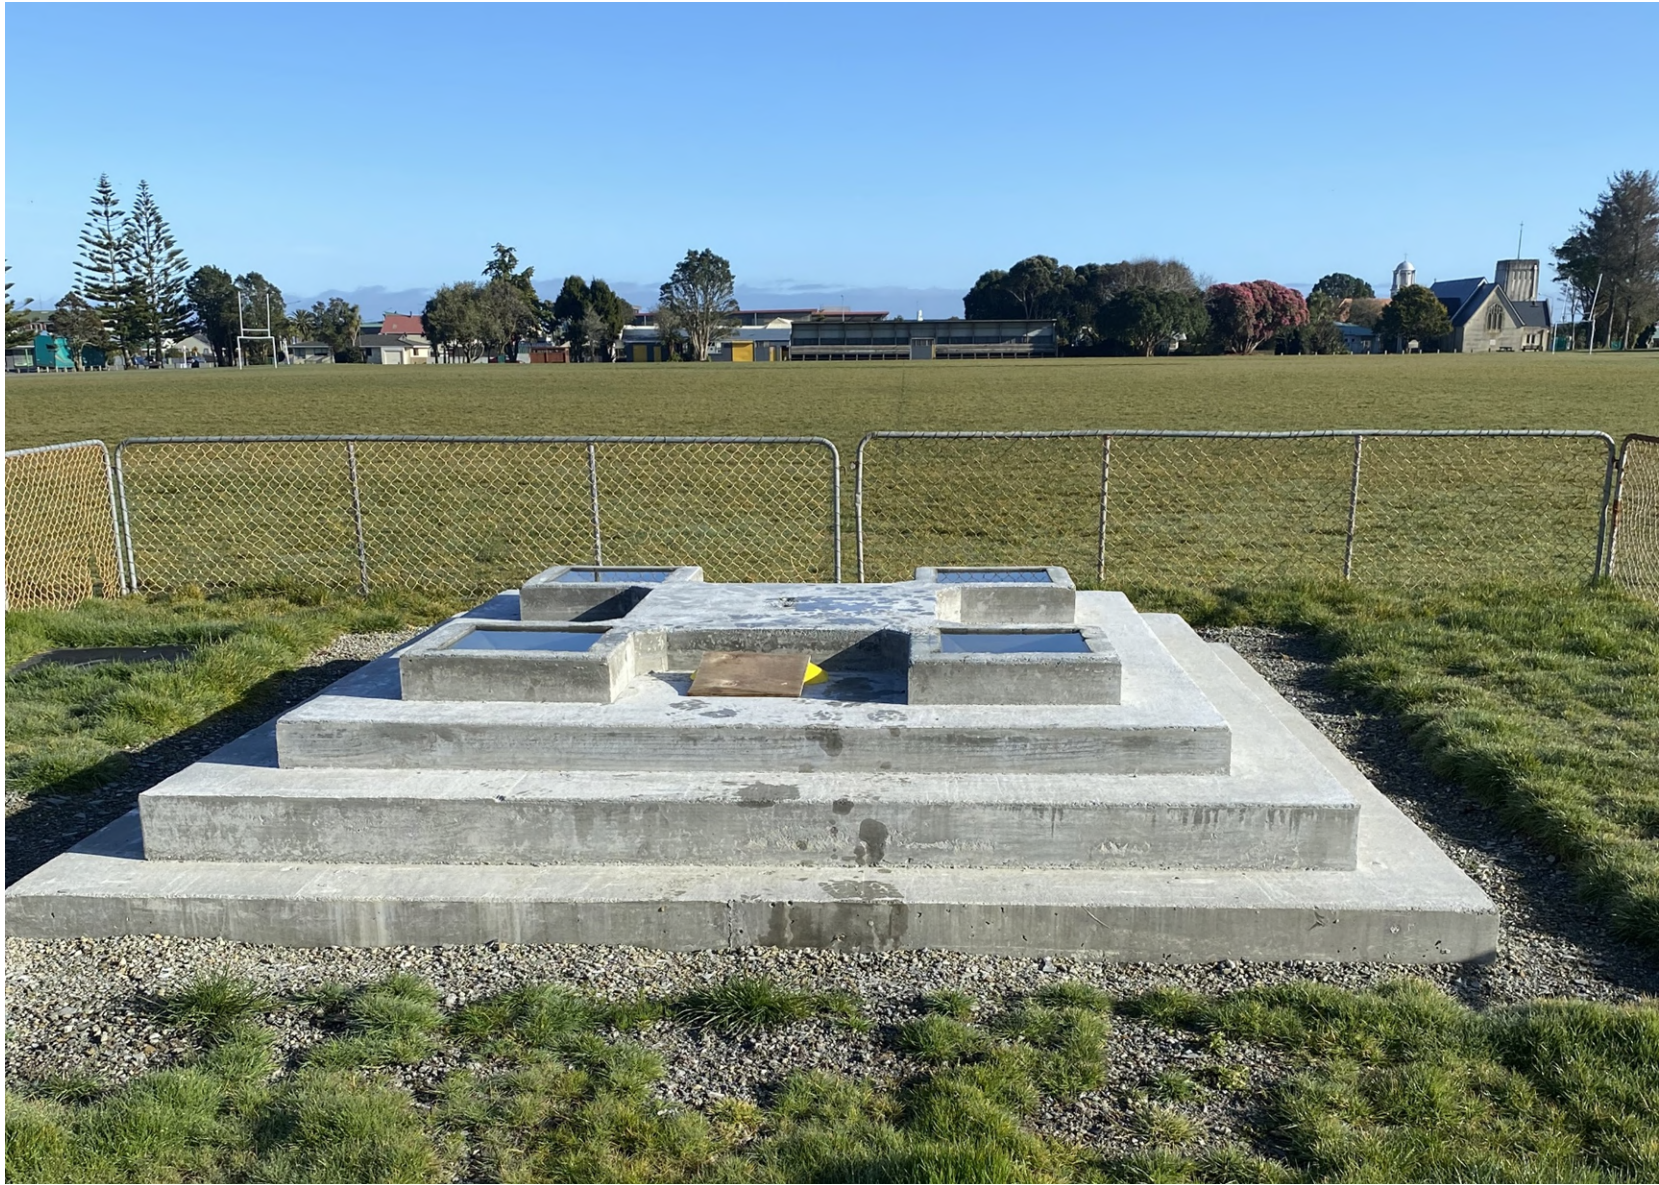
4 steel piles were driven into the ground. They were designed to take the full weight of the Cenotaph.

The piles were installed in April 2023.

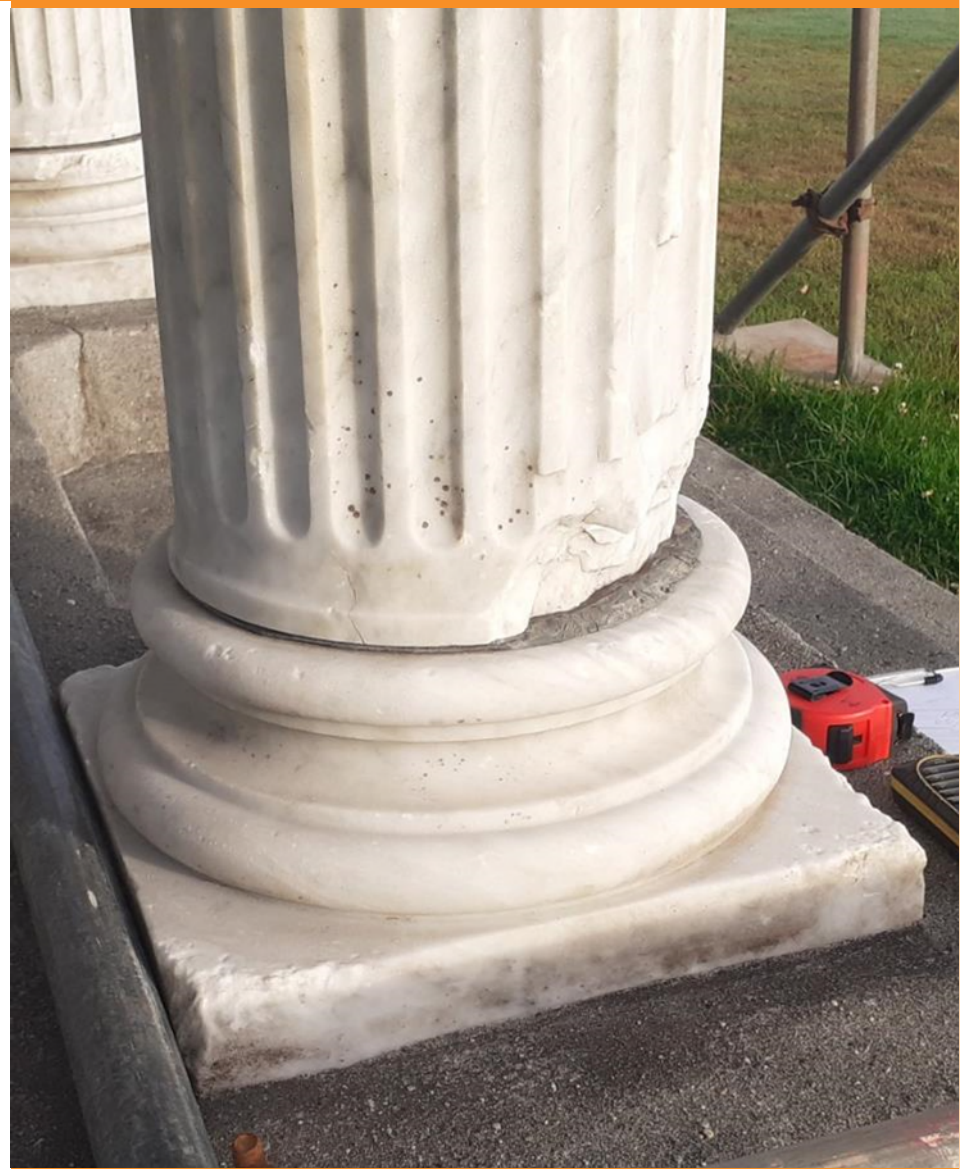
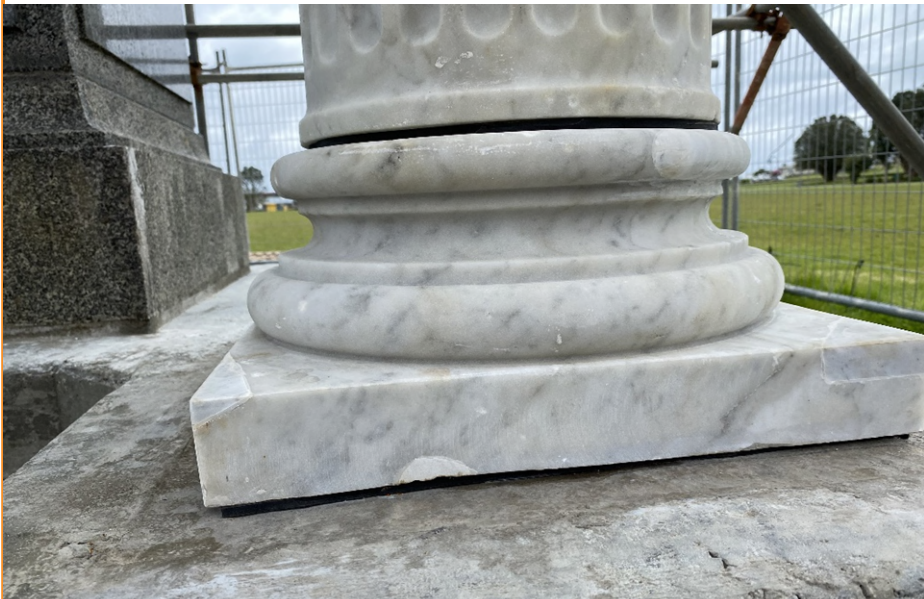
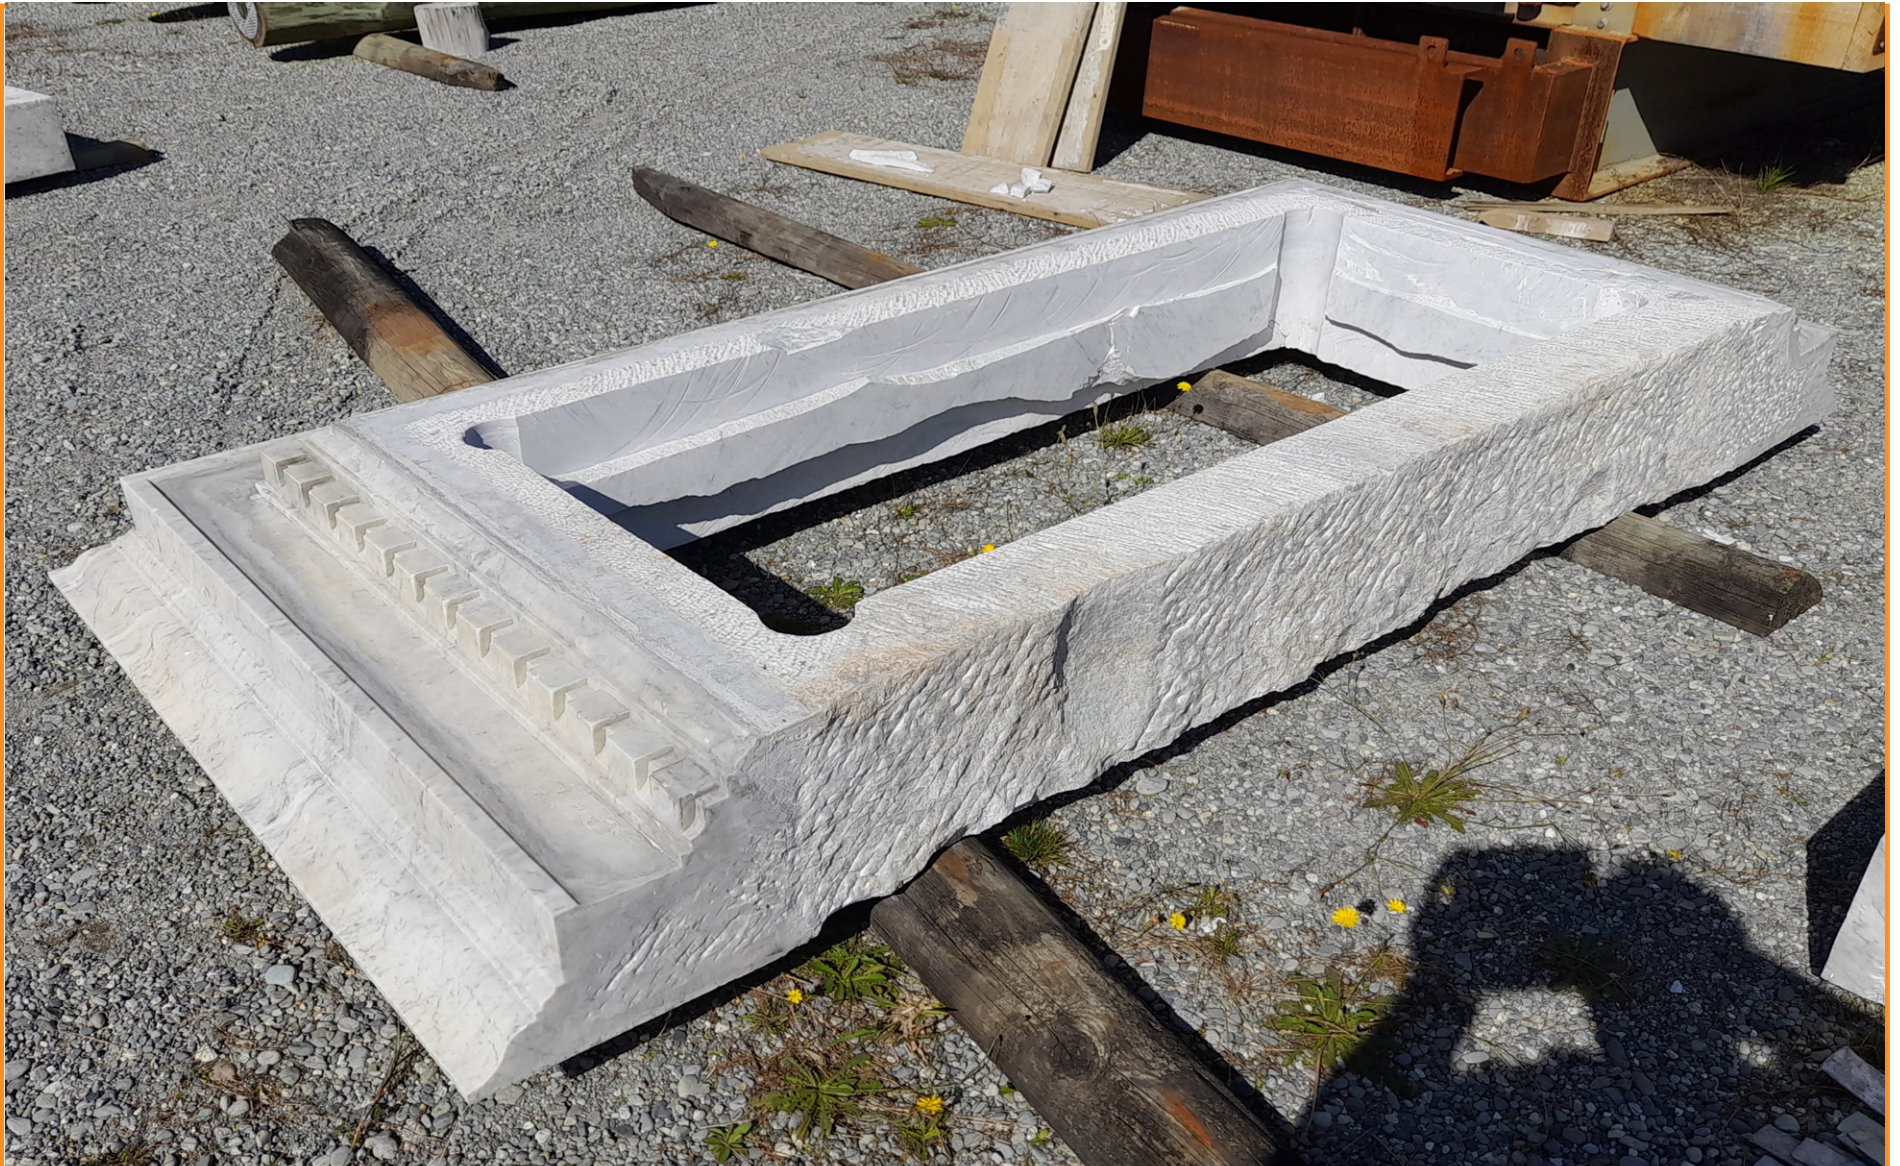
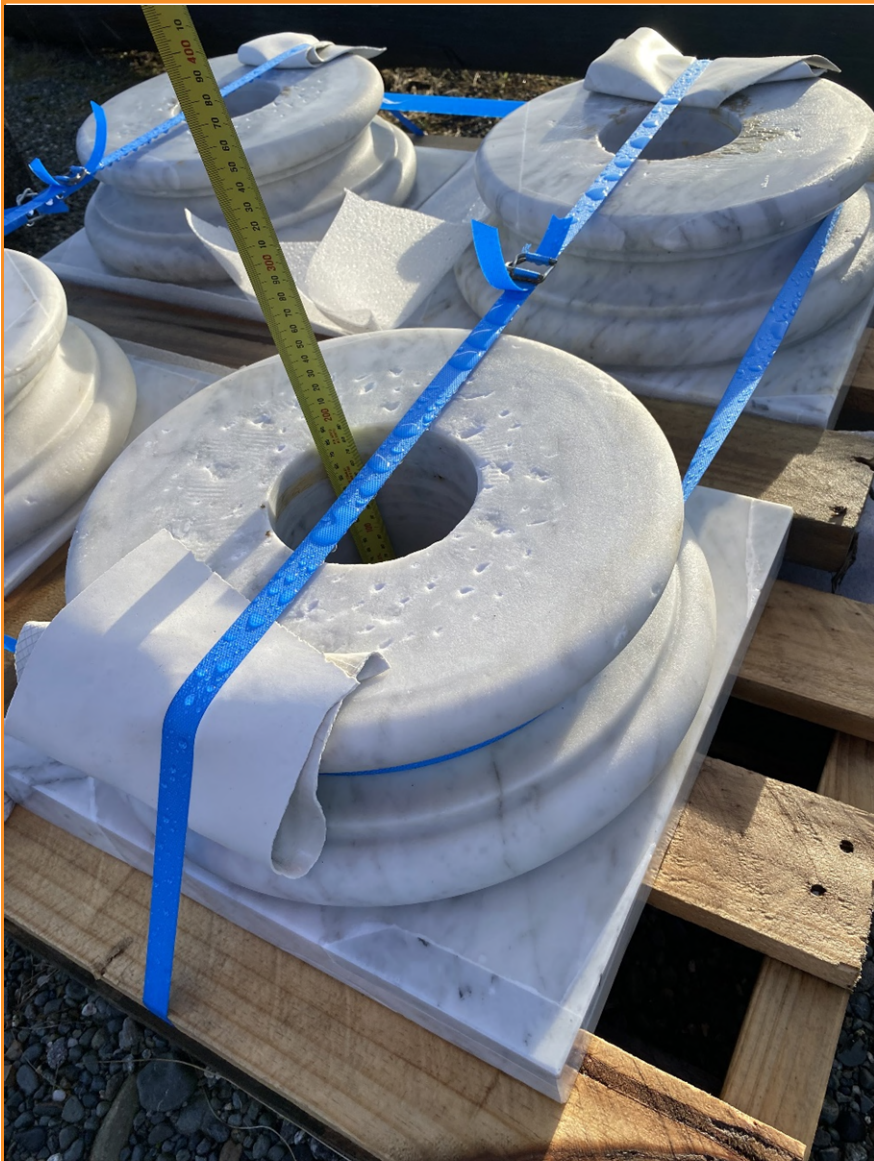
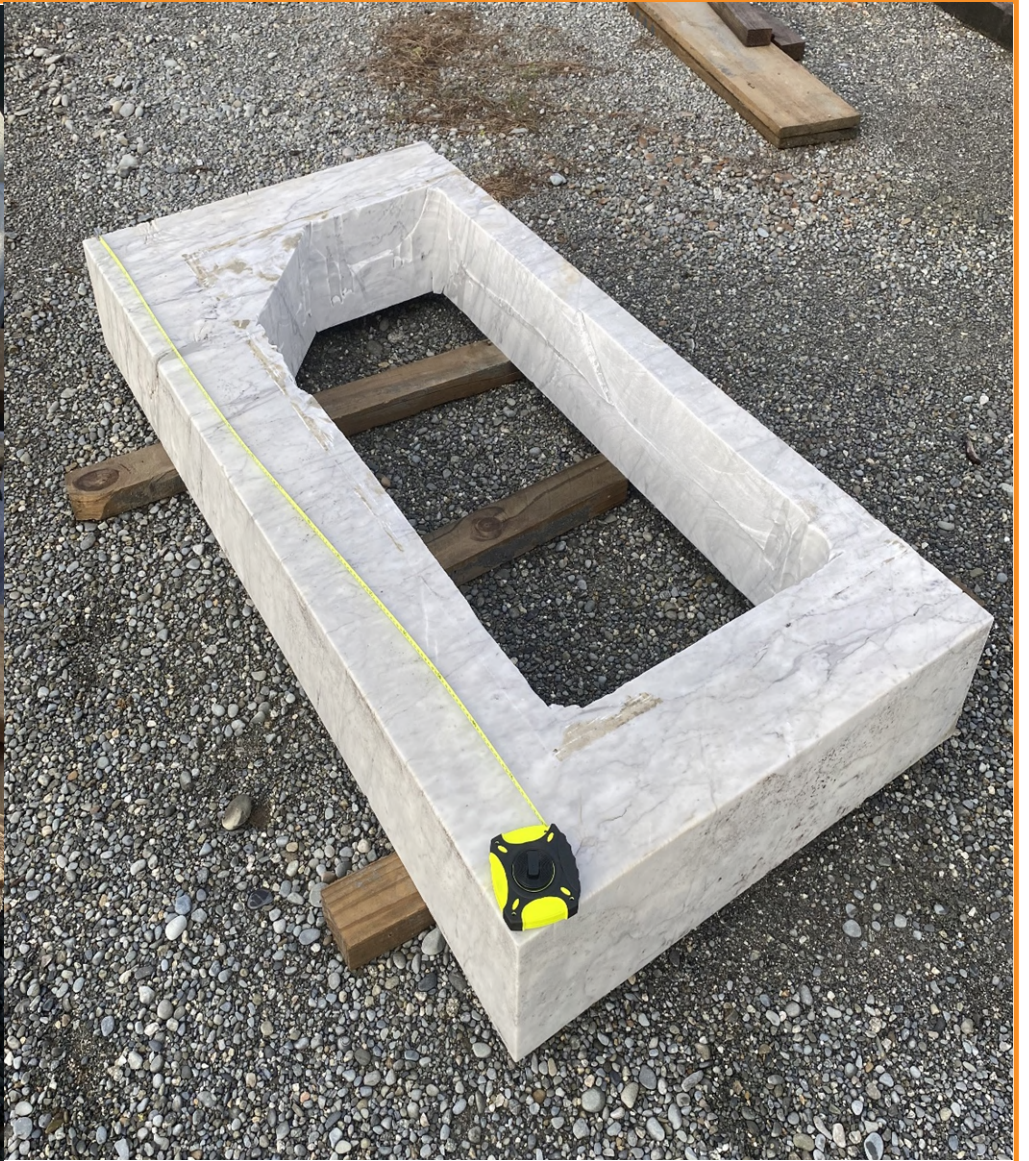
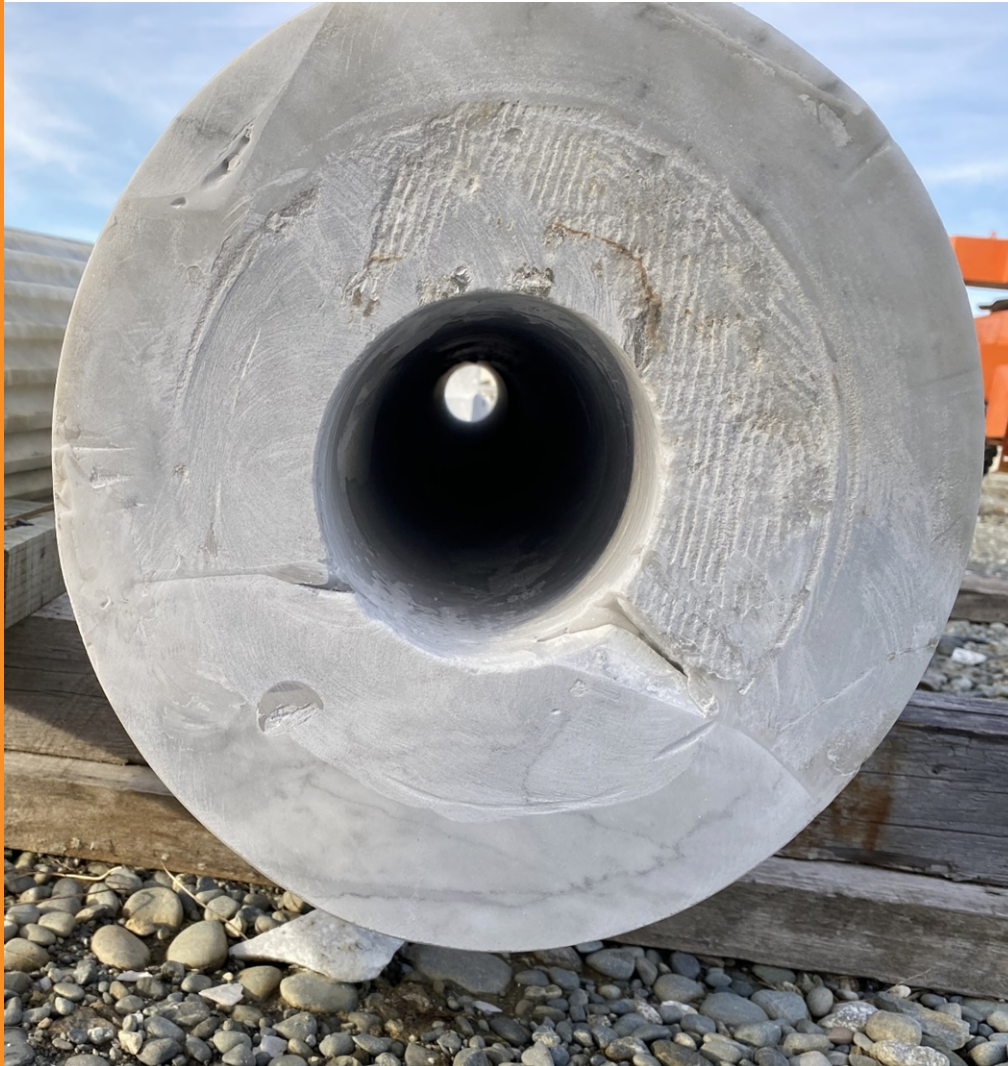
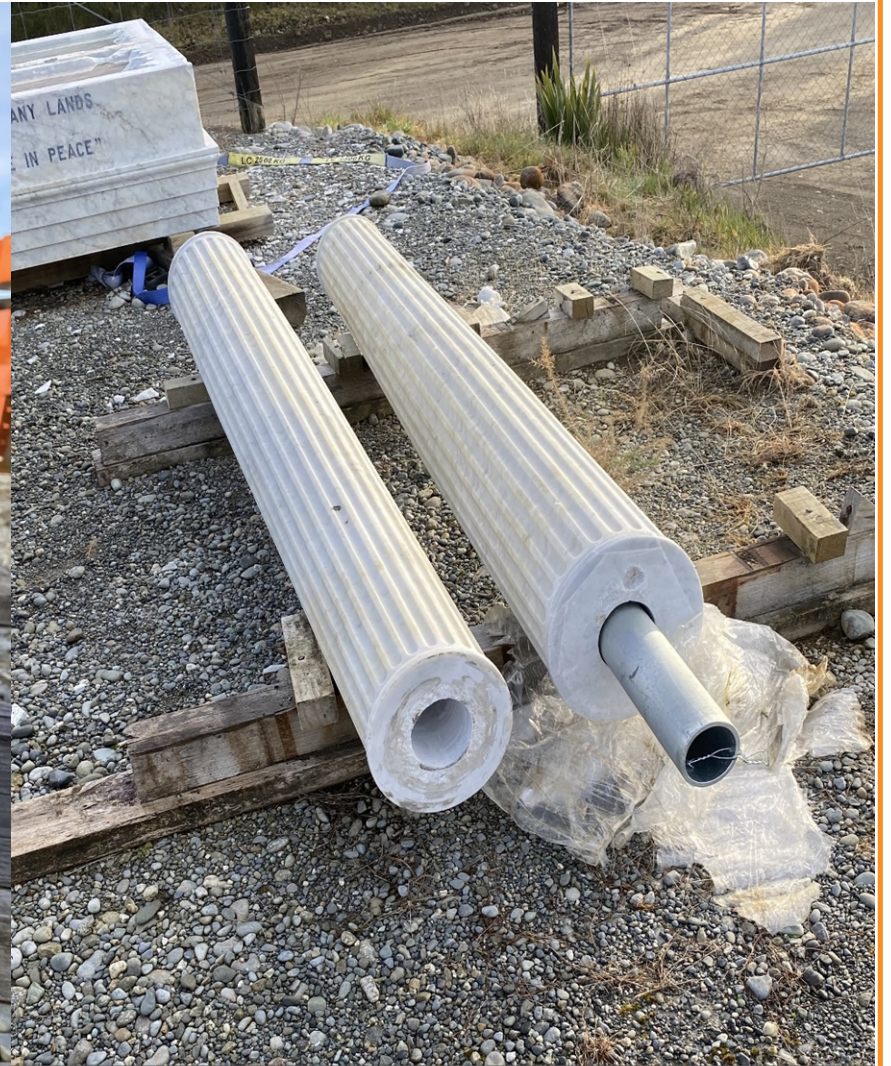
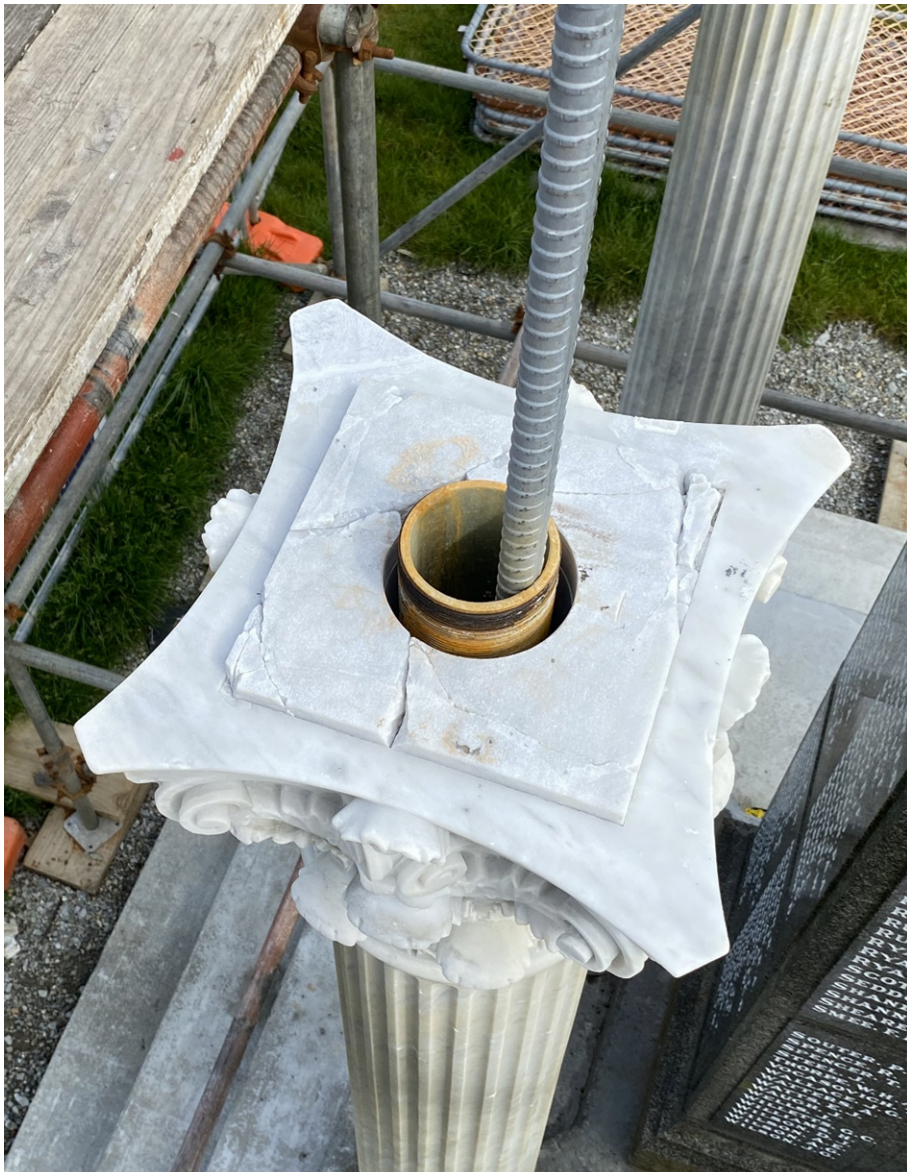
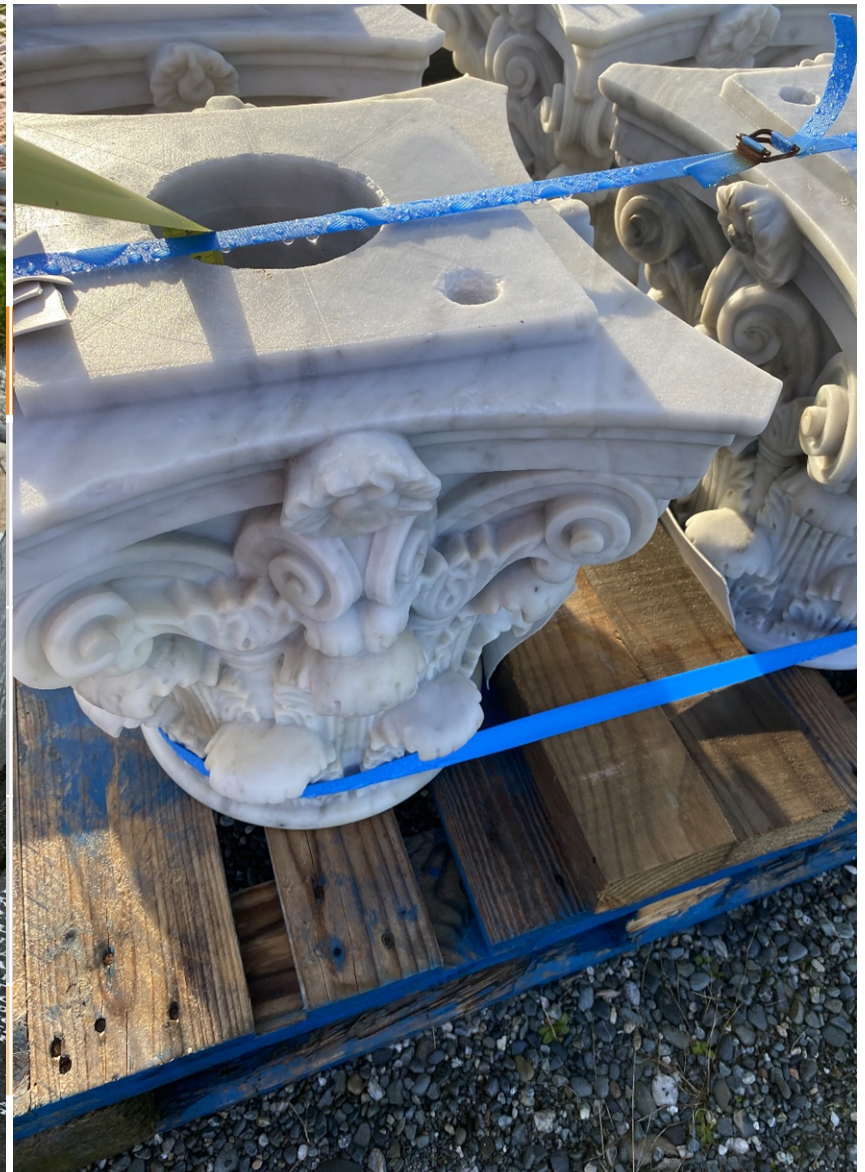
There was quite a bit of damage to the different parts of the Cenotaph that had to be repaired.

This work was carried out by the stone mason.

We also had to reduce the weight. This was achieved by removing the centers from the top pieces. This work was also carried out by the stone mason.
