Liddell
CONTRACTING

**WDC HOKITIKA
CENOTAPH
STRENGTHENING**

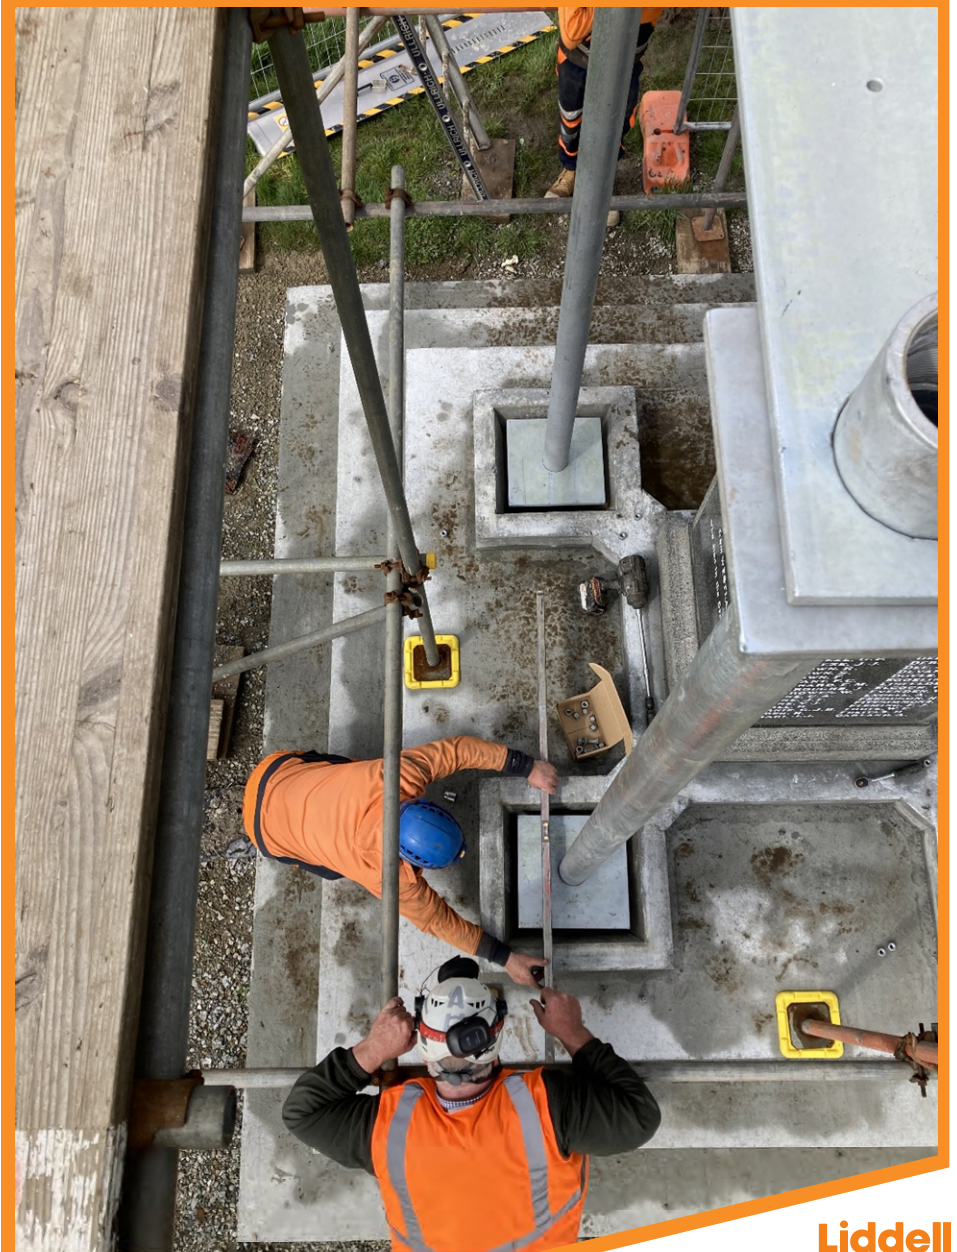
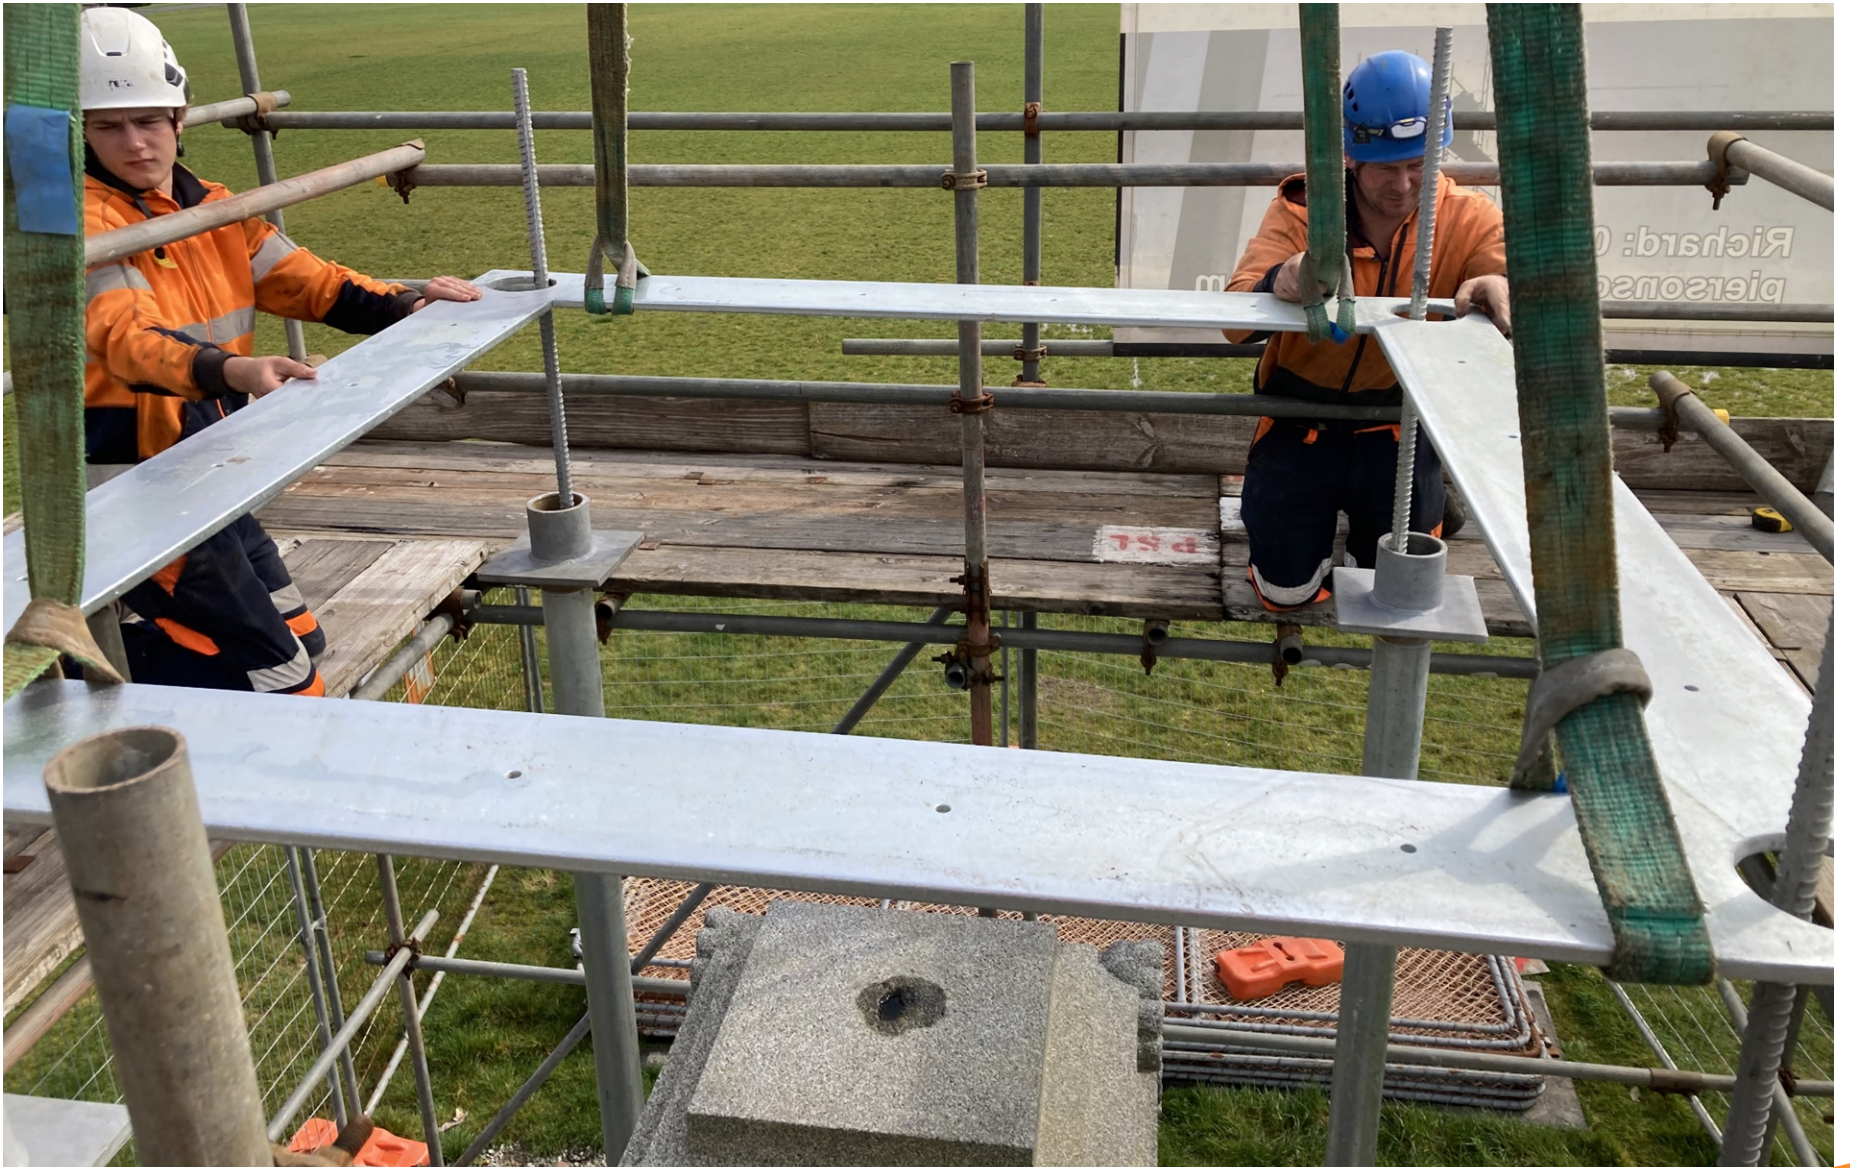
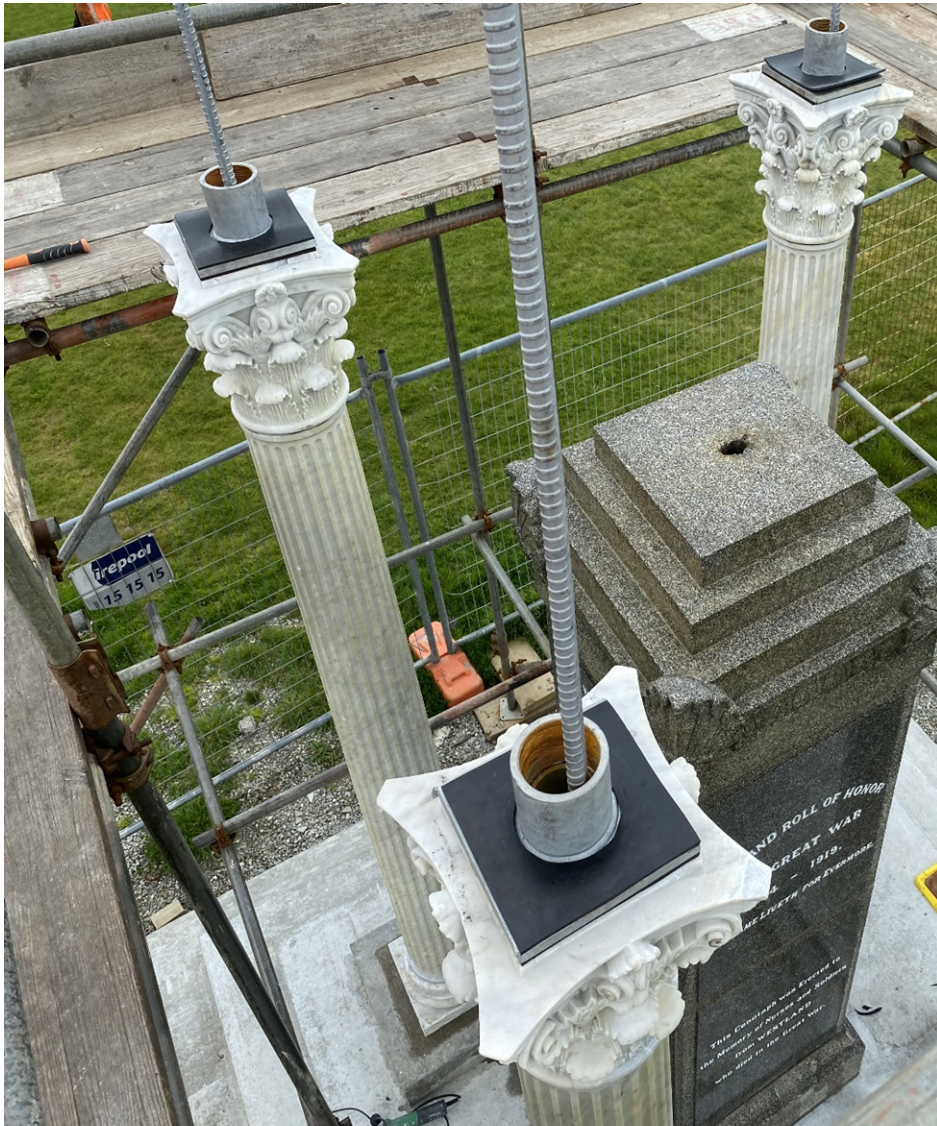
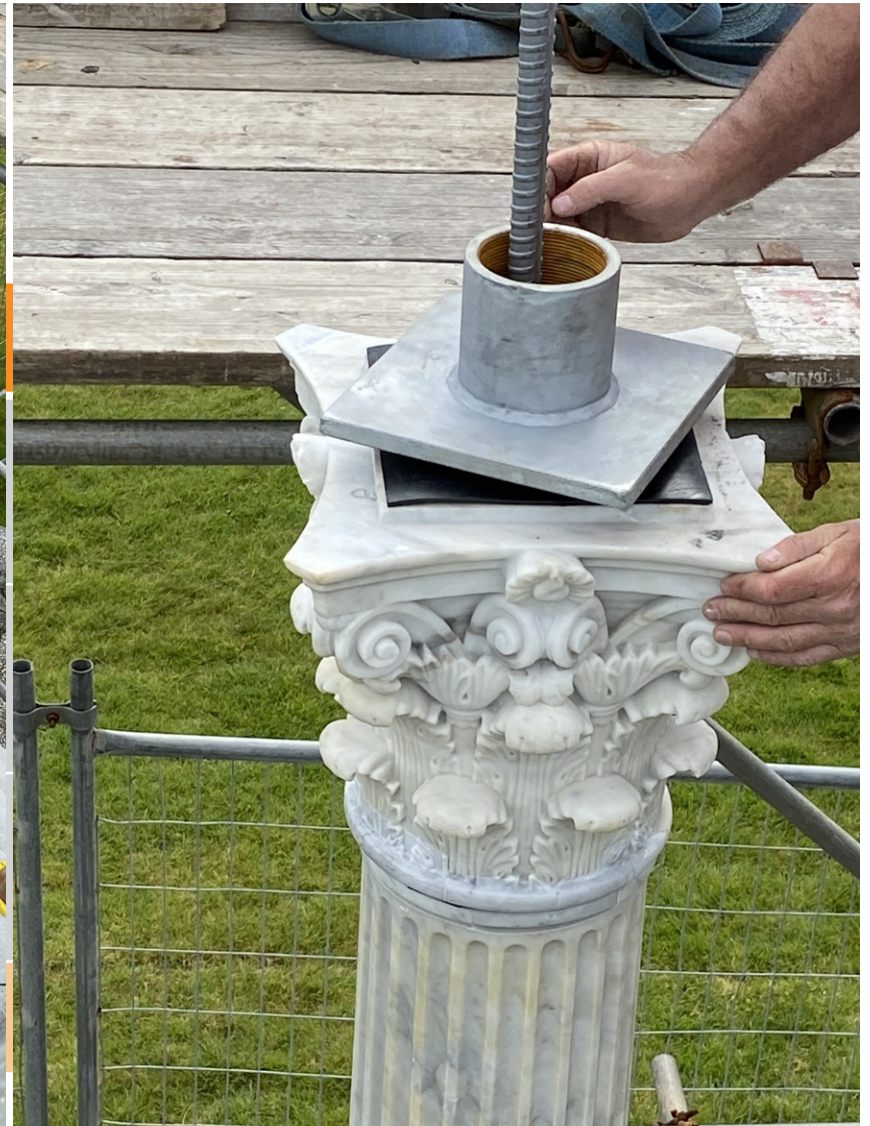
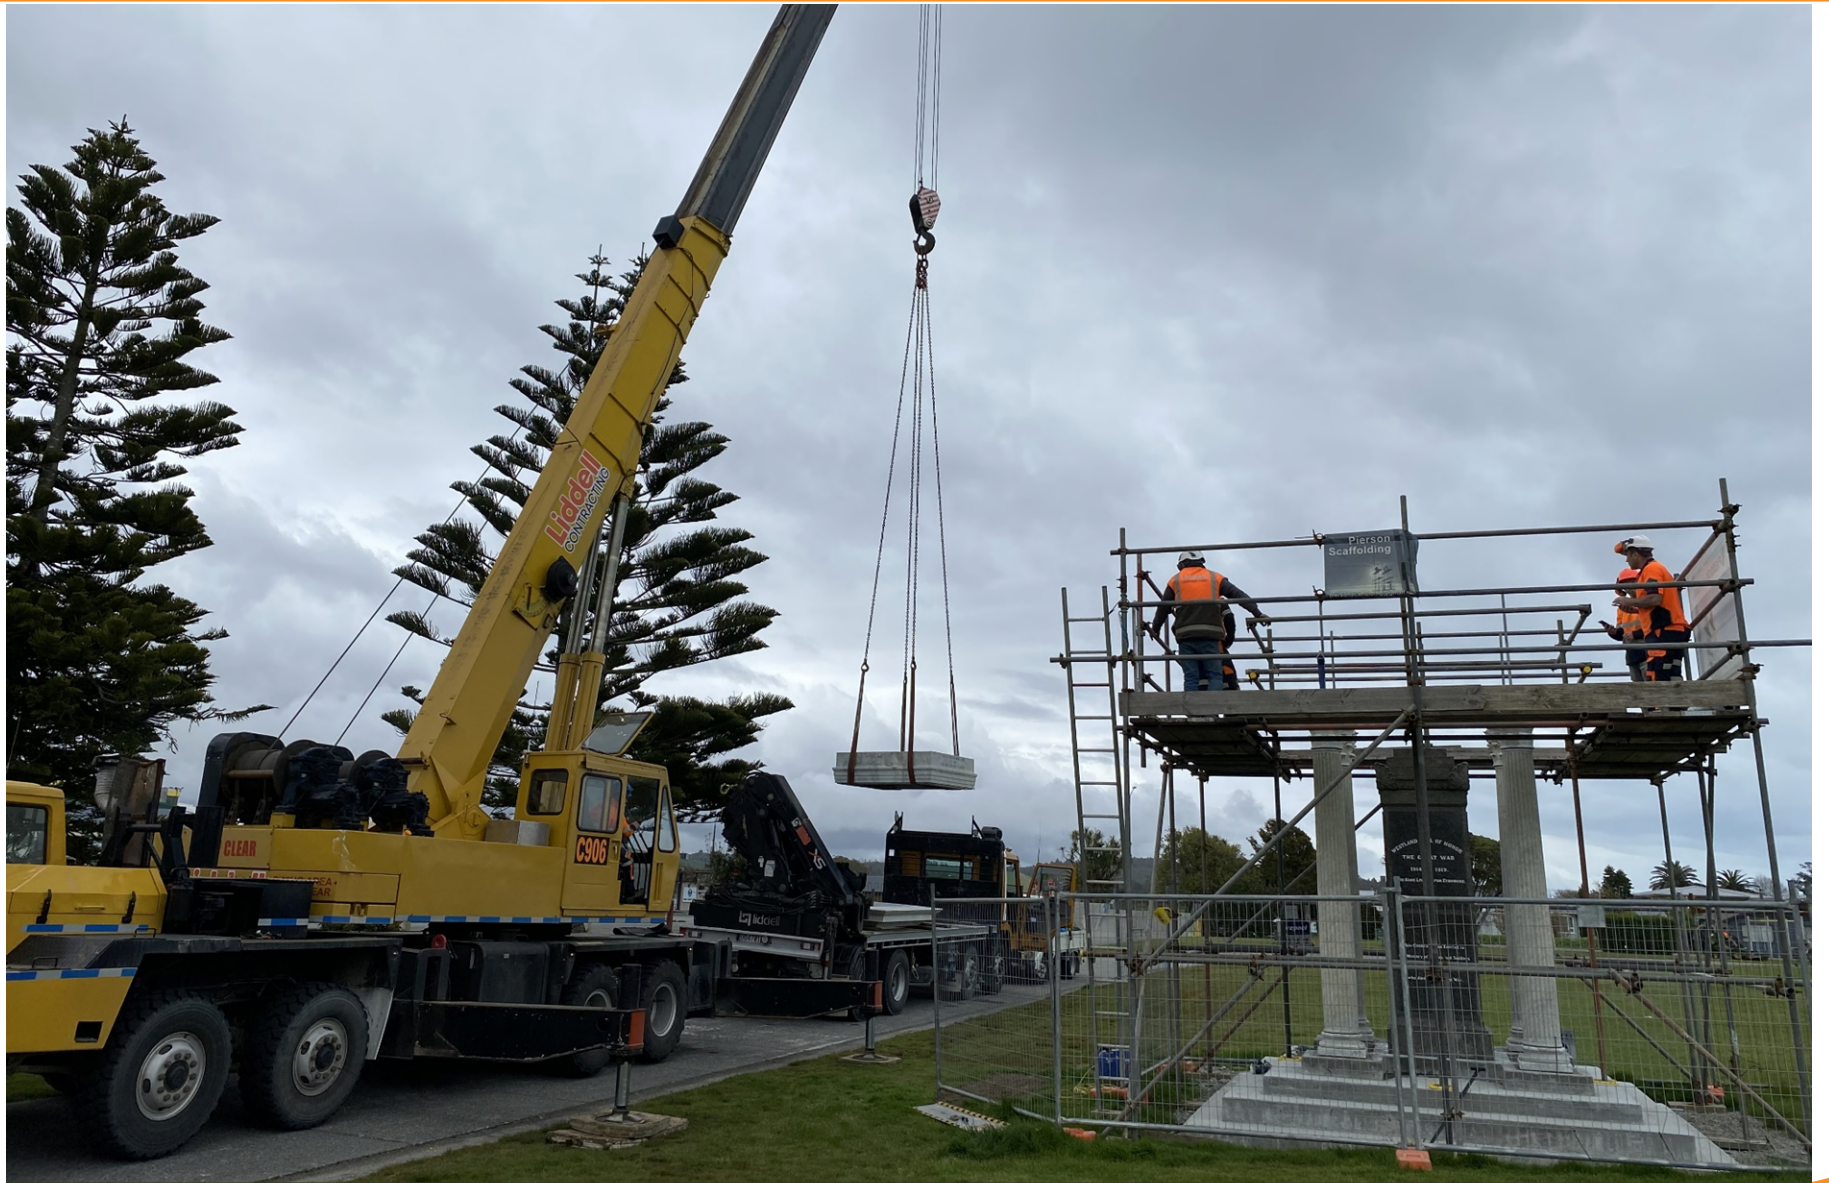
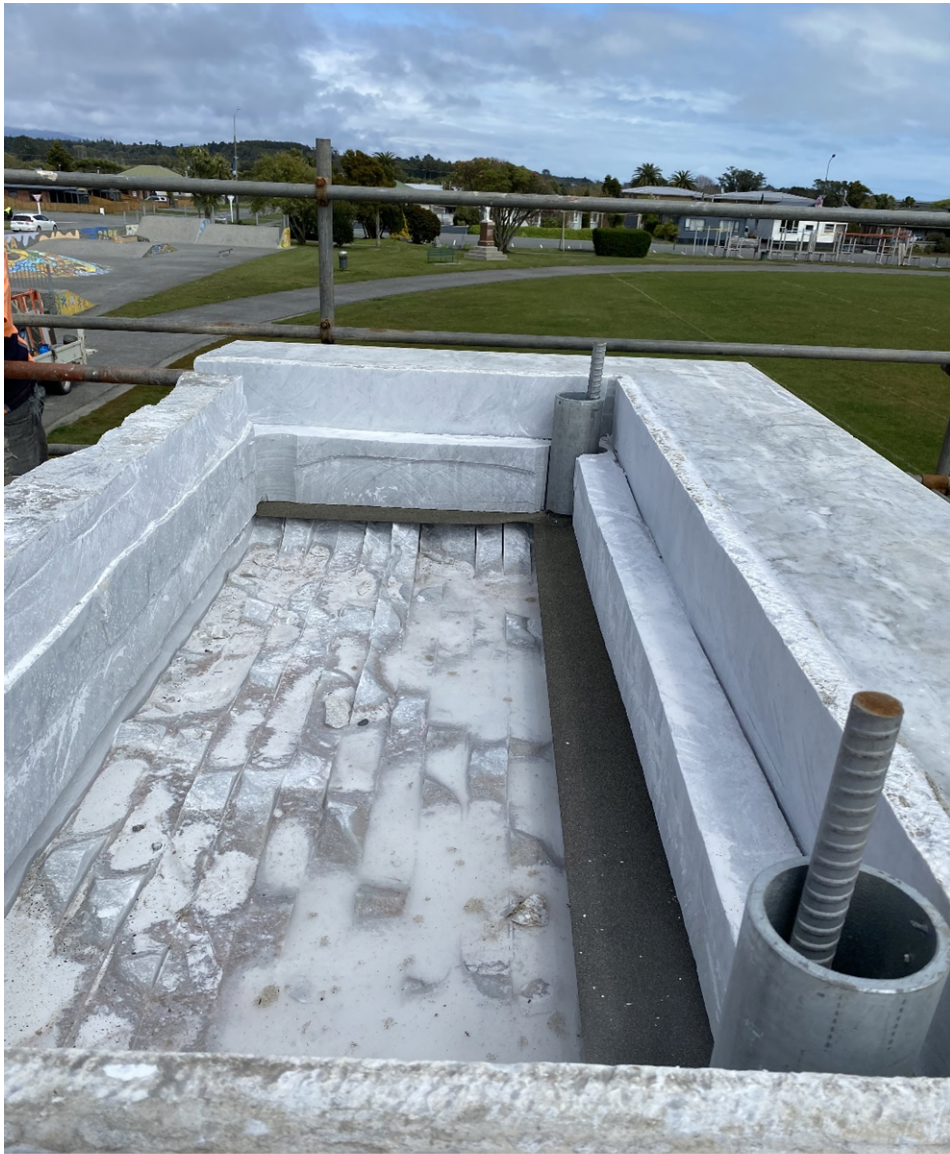
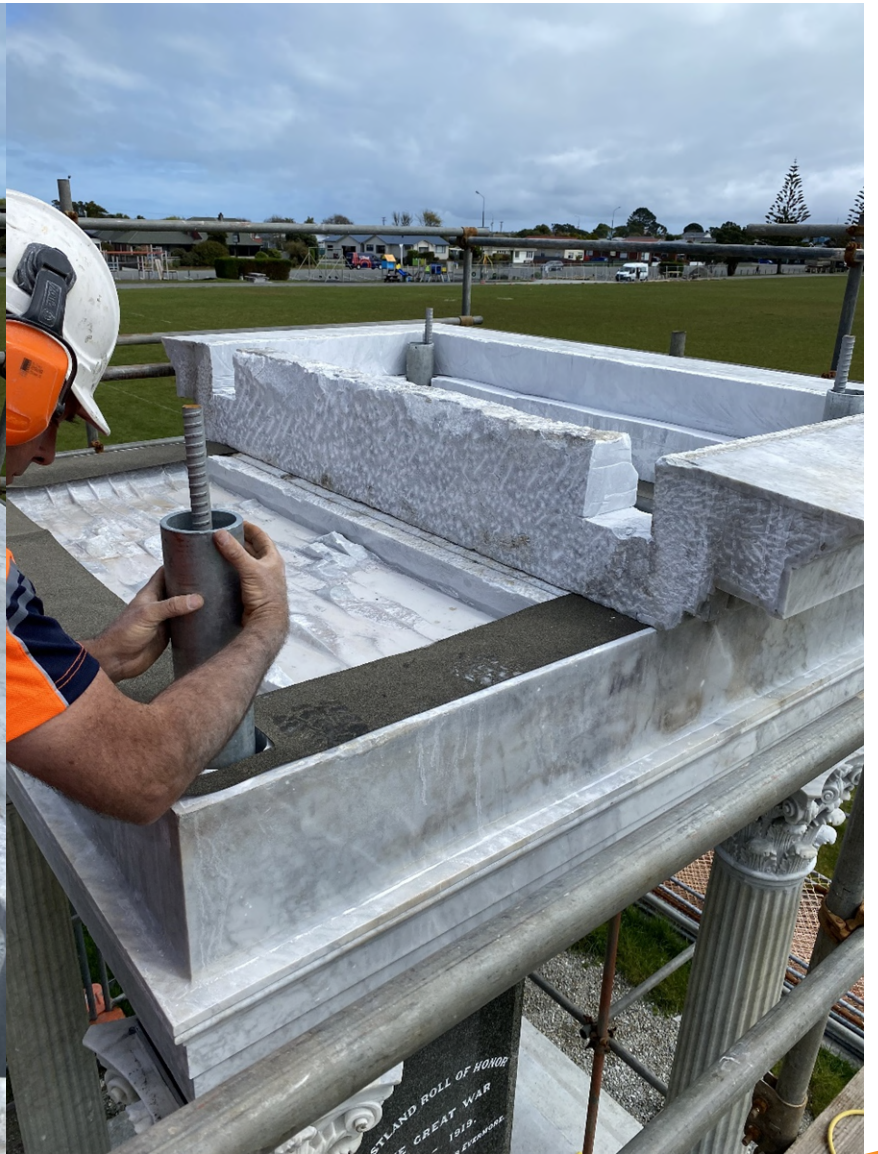
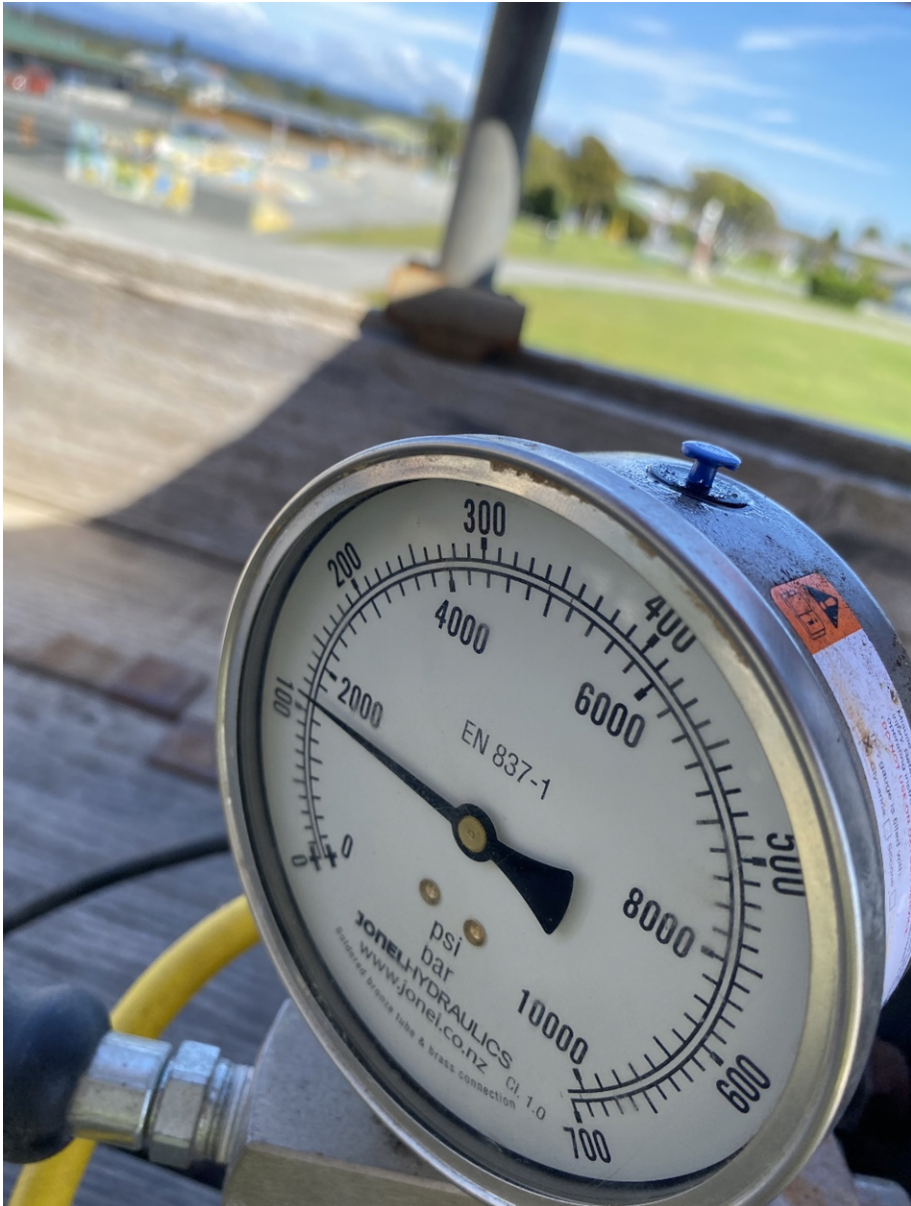
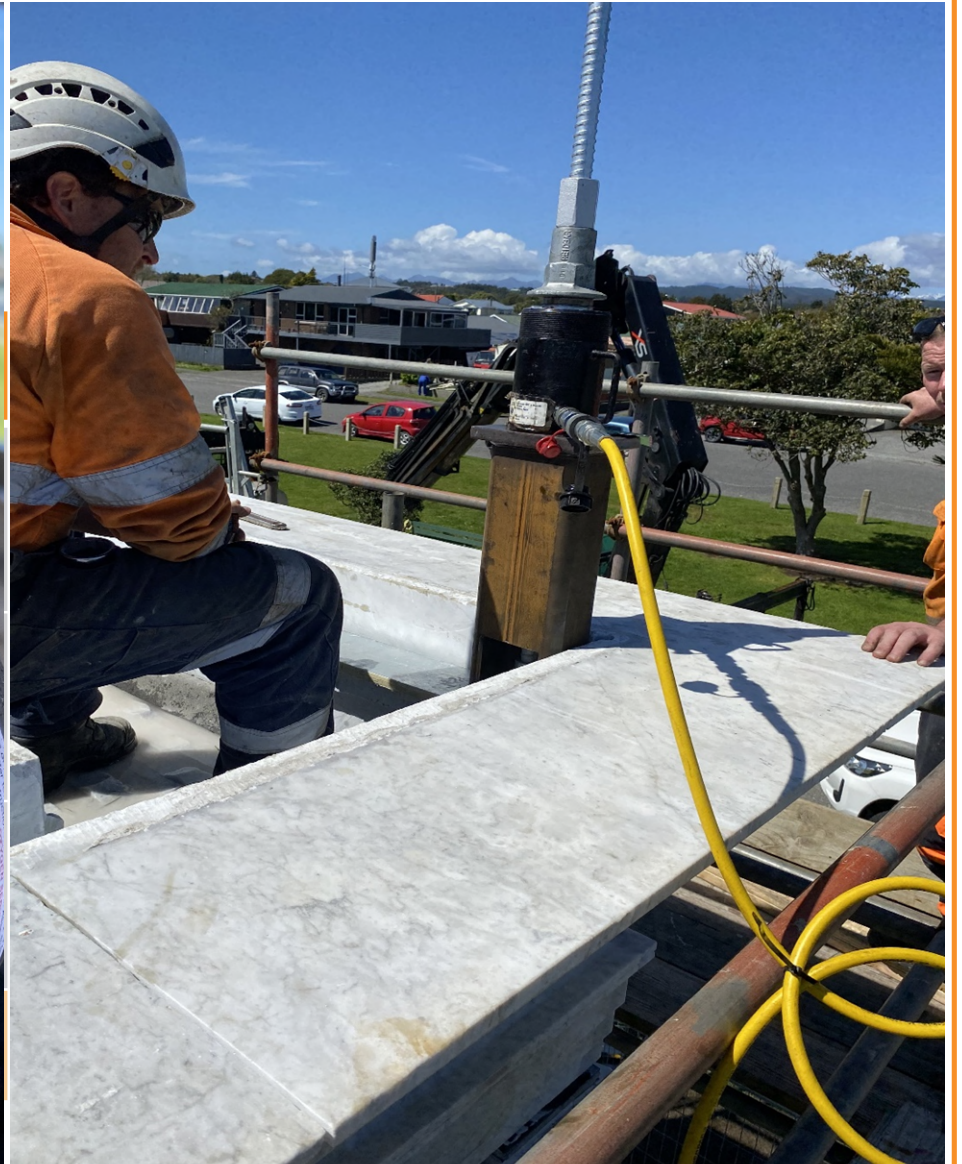
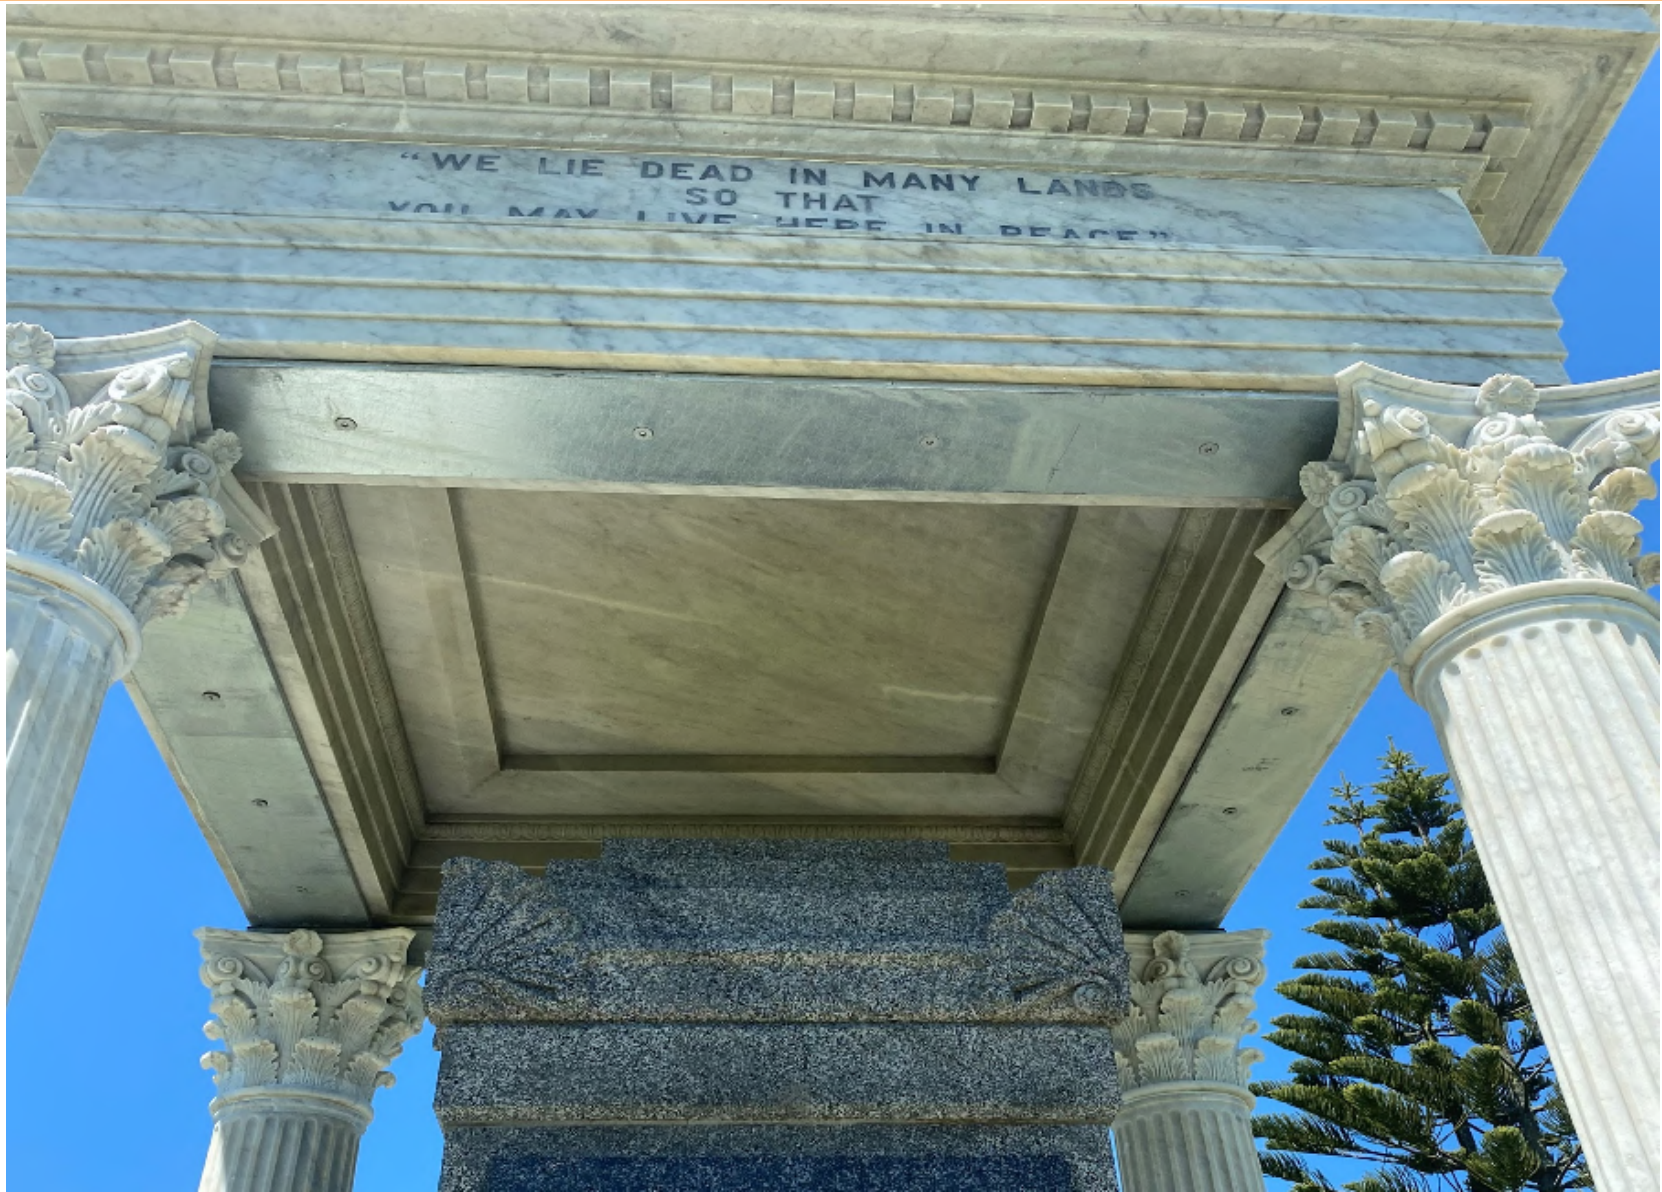
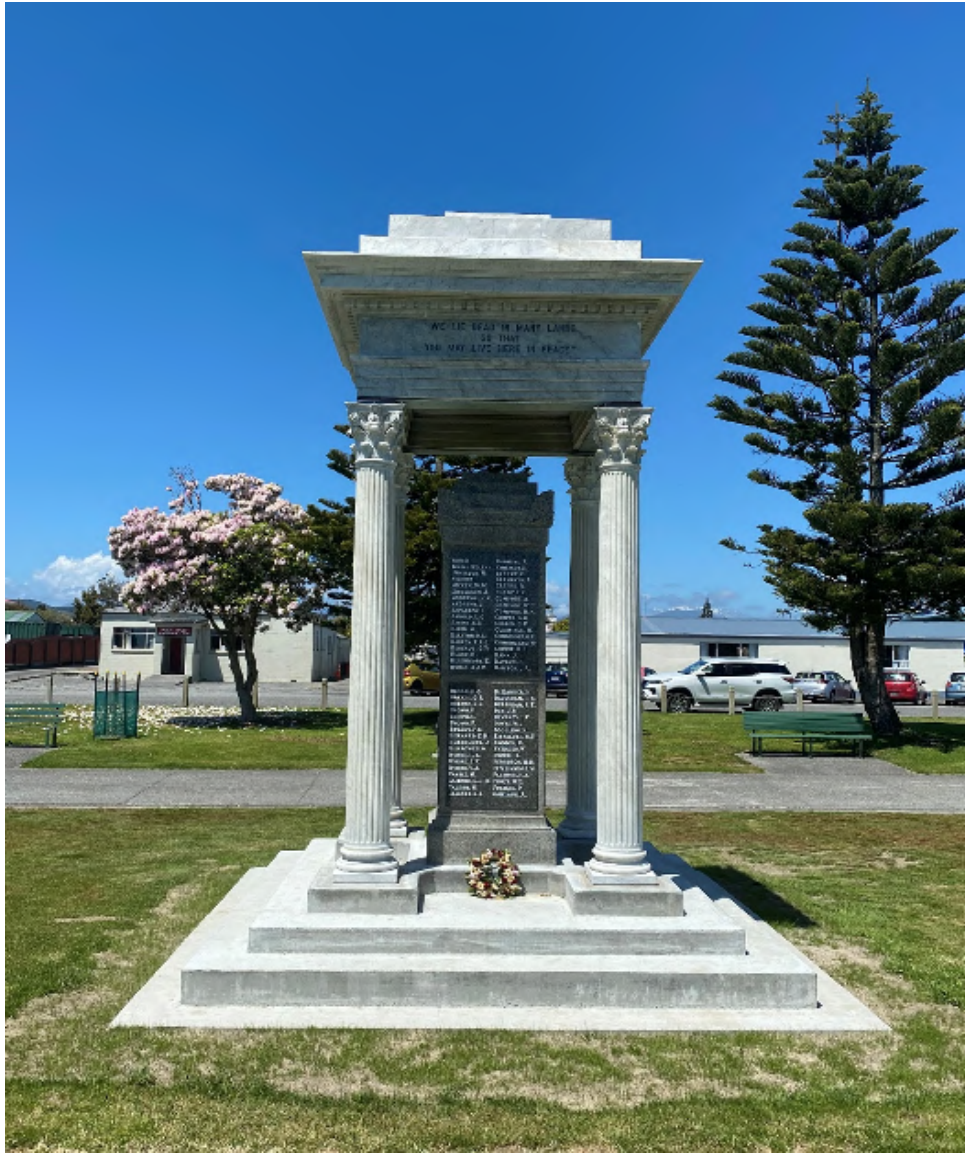
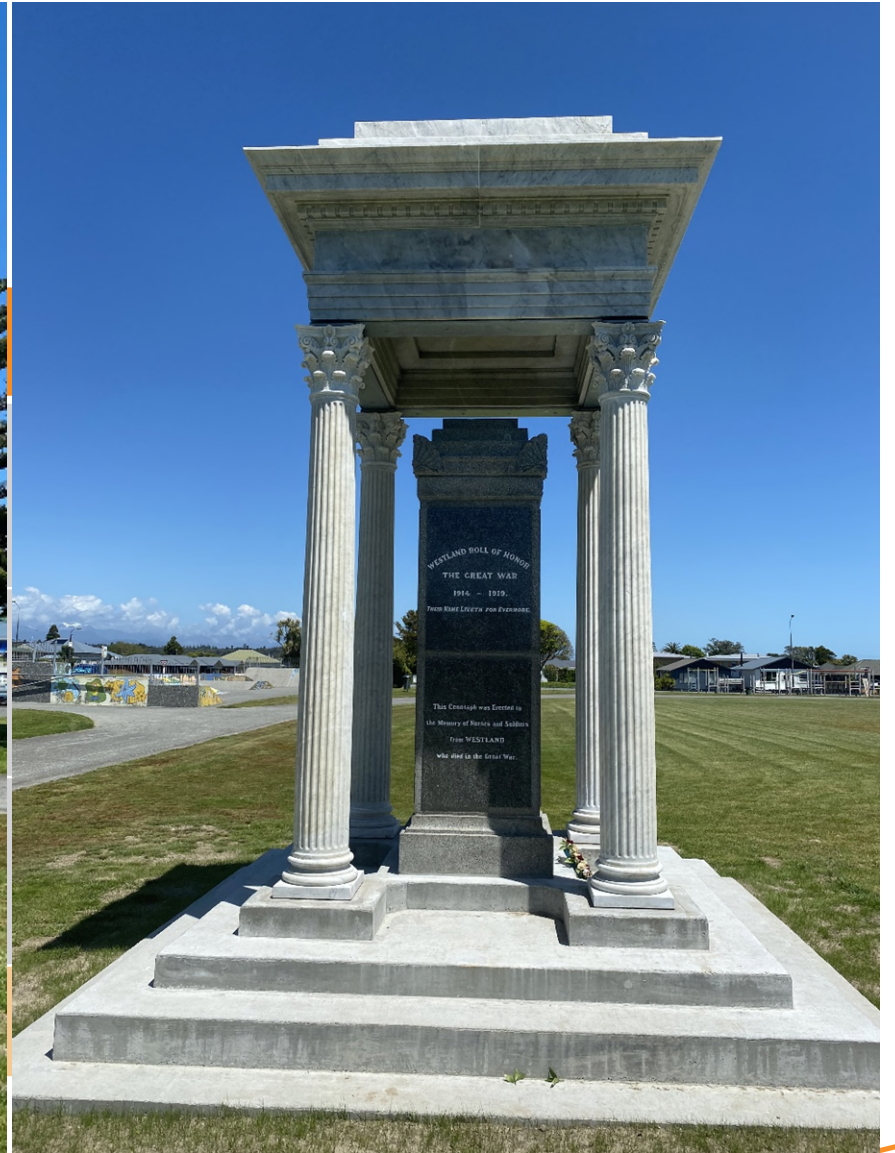
Once the Stone Mason has completed the work he had to do, we could start the re-erection of the Cenotaph.

This was most probably the easiest part of the rebuild because everything was designed and constructed to fit perfectly.
