# Preliminary Fill Material Investigation

*Sunset Point, Hokitika*

**Westland District Council**

19128146-7403-007-R-Rev0

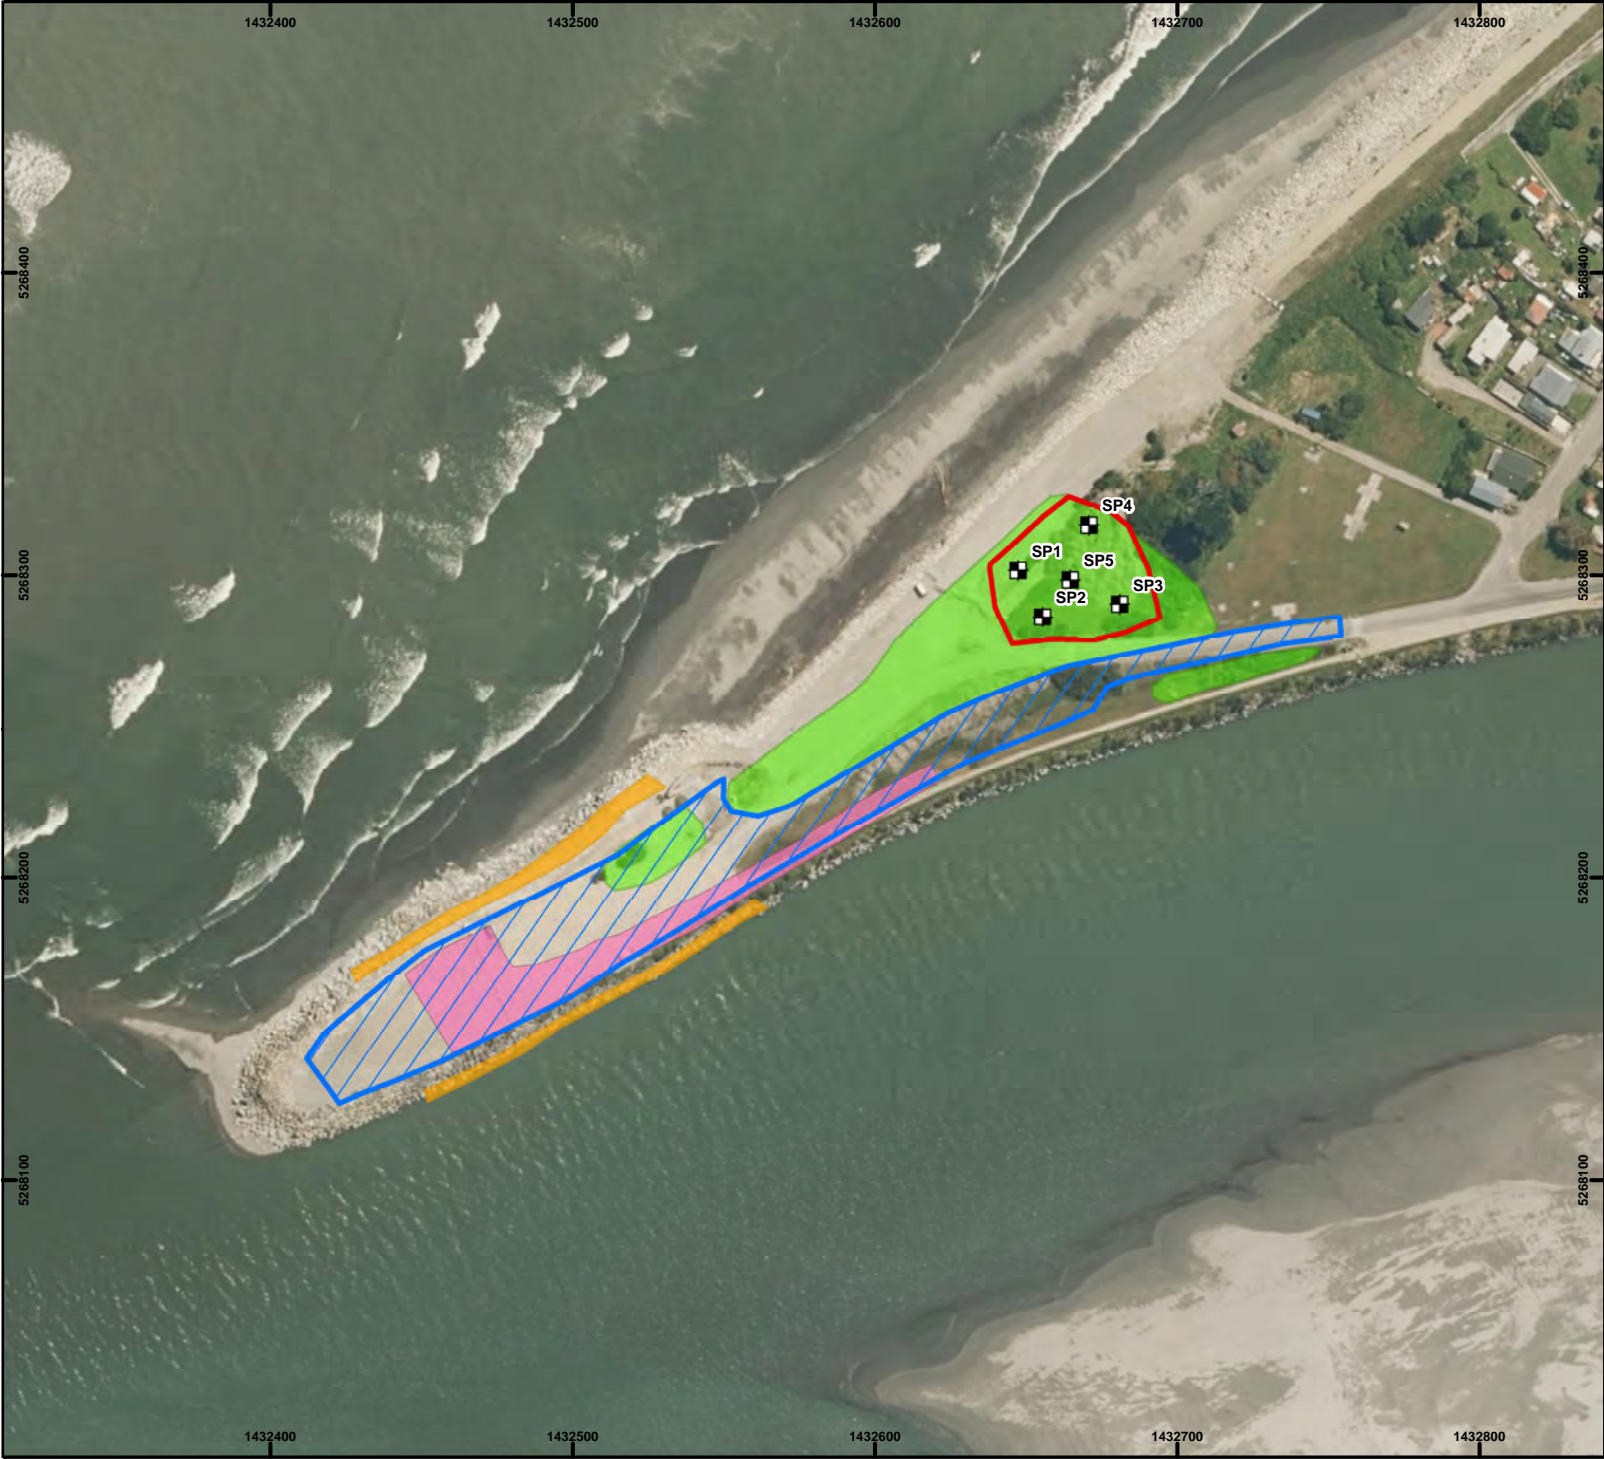
SUNSET POINT LANDFILL SITE PLAN

The area of the Site recently operated by WDC as a clean-fill operation is located at the western end of Gibson Quay and is adjacent to areas noted by WDC as capped with hard-fill. The area of demolition waste material, possibly being used for non-consented fly-tipping, is located within the northernmost portion of the clean fill area (Figure 2).

Five test pits (Figure 2) were excavated to a maximum depth of 2.1 m below ground level (bgl). The test pits were located within the clean fill operation area noted by WDC staff to contain demolition waste.

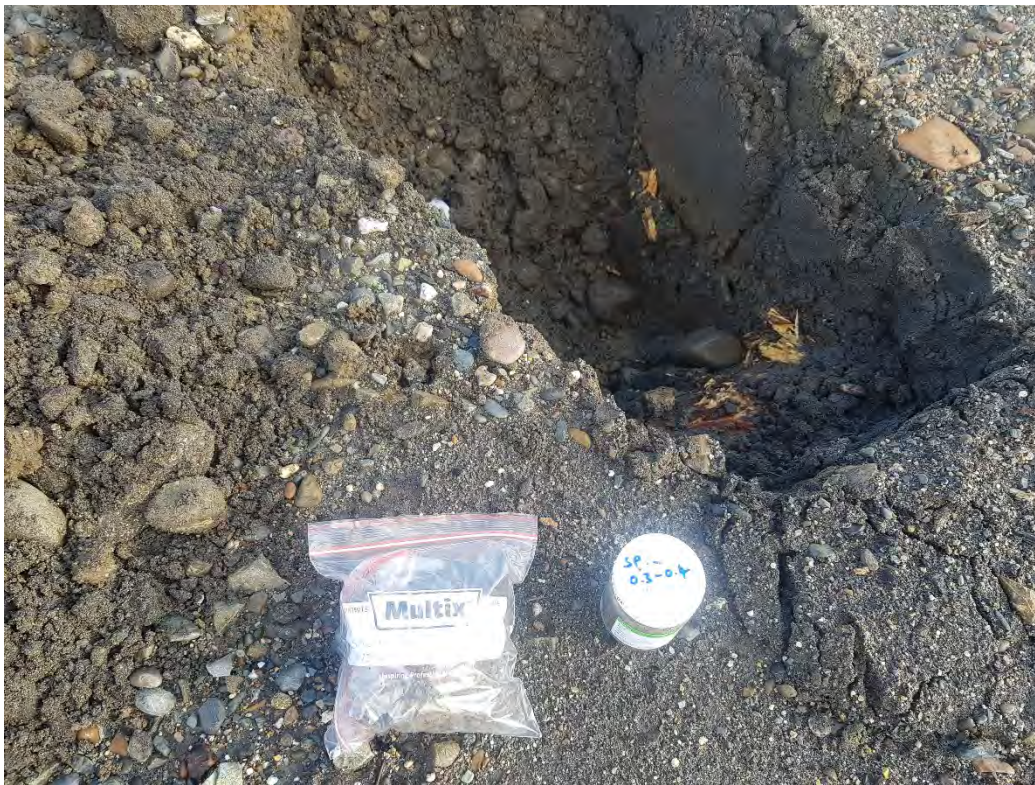
Location	Depth (m bgl)	VOCs (ppm)	Observed geology	Estimate of fill material (% by volume)	Additional observations
SP1	0.0 – 0.1	1.0	SAND and sandy SILT with gravel and cobbles, dark grey, moist, wood debris.	0 %	Bricks, concrete, trace wire observed at 1.3 m bgl.

**Photo 1. Test Pit SP1 showing wood debris in sandy silt matrix.**

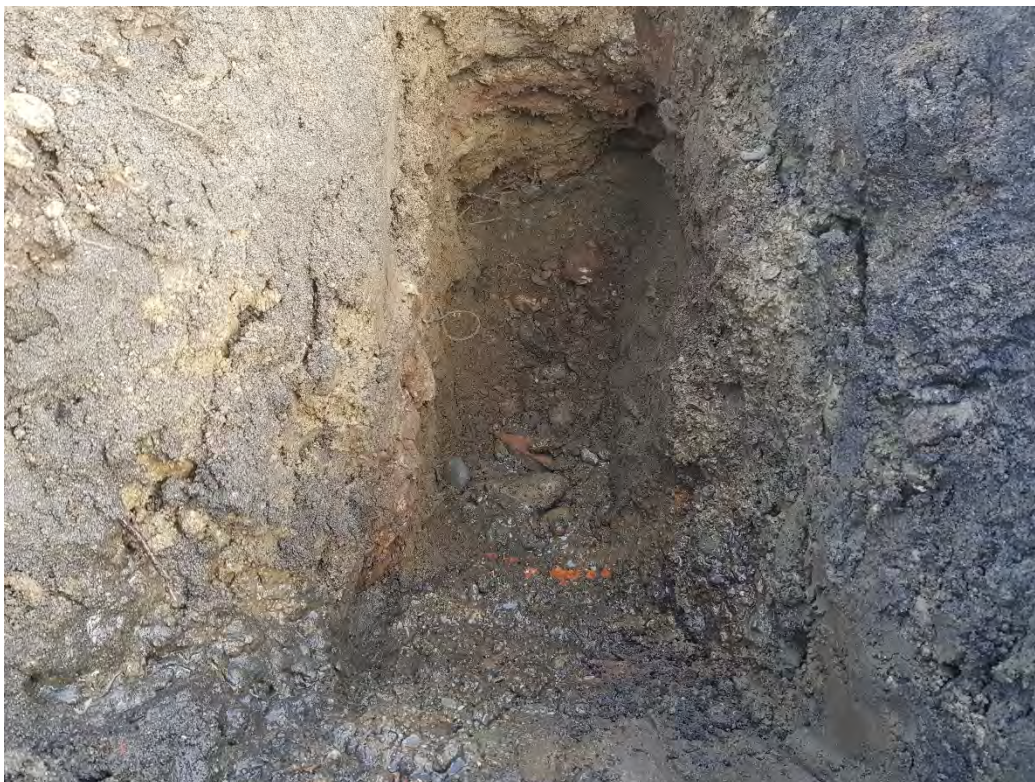
**Photo 2. Test Pit SP1 showing demolition waste (bricks, concrete, wire) at depth (1.3 – 1.4 m bgl).**

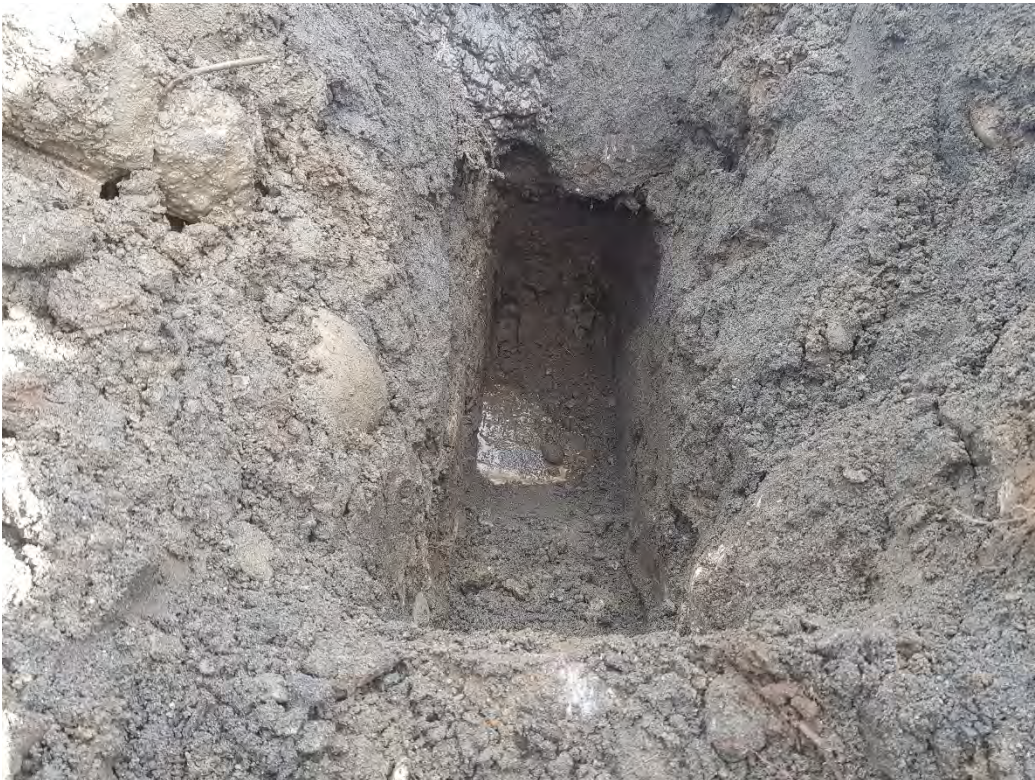
0.3 – 0.4	0.9		0 %	
	1.3 – 1.4	0.9		<5 %	
SP2	0.0 – 0.1	1.0	SAND and sandy SILT with gravel and cobbles, dark grey, moist.	0 %	Concrete block observed at 0.3 m bgl and decomposing organic matter observed at 1.3 m bgl.

**Photo 3. Test Pit SP2 showing organic matter and groundwater at depth (1.3 – 1.4 m bgl).**

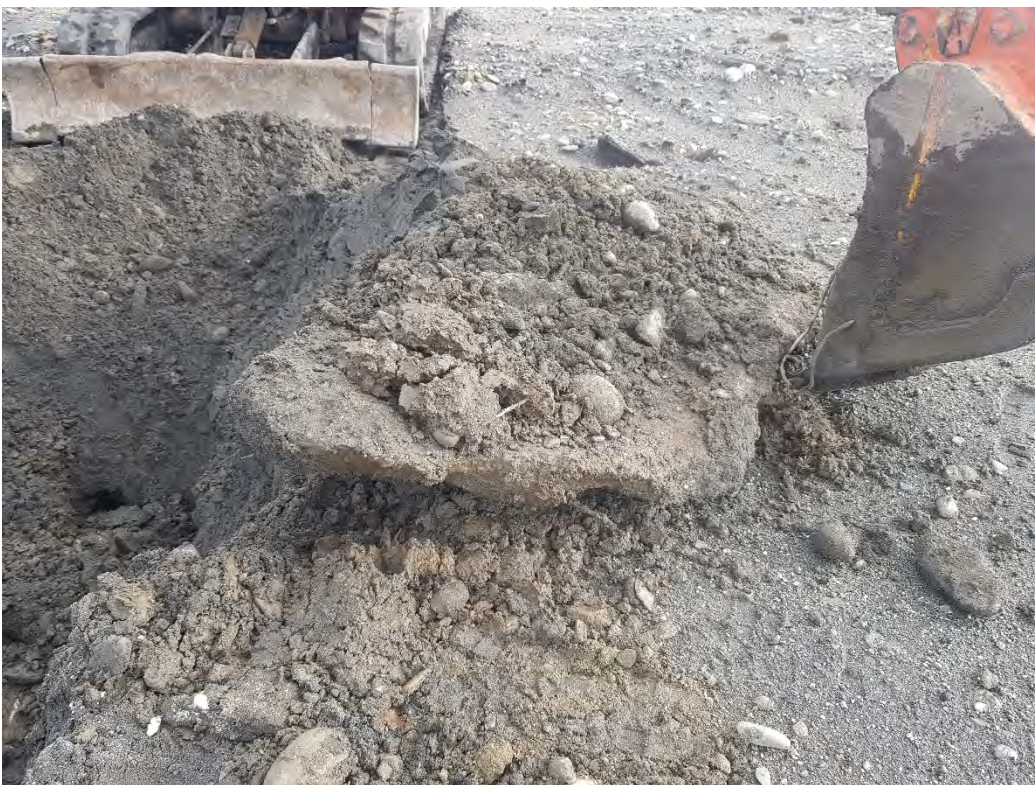
**Photo 4. Concrete block encountered at Test Pit SP2 at 0.3 m bgl.**

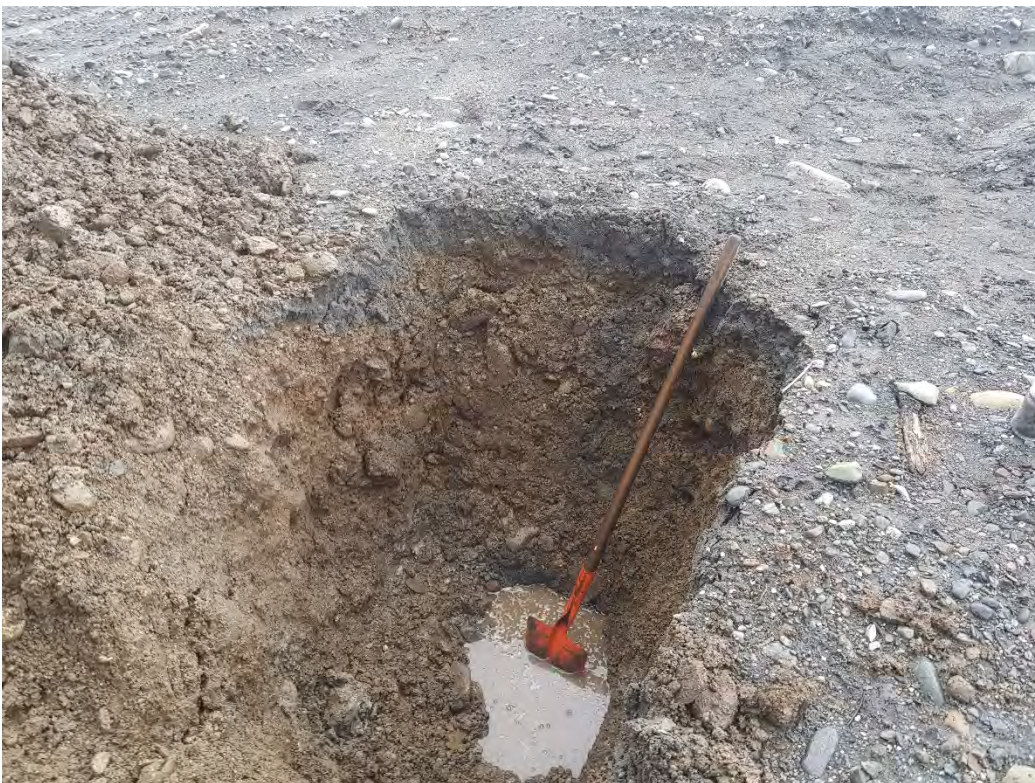
0.4 – 0.5	2.6		0 %	
	0.8 – 0.9	2.3		0 %	
	2.0 – 2.1	2.1		0 %	
SP5	0.0 – 0.1	1.9	Silty SAND with gravel and cobbles, dark grey, moist.	<5 %	Trace asphalt observed near surface.

**Photo 10. Close up of Test Pit SP5. Trace asphalt observed near surface.**
