Memorandum

To	Erle Bencich
Copy	Mark Smith, Kathie Ragg
From	Rem Markland
Office	Greymouth
Date	19 June 2024
File/Ref	6-WWES5.02
Subject	Totara Rail Bridge - Summary Assessment 2024

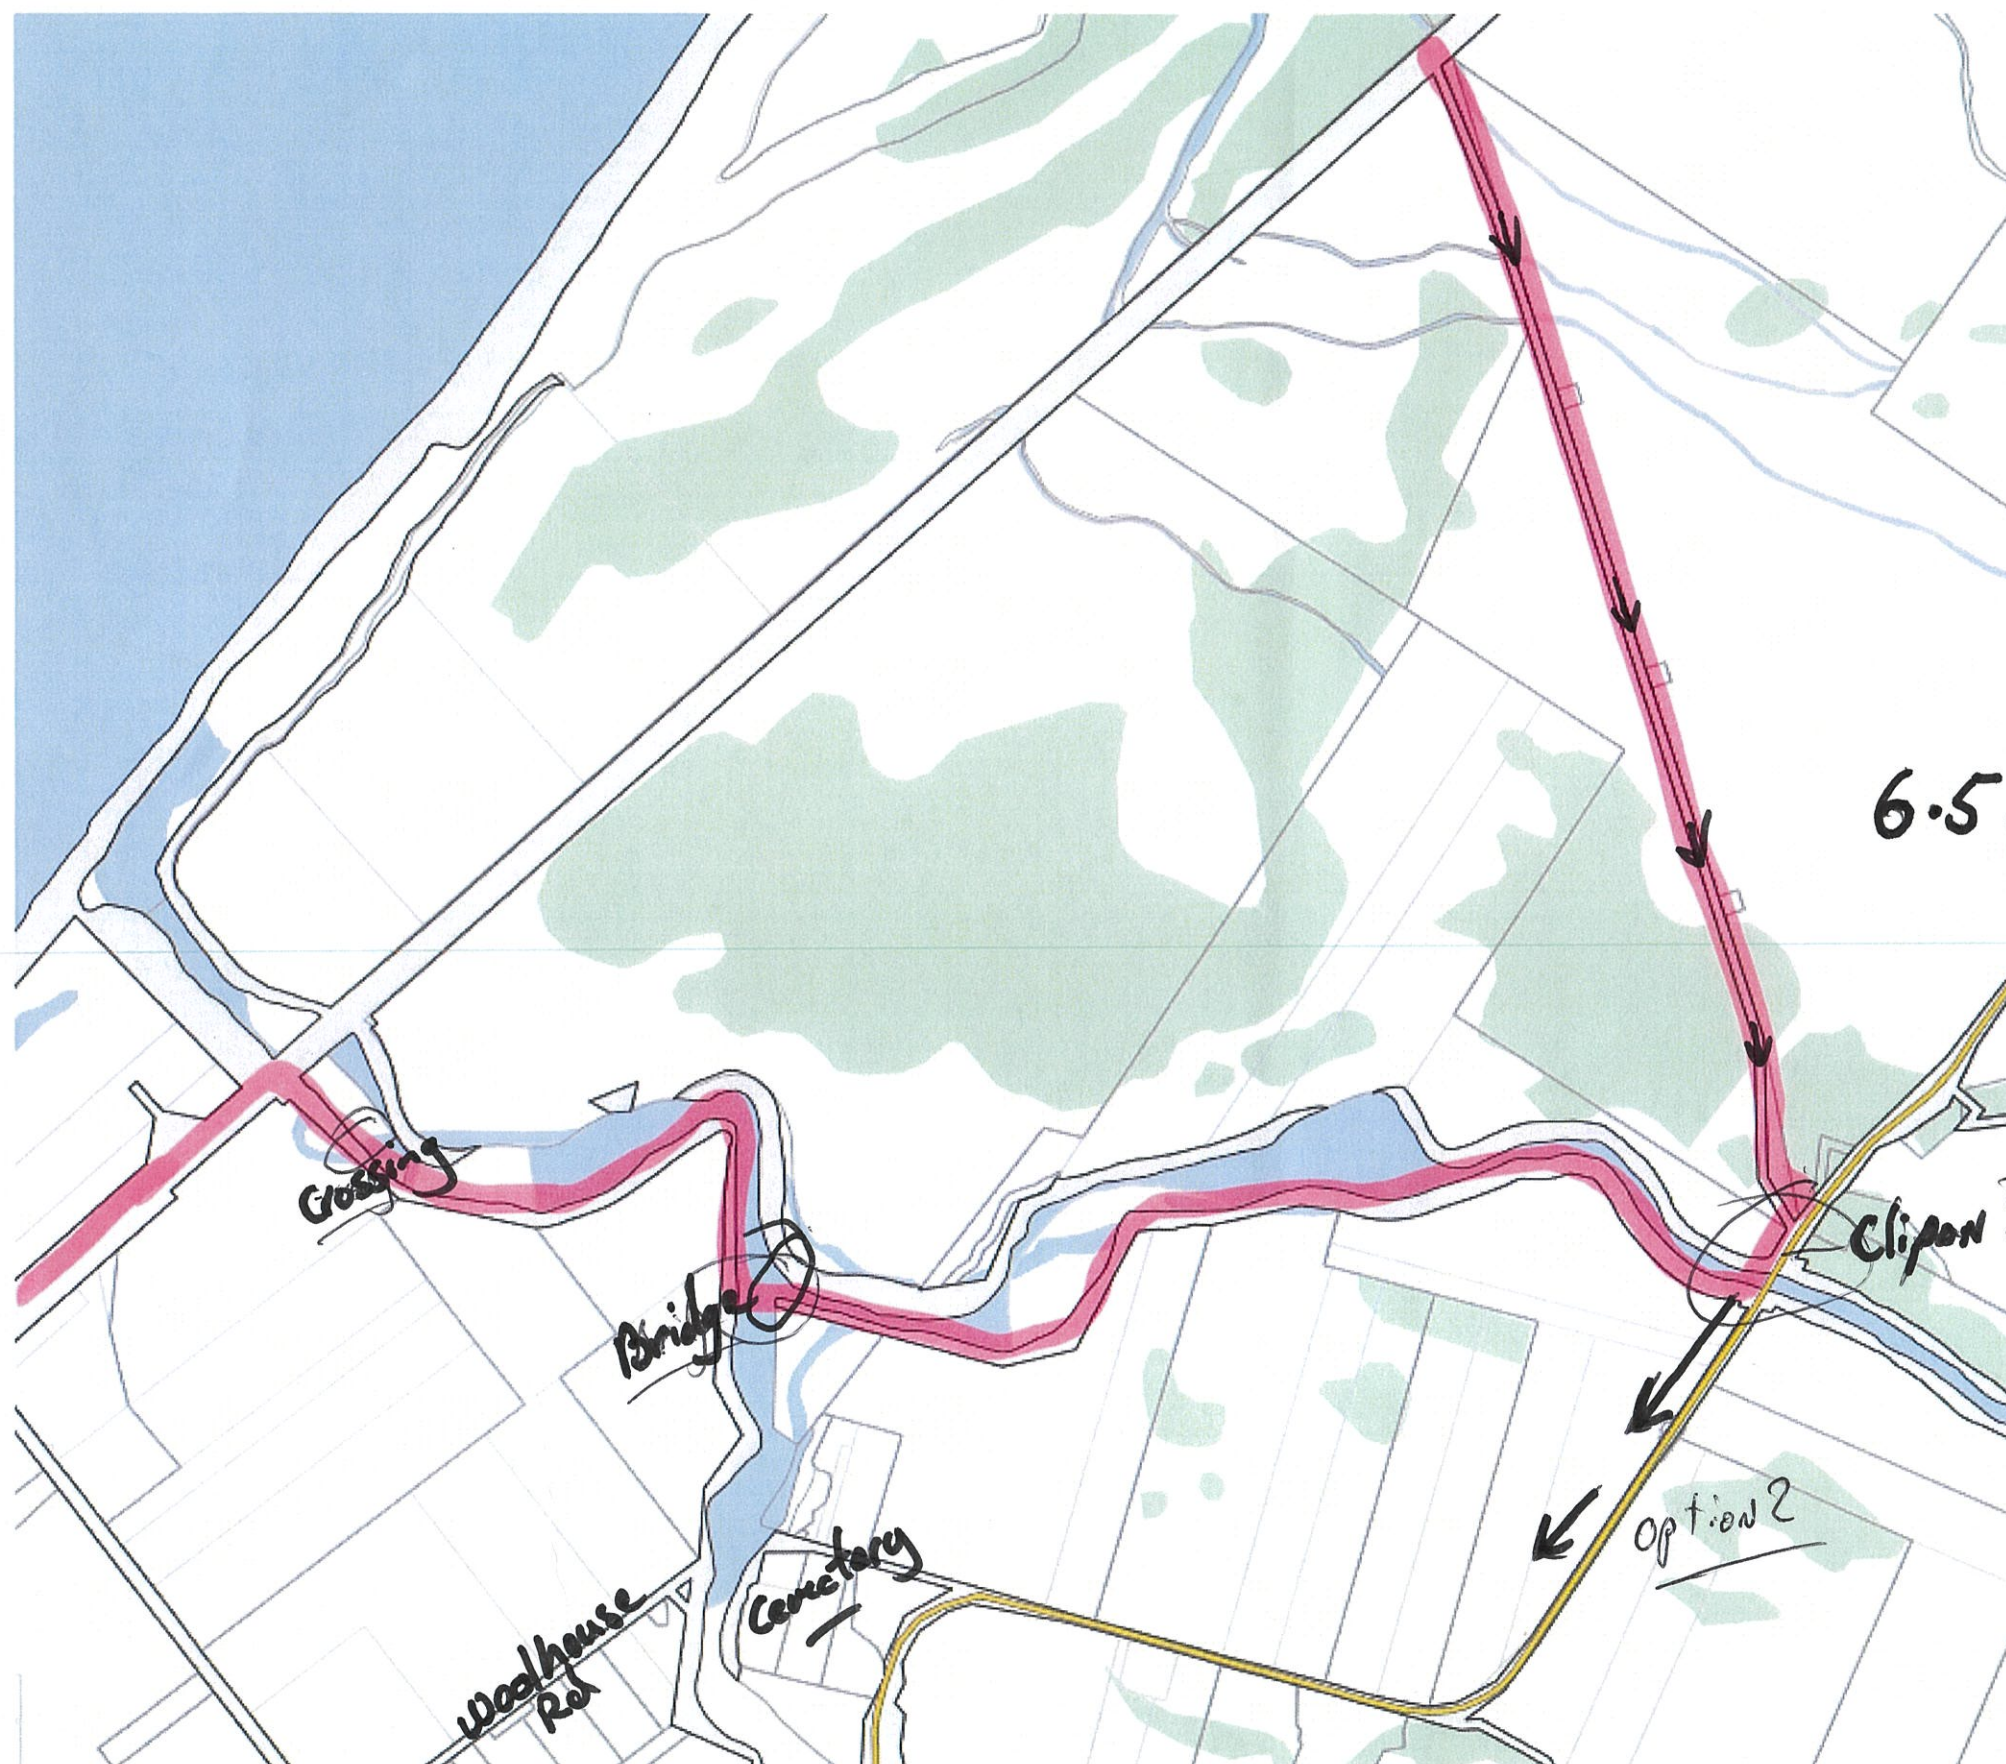
Option 1

- divert to Papakāwai Rd
- cross Totara bridge (highway)
- perhaps a clip on
- divert back to original course via road reserve

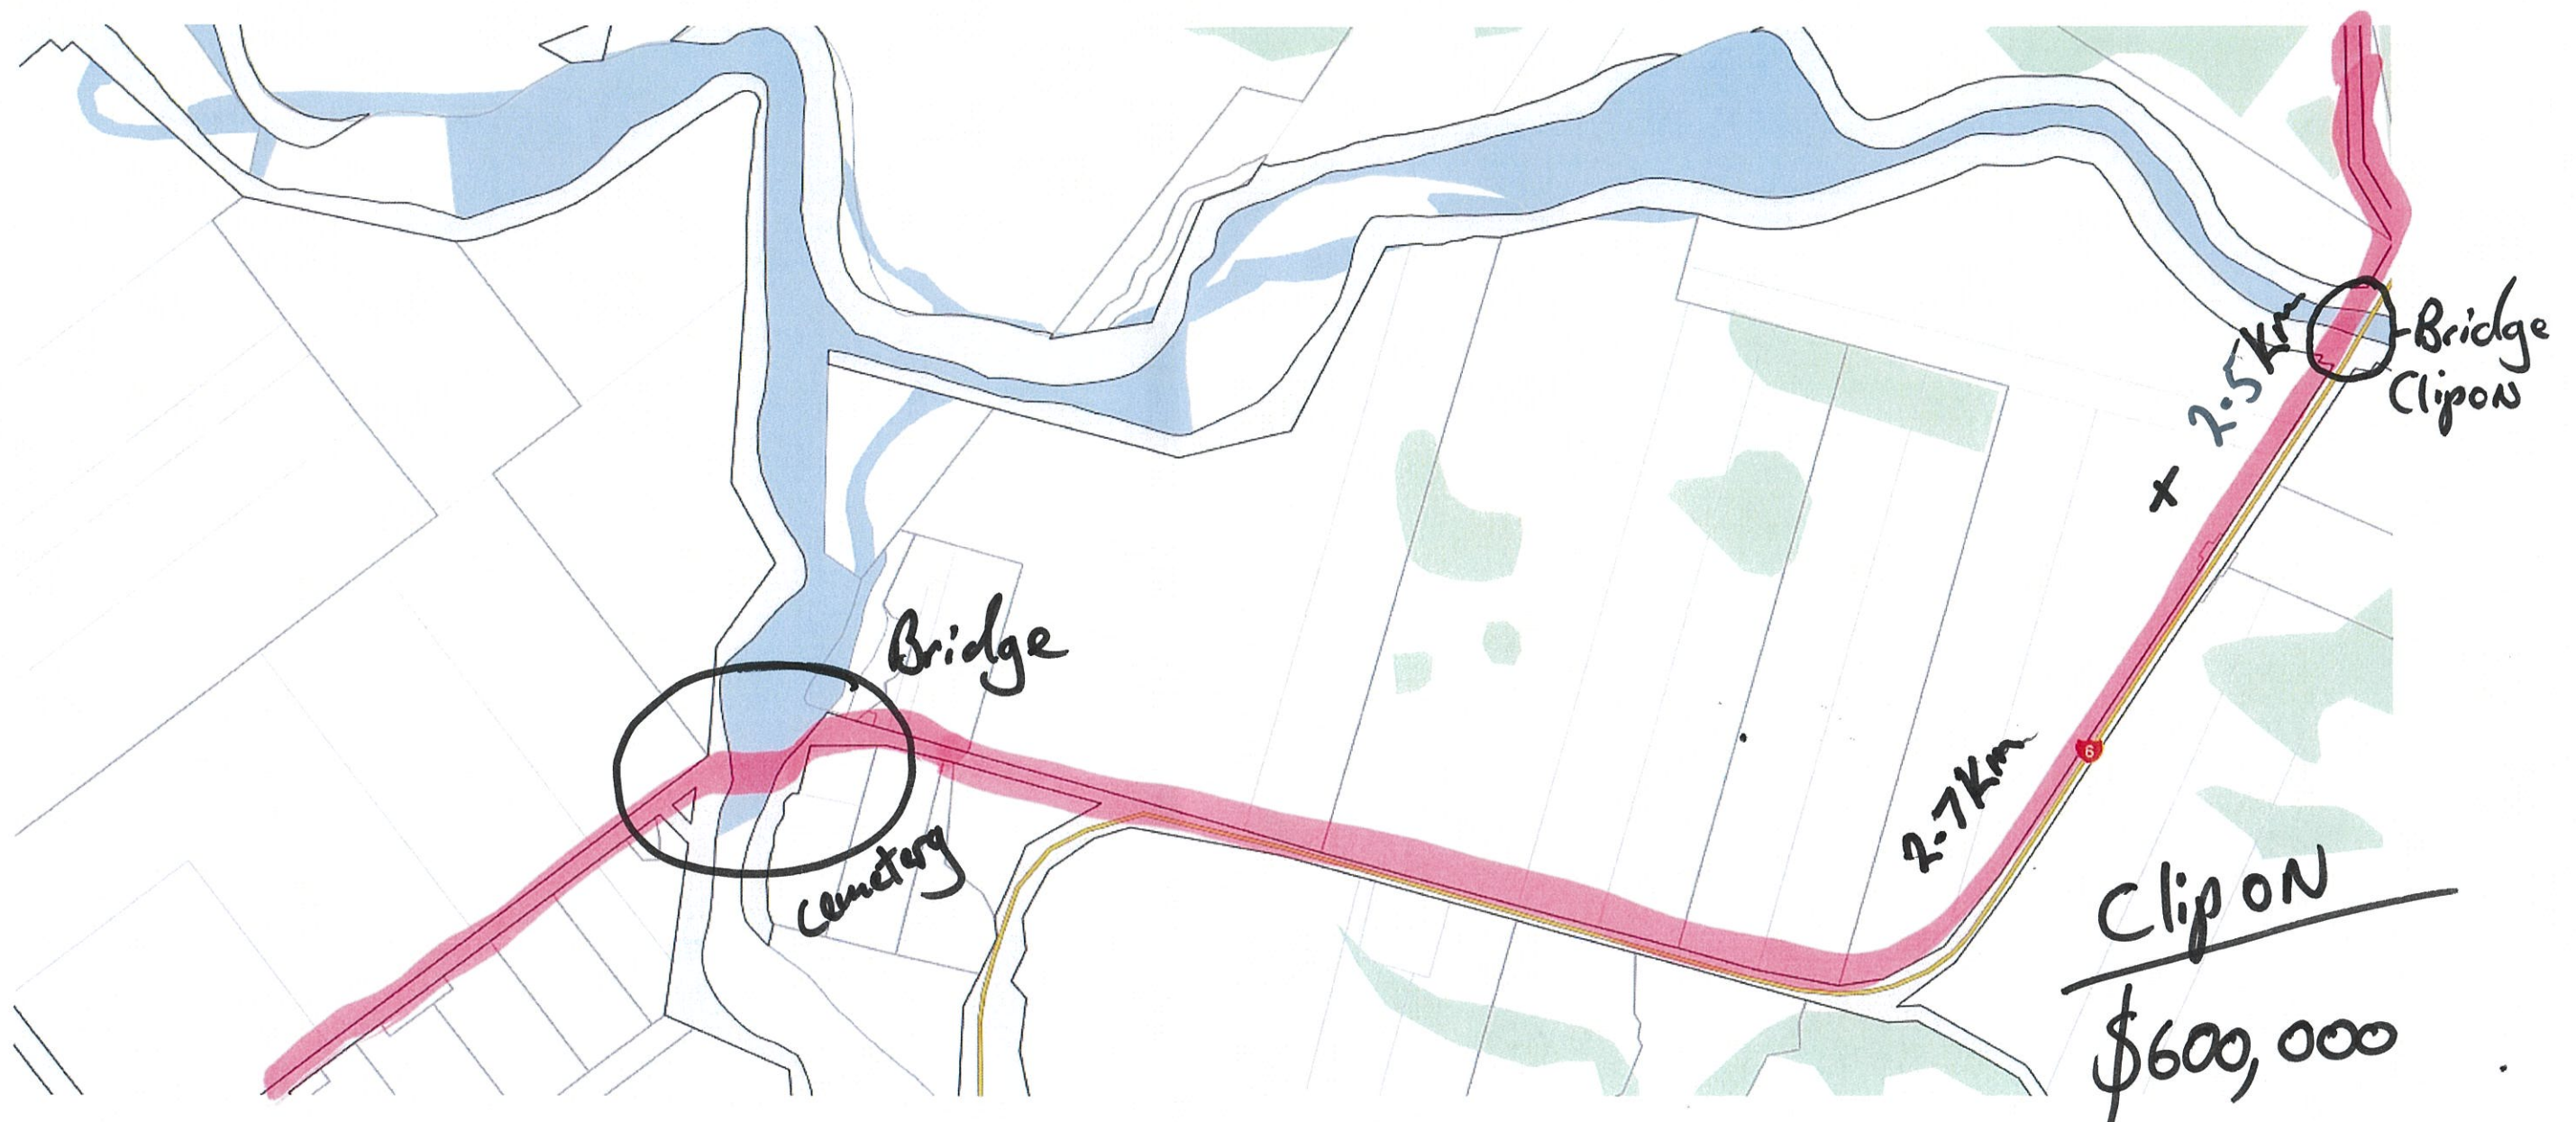
Option 2

- divert down Papakamoi Rd
- cross highway Totara bridge (clip-on?)
- State highway - Cor across private land??
- Down ~~the~~ Woolhouse Rd

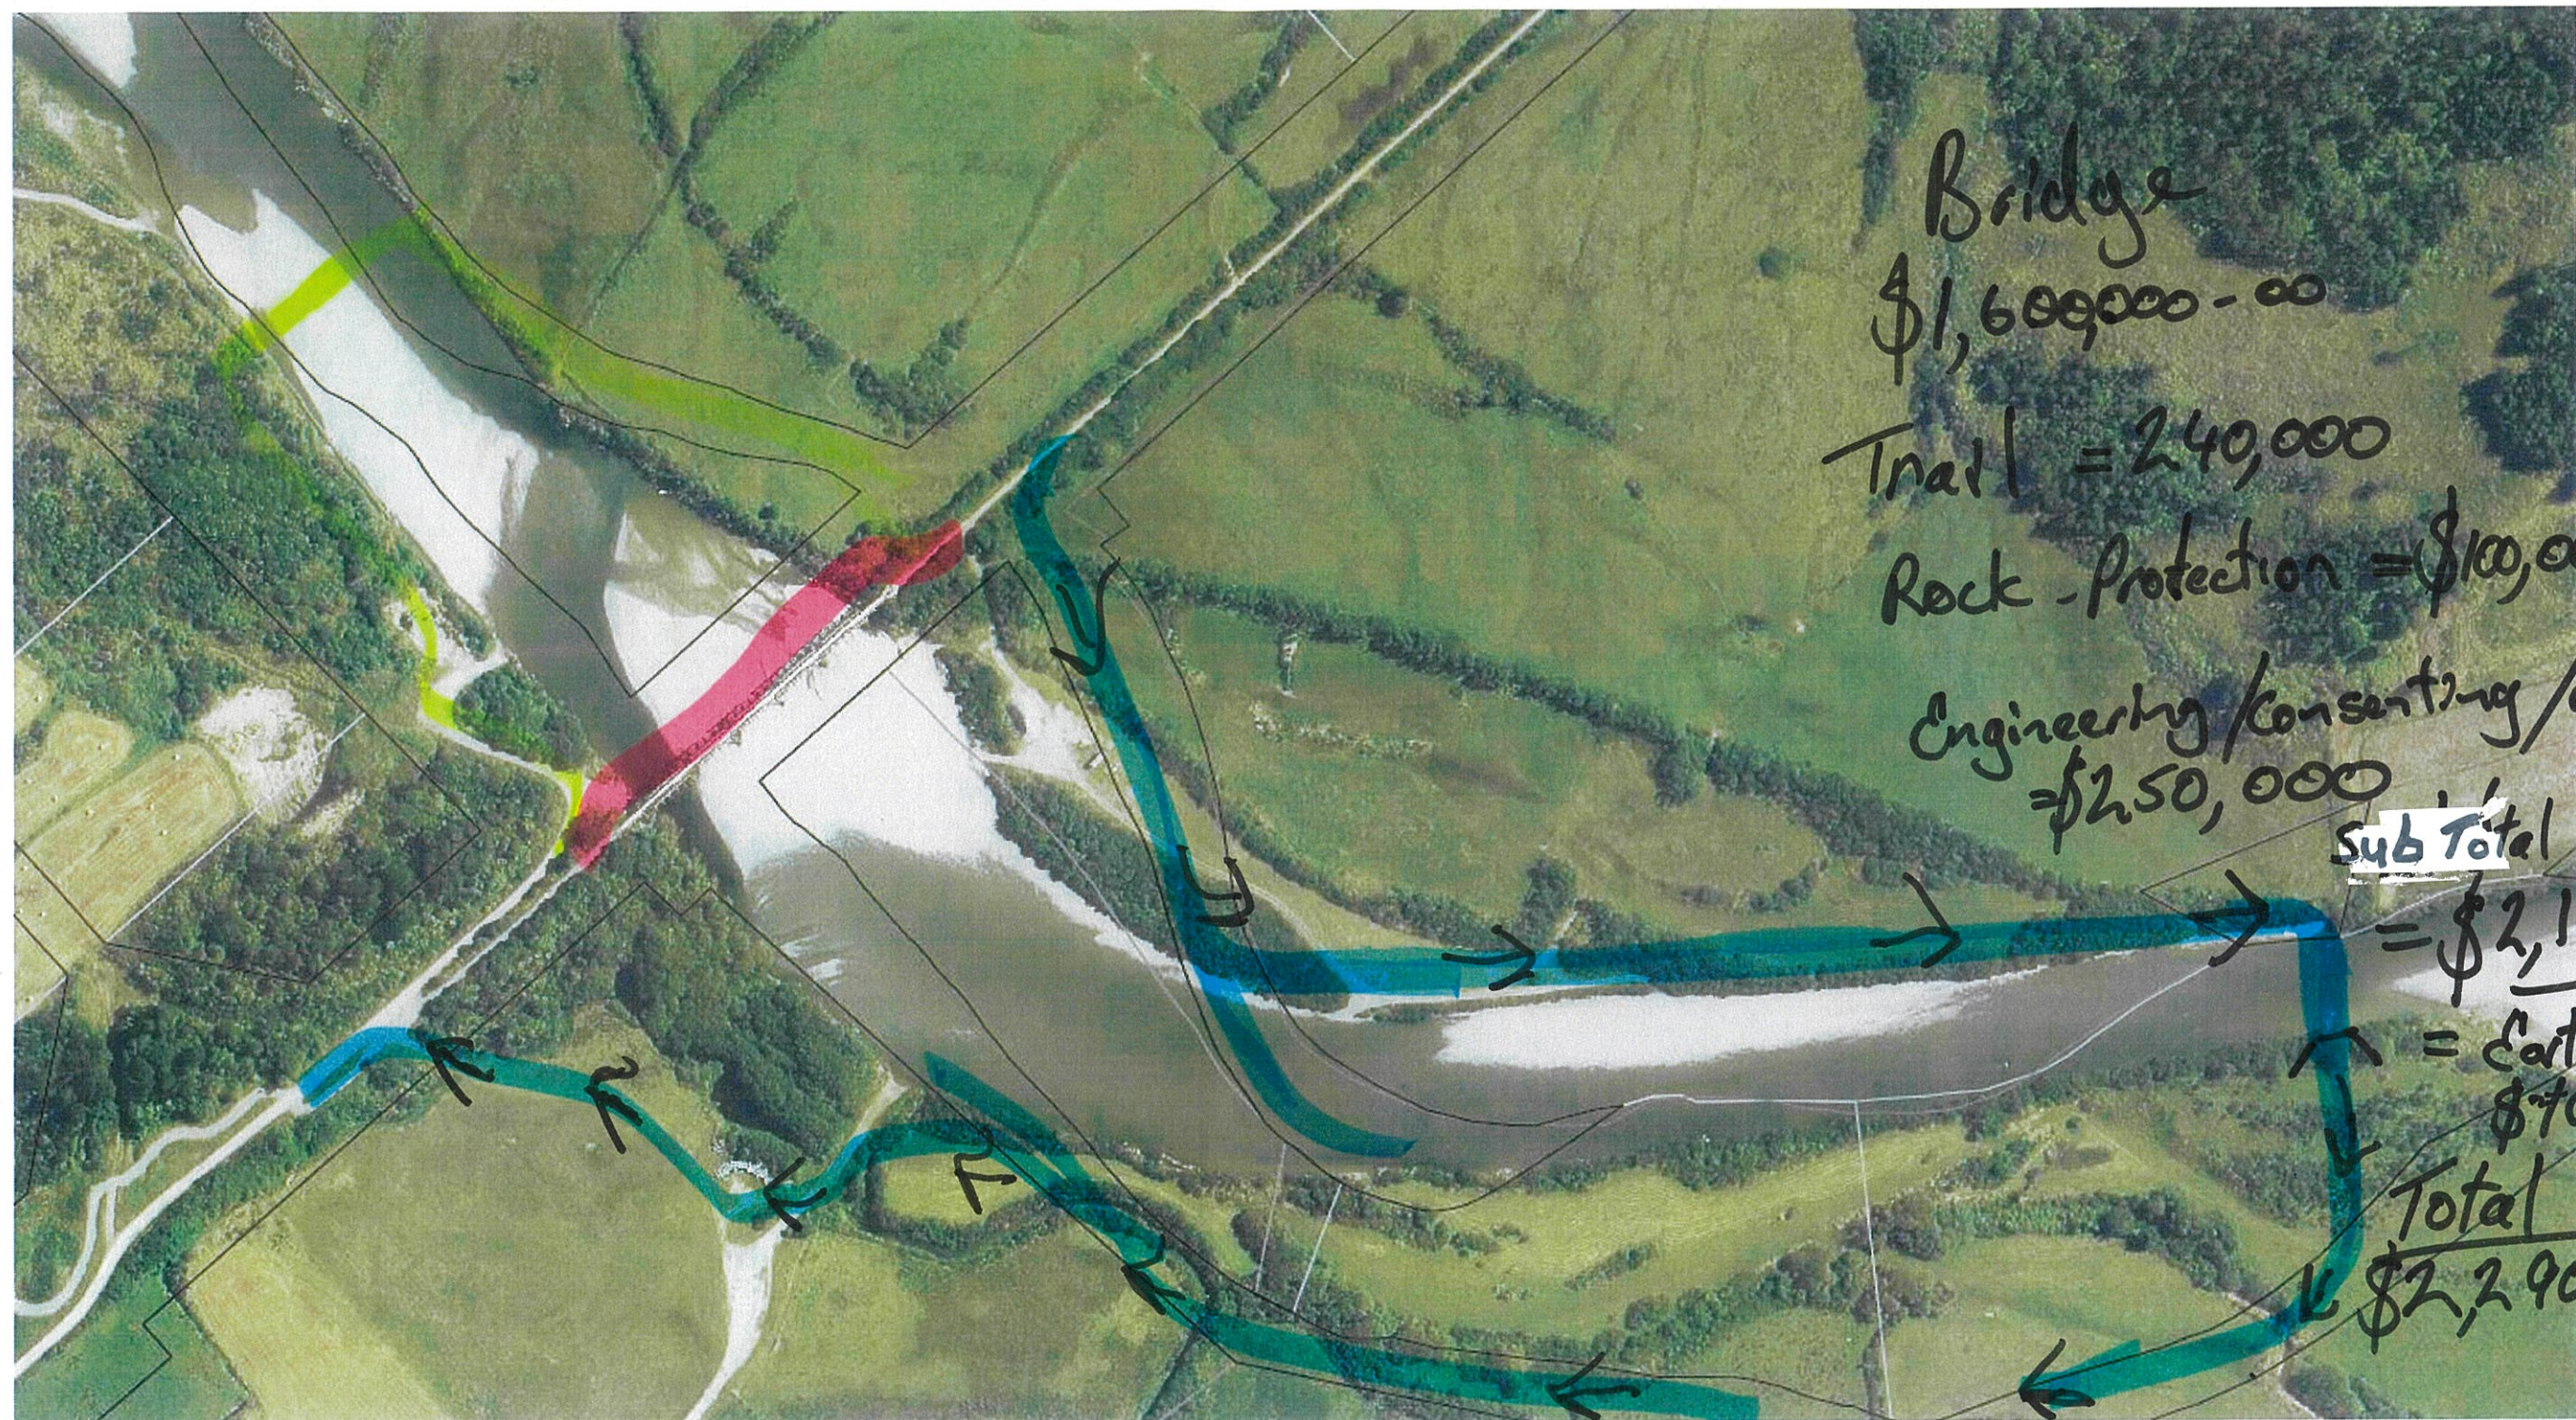
Option 3 - new swingbridge beside the Totara Railway Bridge
 Option 4 - " " down stream
 Option 5 - " " up stream & back up the road reserve

1.6 Km New trail
 80m New Bridge.
