St Mary's Catholic Church, Hokitika

Partial Strengthening and Early Opening Scheme

Resource Consent Application to Westland District Council

**Consideration of strengthening options
to allow reoccupation**

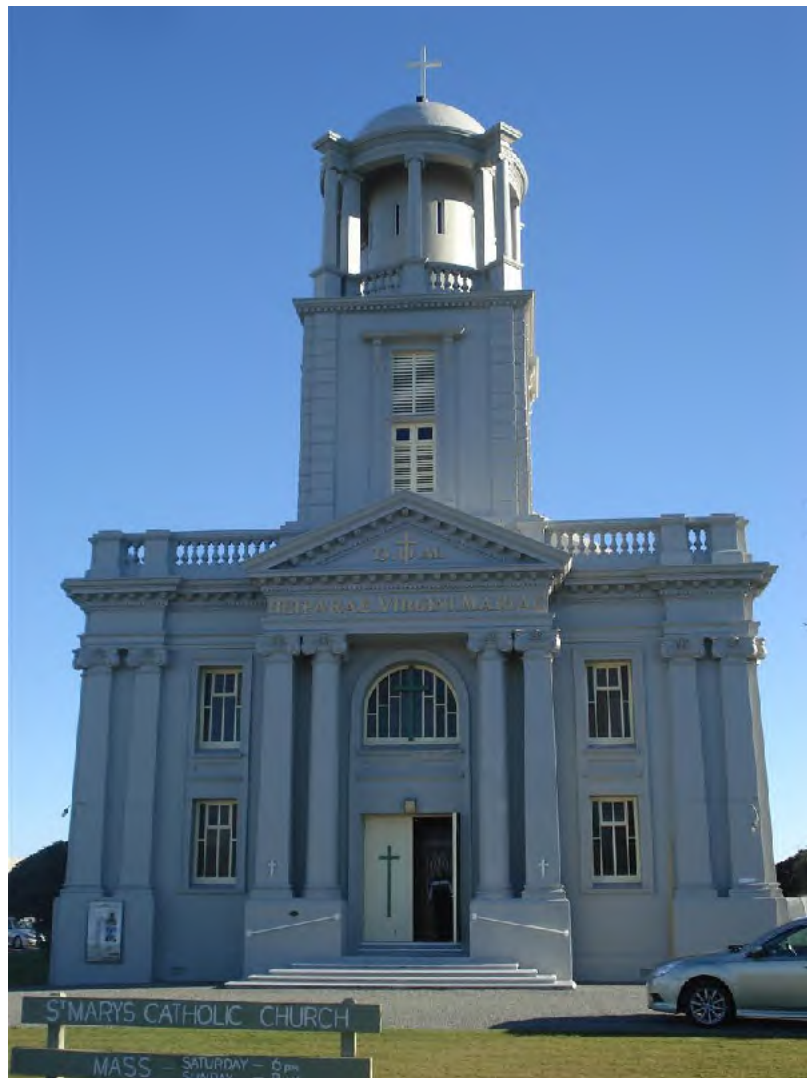
Figure 2: Photograph of St Mary's, Hokitika

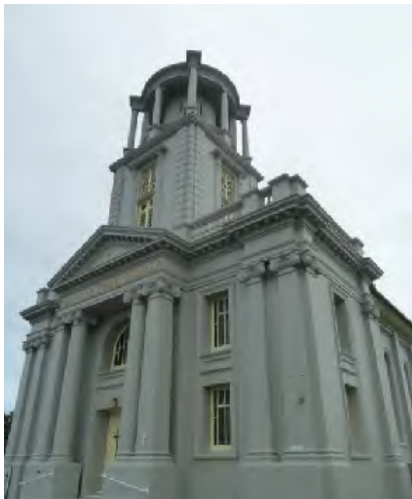
Figure 2 – East Elevation

Construction on St Mary's Church began in 1914 and completed in the same year with the opening of the nave. It was not until after the First World War, that the porch and tower were constructed; see *Figure 2 and 3* for general photos. The church that stands today was completely finished in 1928. St Mary's Church is located on the corner of Stafford and Sewell Street, Hokitika shown *Figure 4*.

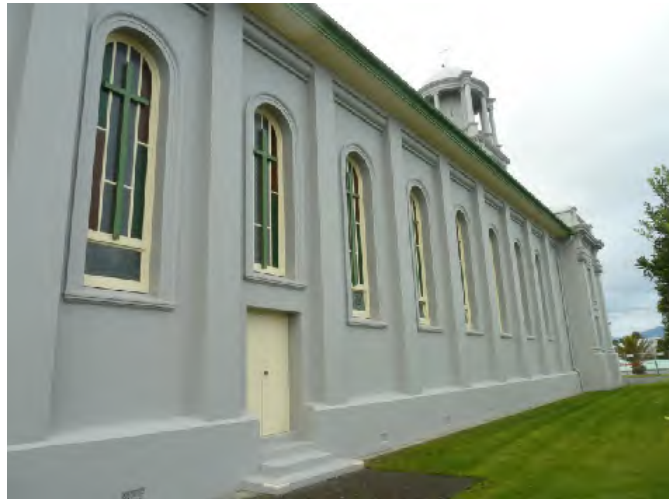
Figure 3 – South Elevation

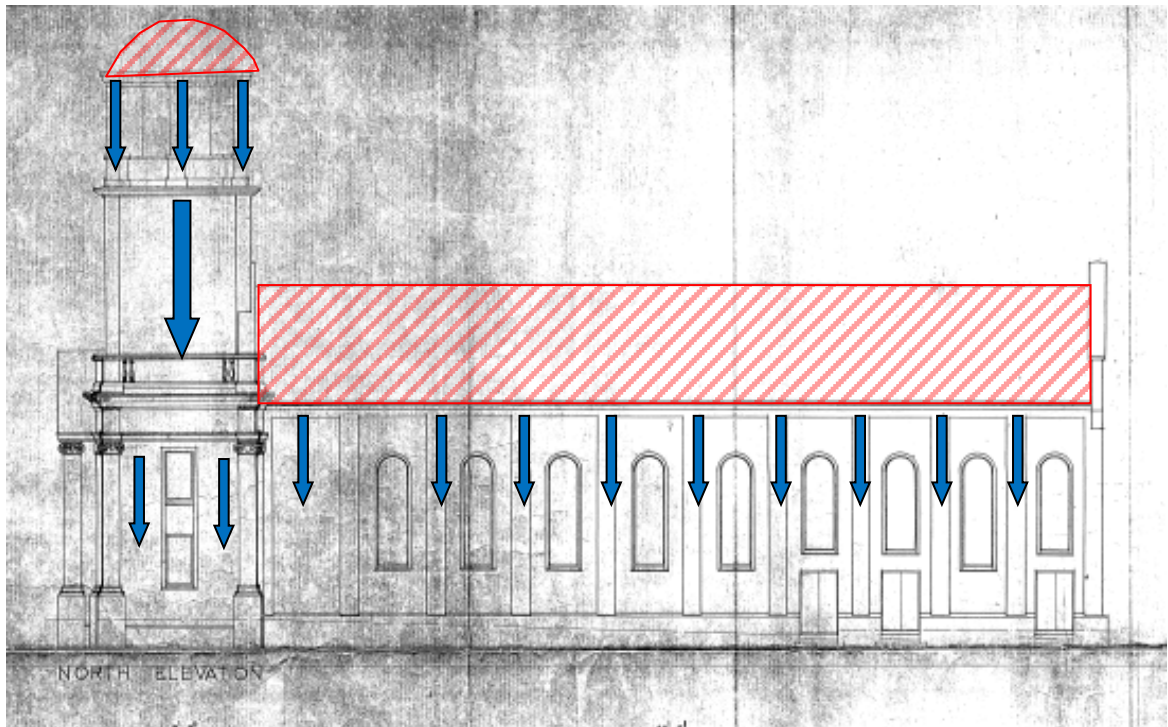
The gravity loads from the roof (clad with slates) are transmitted to the concrete ring beam located on top of the 400mm thick load bearing masonry nave walls. This in turn carries the load down to the concrete strip footings and subsequently to the ground, shown *Figure 6*.

Figure 6 – Gravity system

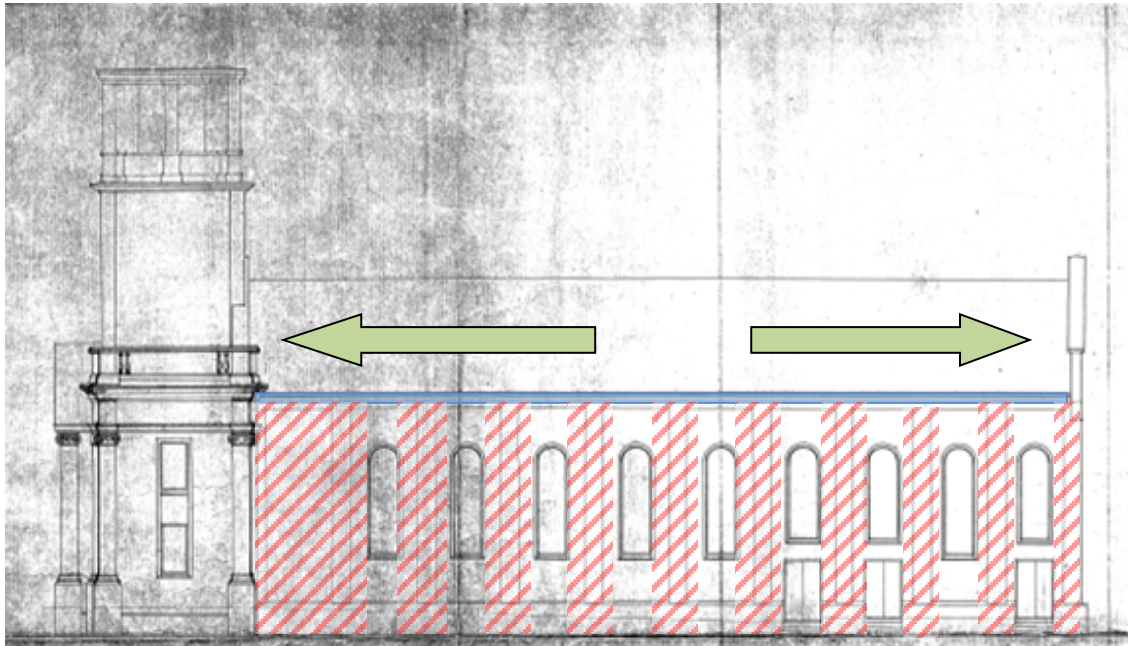
Horizontal seismic loads within the roof are transmitted through the purlins and sarking to the nave walls. Some horizontal load will be transmitted to the gable ends shown with the green arrows on *Figure 7*. The gable ends are attached to the purlins with steel straps.

The remainder of the seismic loads is transmitted to the concrete ring beam, reliant on the bond strength between the ring beam and the masonry load bearing walls shown in the red hatch on *Figure 7* these loads are carried through the masonry walls in plane and eventually to the ground.

Figure 7 – Seismic load resisting system longitudinal

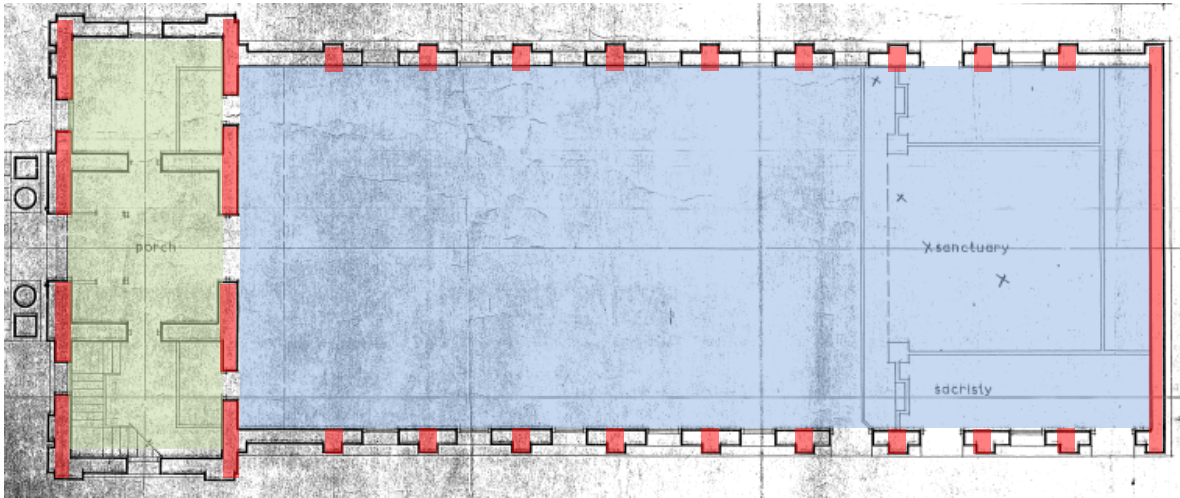
The transverse seismic loads are transmitted through the flexible ceiling diaphragm shown in blue on *Figure 8* to the concrete ring beam above the Nave walls. These loads are transmitted to the red areas denoting the external buttress walls and shear walls.

The green area denotes the mezzanine floor which is constructed from reinforced concrete and transmits lateral seismic loads to the internal and external shear walls, these loads are transmitted to the strip footings and eventually to the ground.

Figure 8 - seismic load resisting system transverse

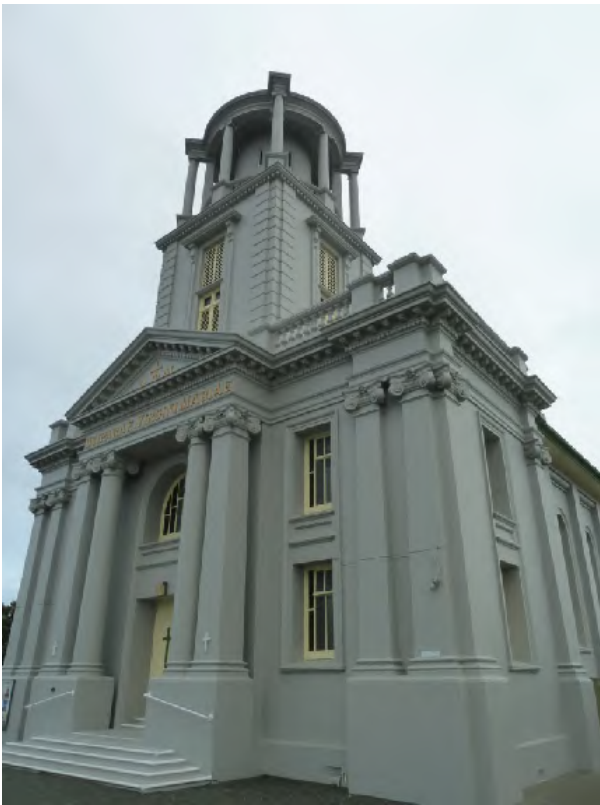
Photo 1 – General front Elevation

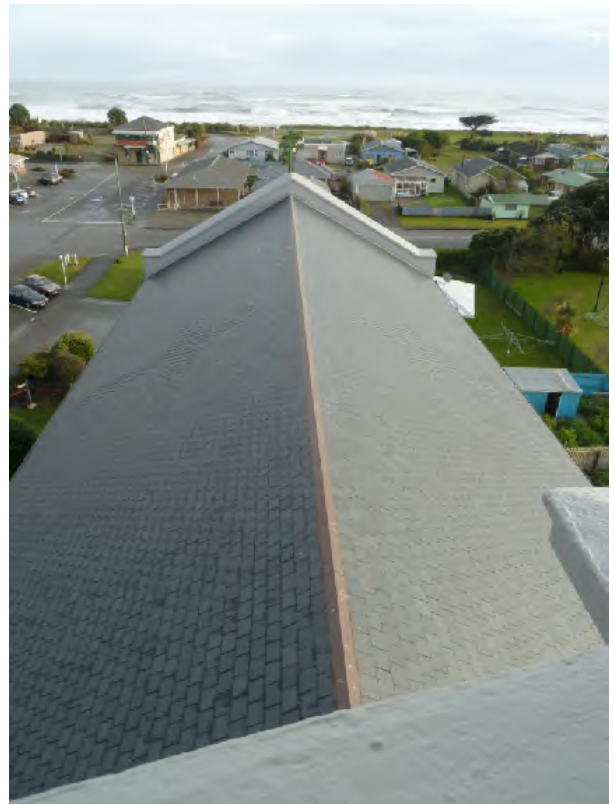
Photo 2 – Roof looking West

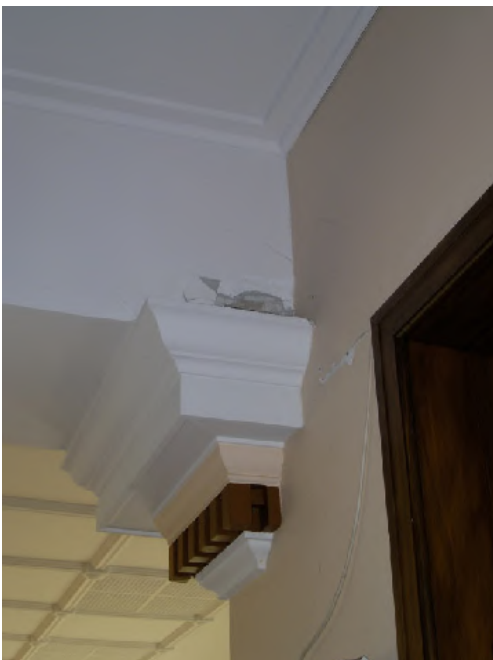
Photo 3 – Damage to the beam above the mezzanine floor prior to restoration works

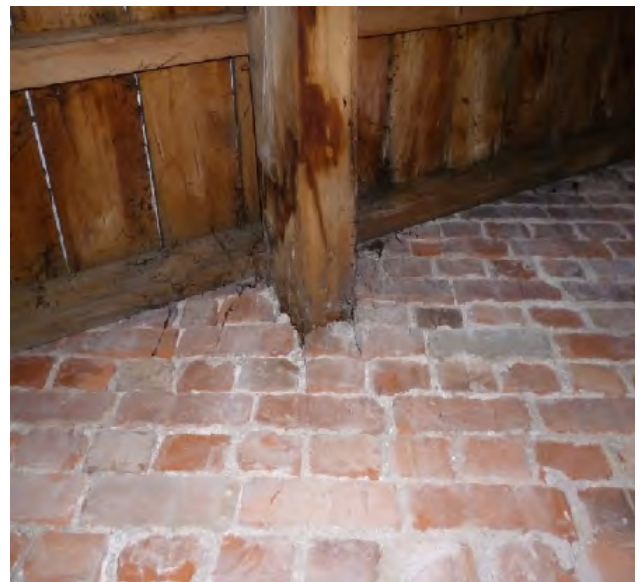
Photo 4 – Typical connection between purlin and gable wall

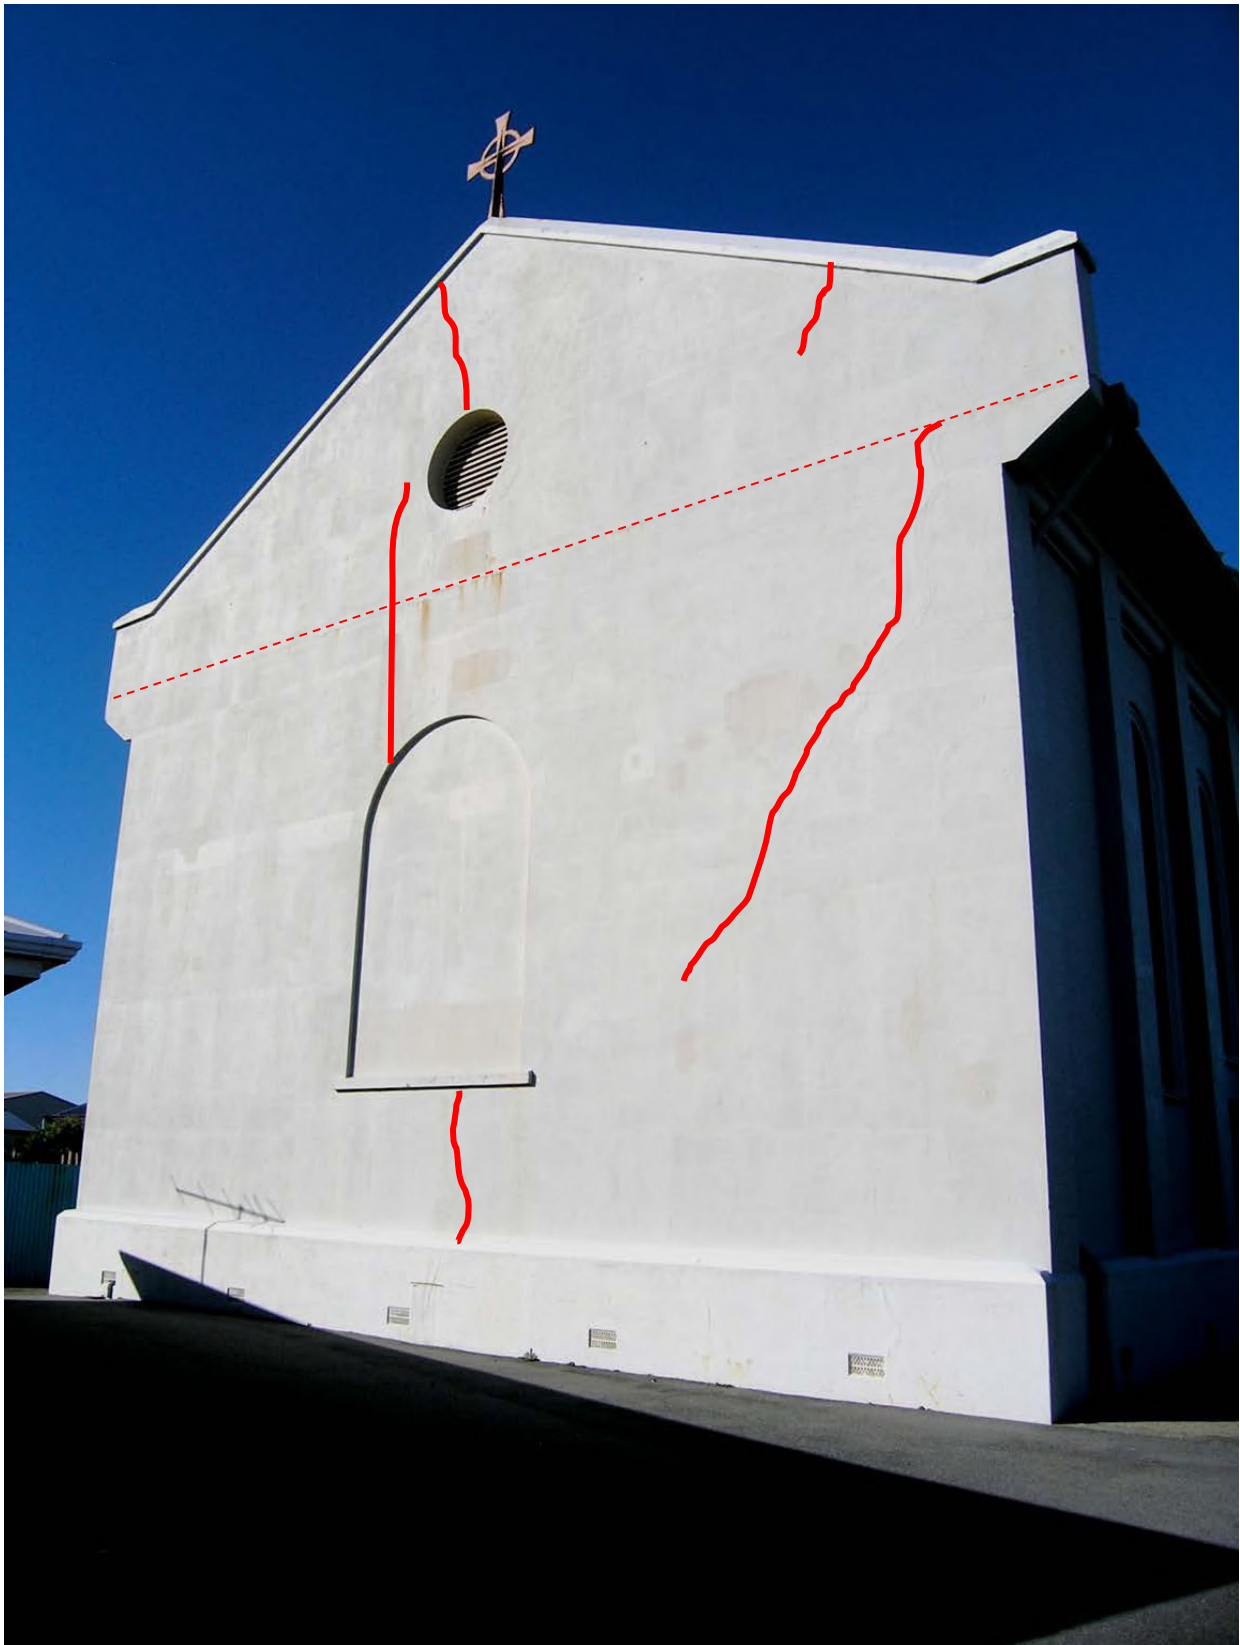
Photo 5 – Showing cracking pattern on the west gable. The dashed red line highlights the line of the existing concrete ring beam

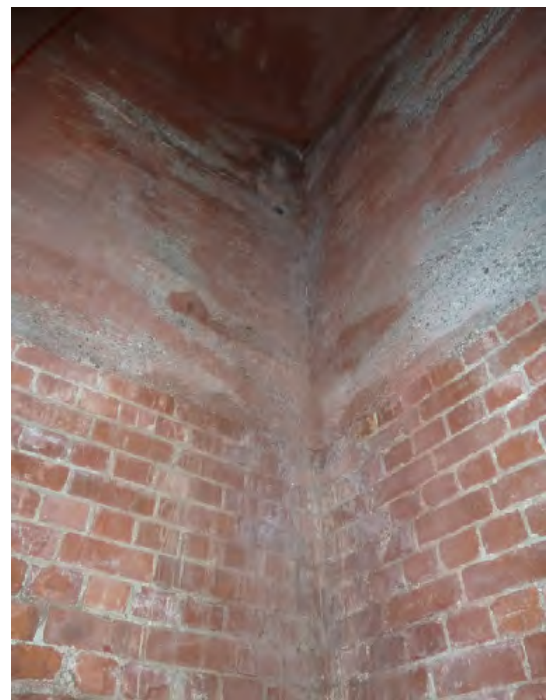
Photo 7 – Reinforced concrete tower sat on unreinforced masonry wall at mezzanine floor level

Applied seismic load acting on the tower over the porch will result in overturning of the tower. The reinforced concrete tower resists this overturning by the assumed reinforcement in the concrete. The reinforcement acts in tension however at the mezzanine floor level where the wall becomes un-reinforced masonry there is no tension reinforcement to resist the overturning force. It is assumed that the towers rigid shape in plan this will provide some resistance from overturning. This is an area that will require further investigation to gain an understanding of how the tower is connected to the structure below.

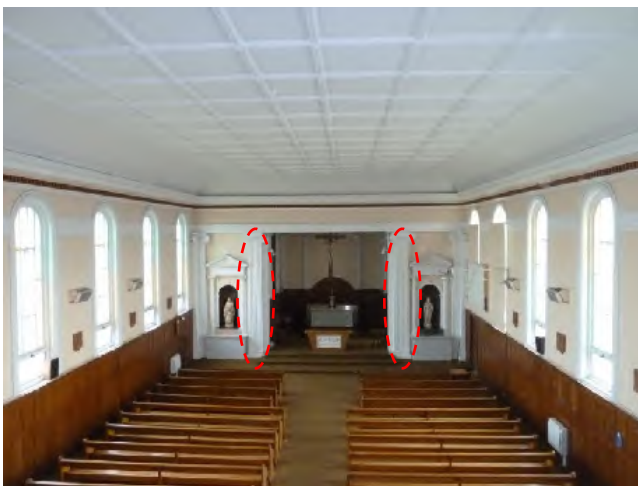
Photo 8 – Internal shot showing columns supporting masonry wall between the sanctuary and the nave

- The columns between the nave and sacristy are assumed to be carrying a masonry structure above. It is unclear how the structure is held in place at the top, and in a moderate earthquake event this element above could fail in a similar manner to the end wall

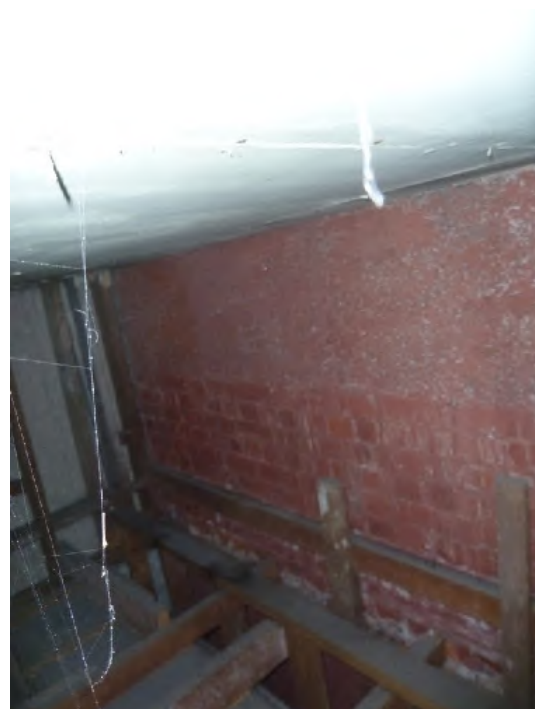
Photo 9 – Internal masonry wall sat on columns in photo 8

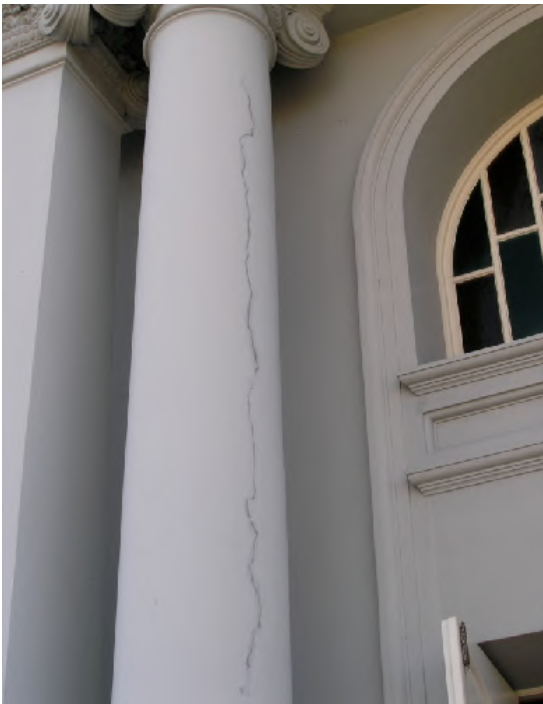
Photo 9 – External columns prior to the restoration works showing vertical cracks

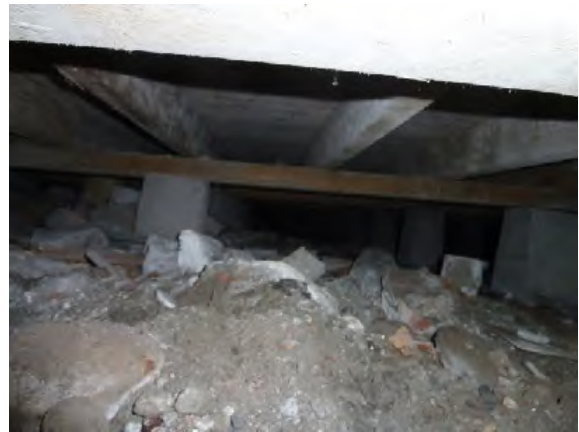
Photo 10 – Internal floor void

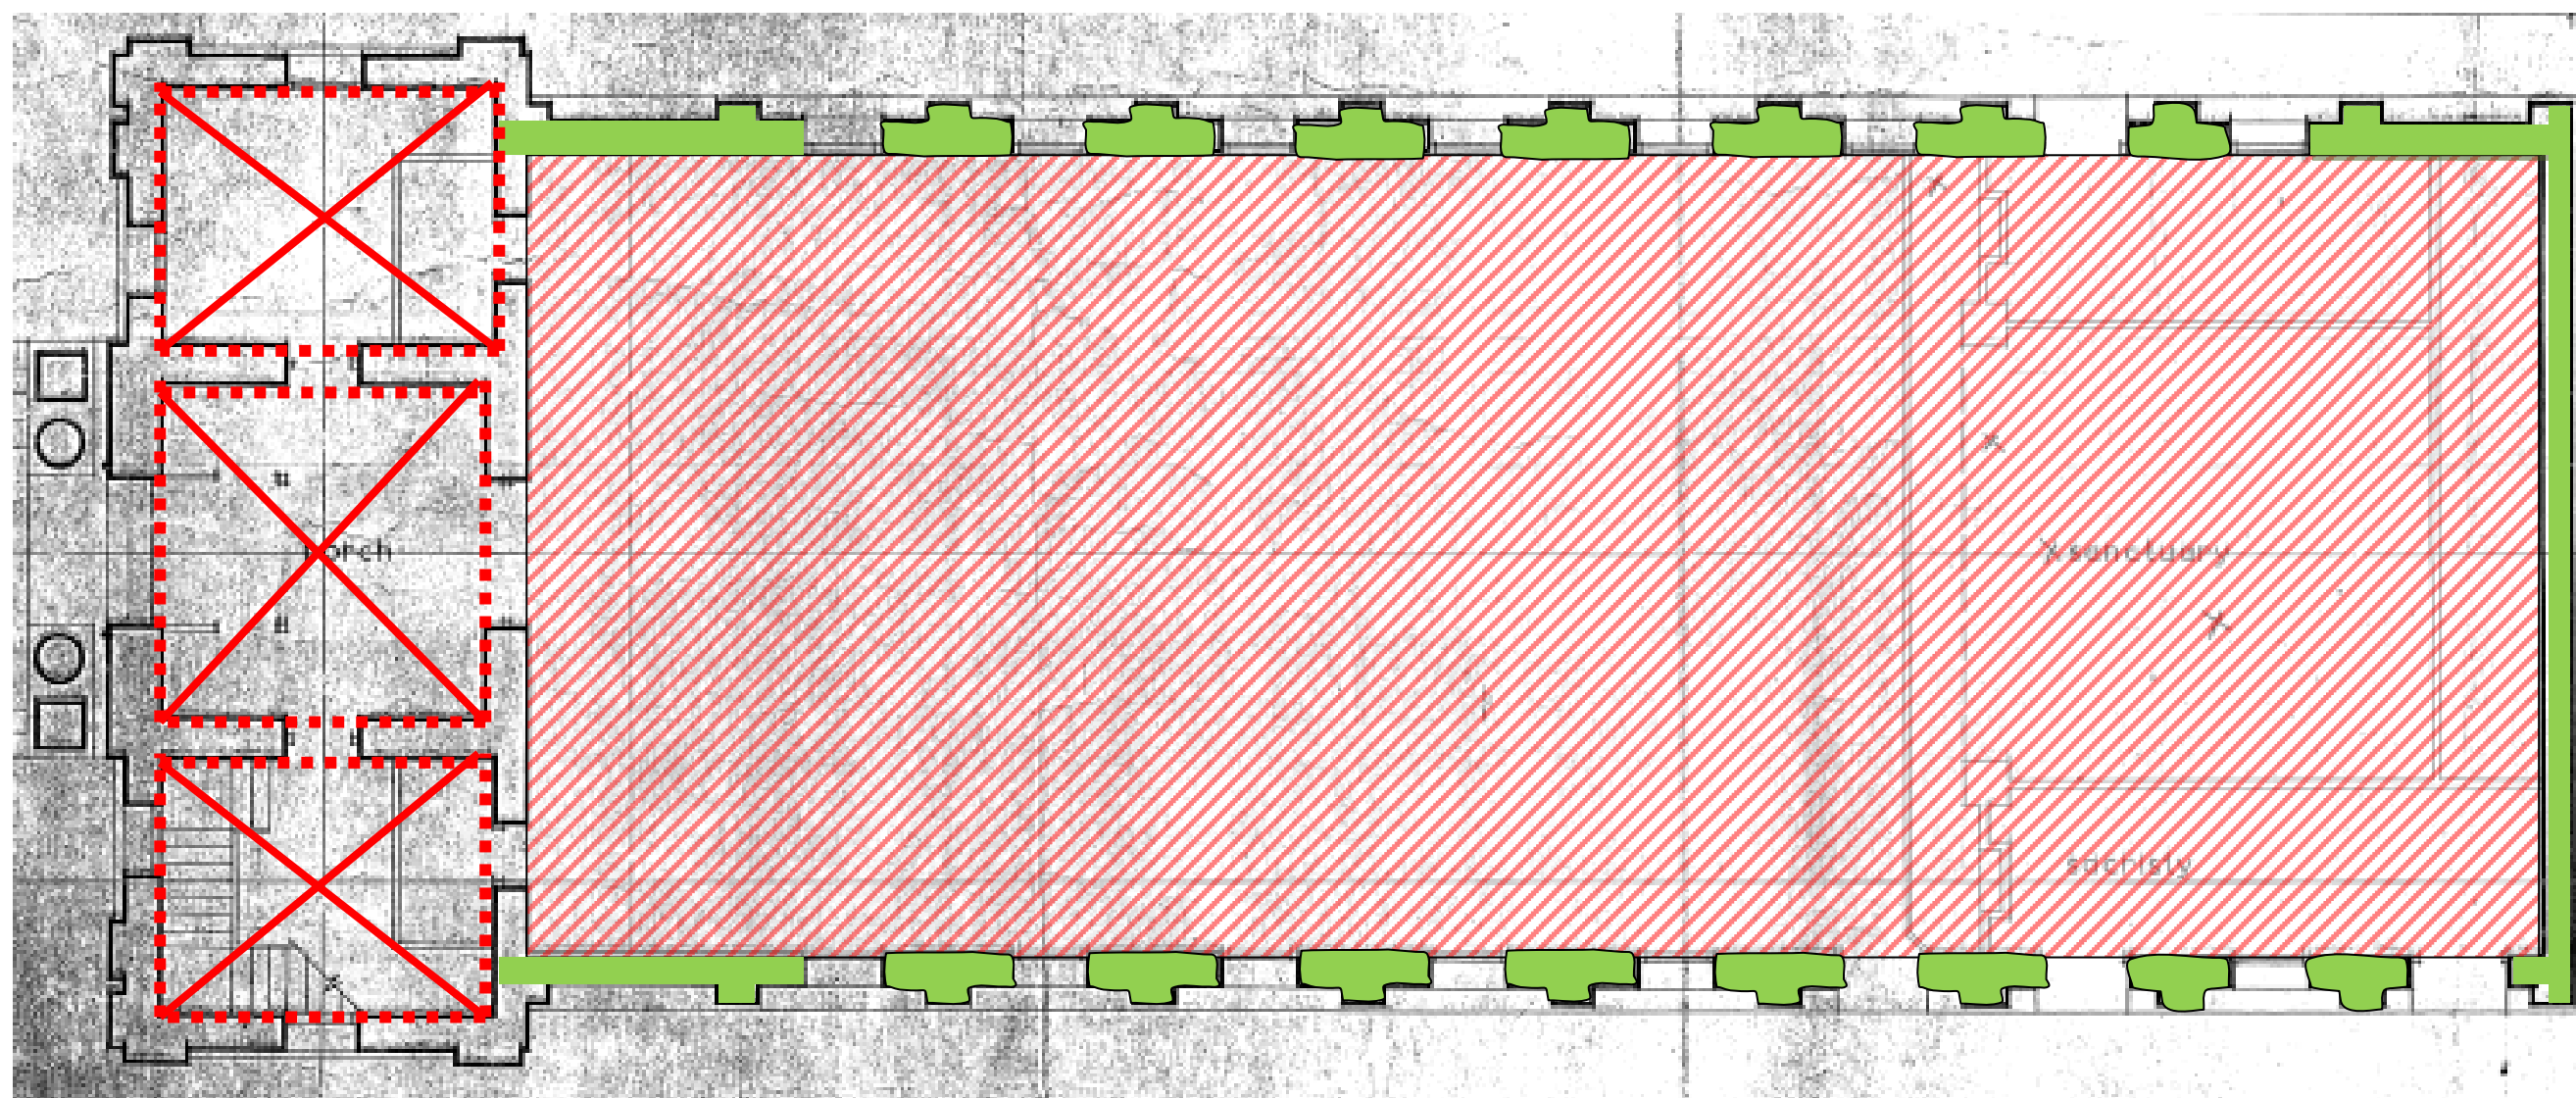
Steel bracing to be placed in the tower

Plan A - General arrangement of the strengthening scheme

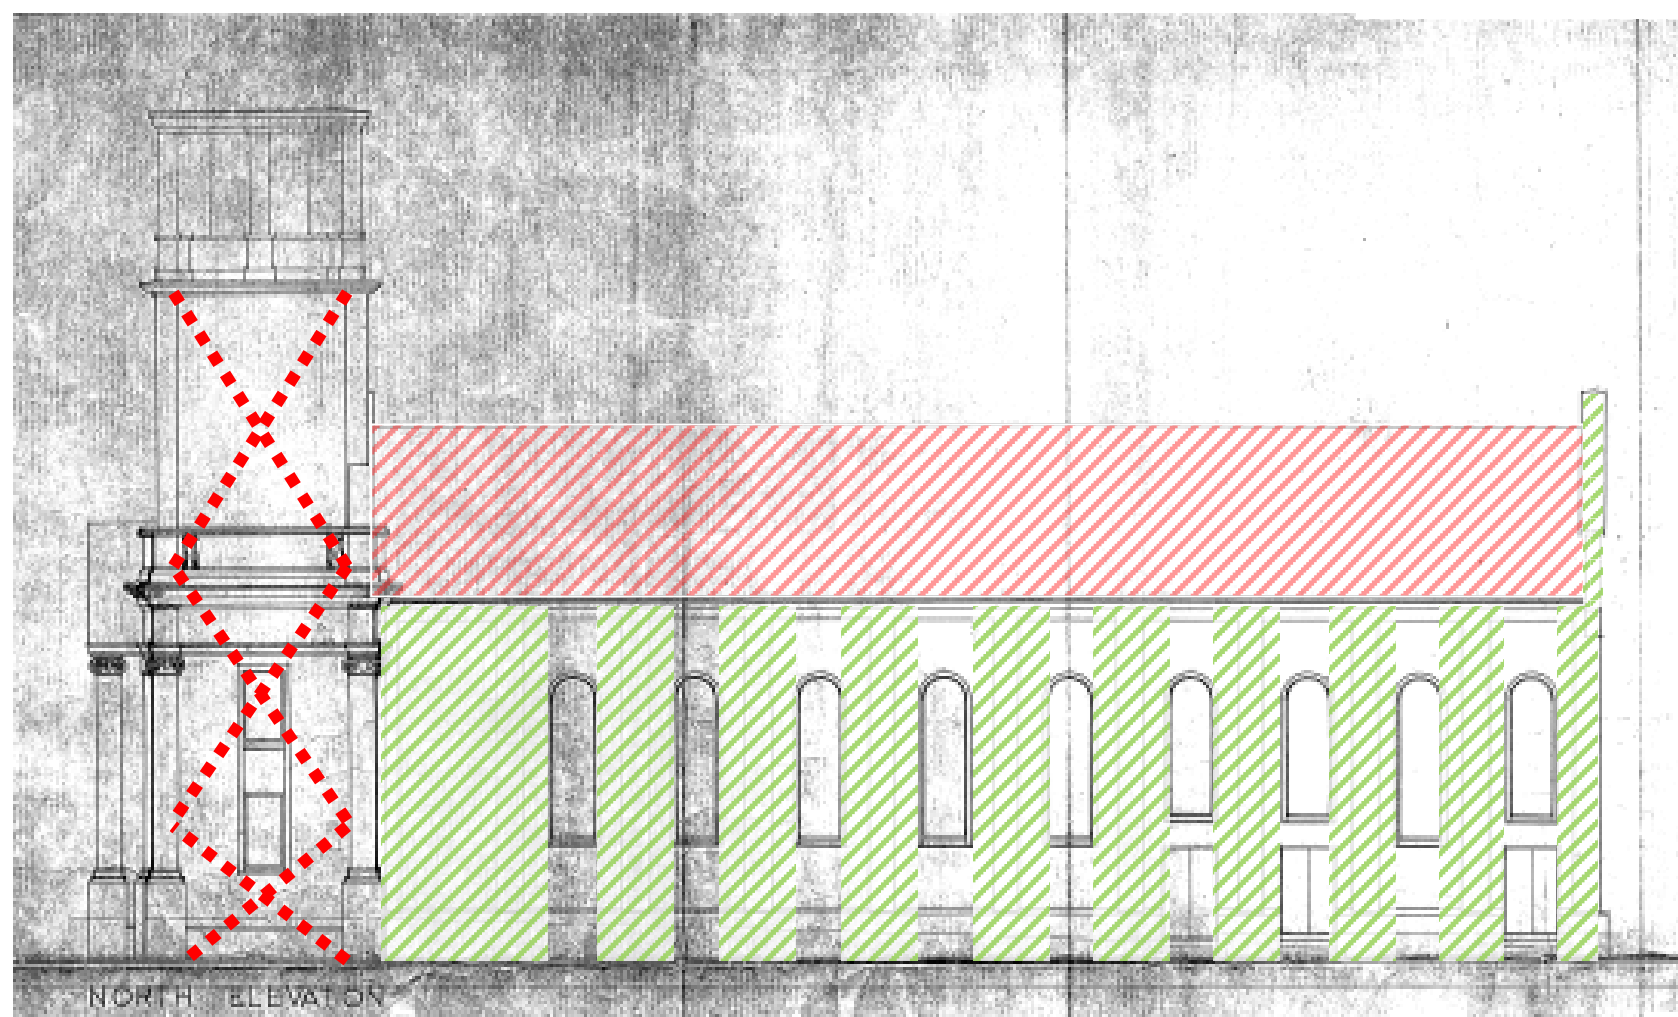
Steel bracing to be placed in the tower

Elevation 1 - Elevation of the strengthening scheme

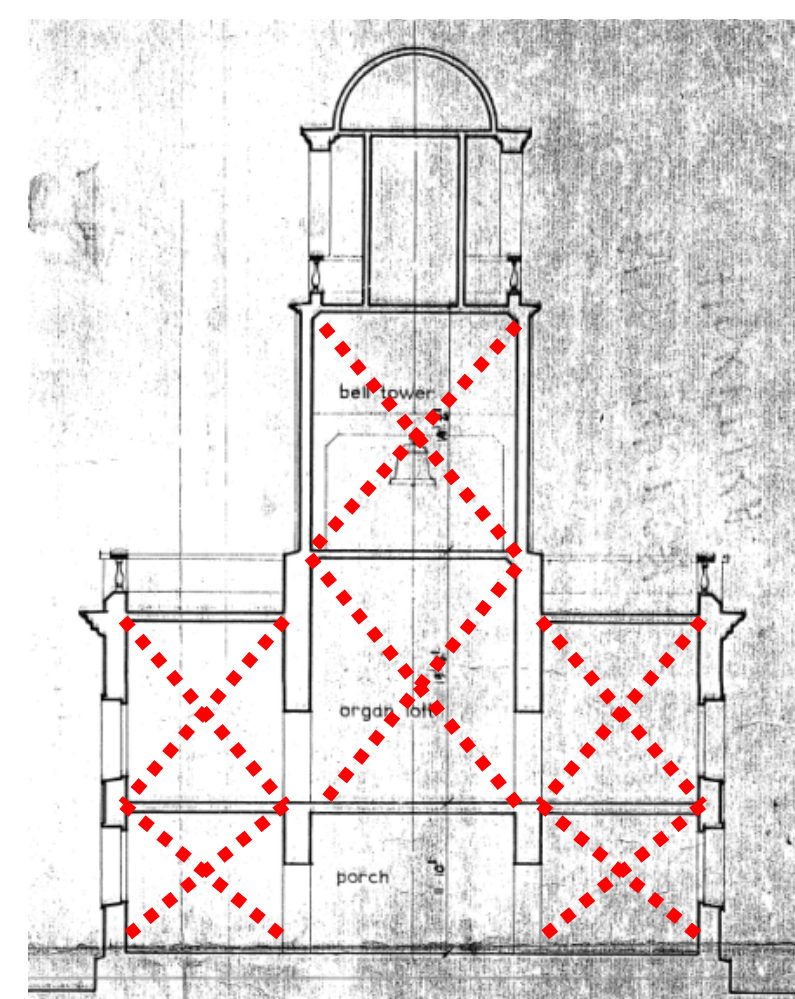
Section A- section through the East face of the tower and porch

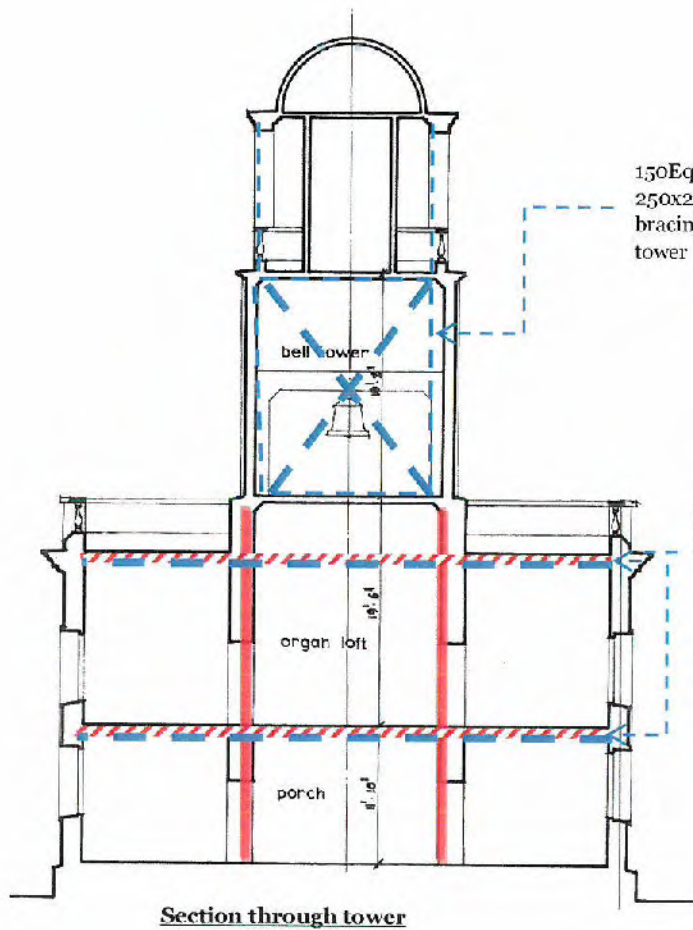
**CONCEPTUAL
STRENGTHENING 67%NBS**

Denotes 150mm shotcrete applied to the inner face of existing masonry. 150mm of existing masonry to be carefully removed and shotcrete applied. Shotcrete to not infill existing openings with D20's @ 150 c/c horiz and vert

Allow for investigation of the existing foundations we have assumed for this stage of the works that there is no damage to the footings.

Assumed masonry wall to be removed from above the existing beam and replaced with timber stud wall. Lath plaster to be retained during removal of masonry and new timber wall to be tied into lath plaster

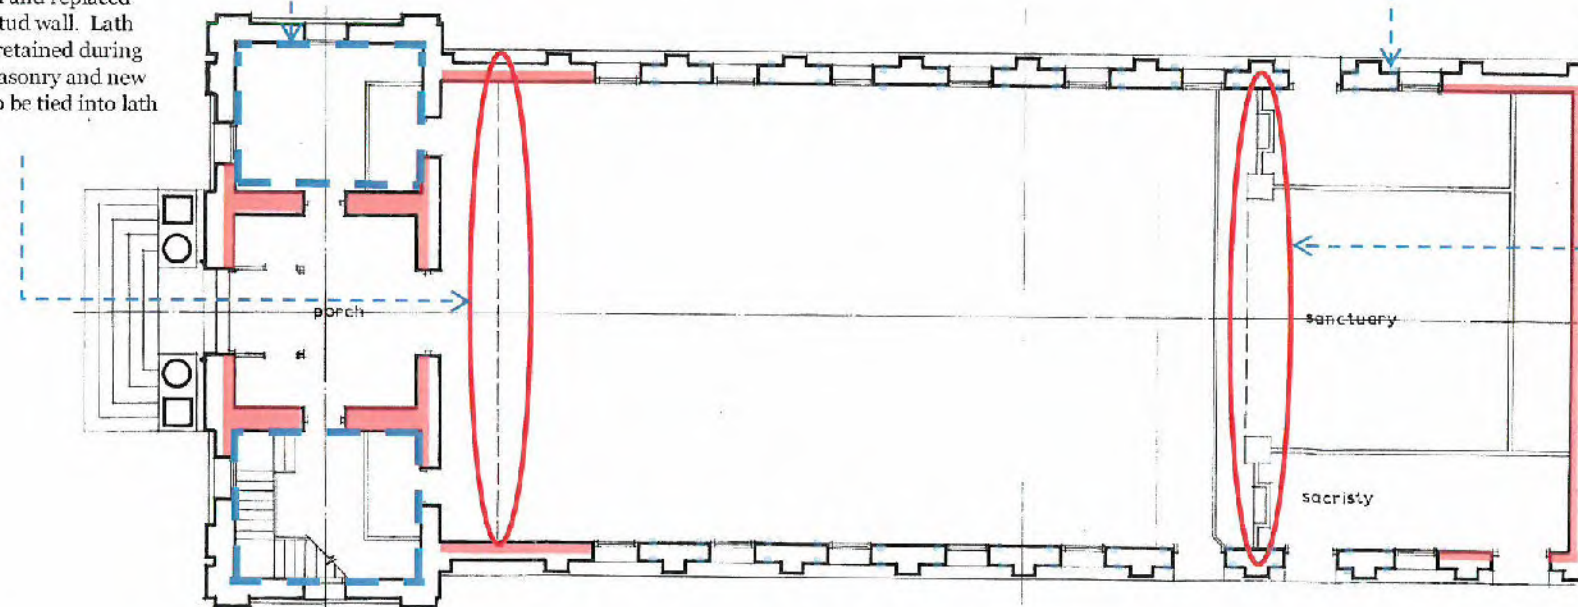
Masonry wall to be removed from above the existing beam and replaced with timber stud wall. Lath plaster to be retained during removal of masonry and new timber wall to be tied into lath plaster

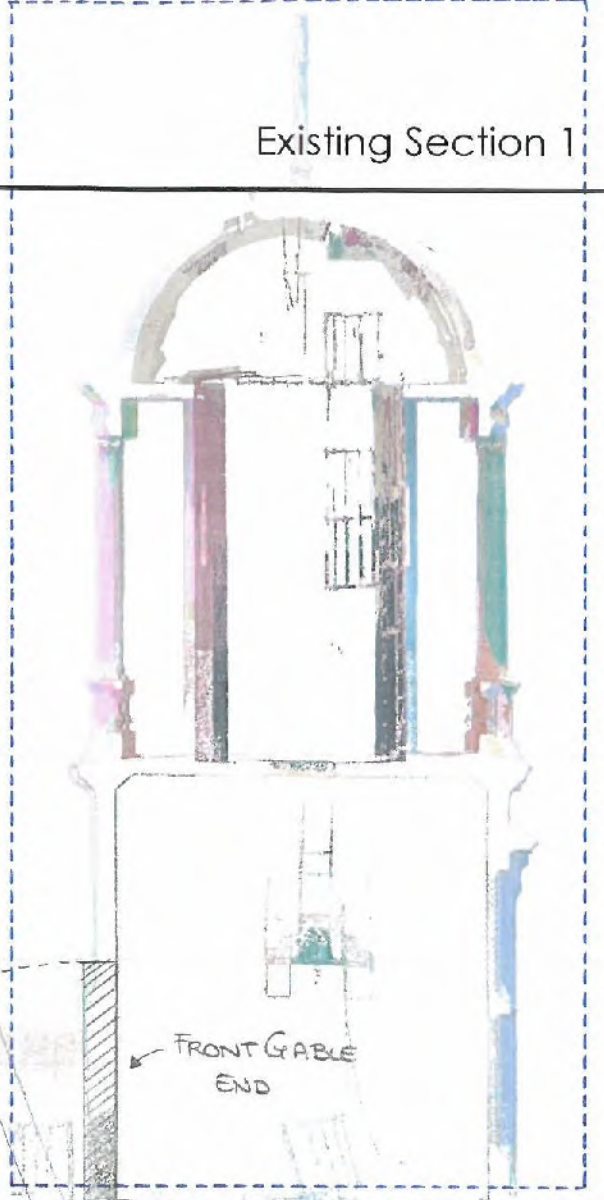
- PROVIDE ACCESS RESTRICTION on PORCH INTERNAL and EXTERNAL AREAS.
- FENCING OFF a FALL ZONE EXTERNALLY and RESTRICTING ACCESS in the CHURCH WHERE BRICK COULD FALL.

THE FRONT GABLE END IS STILL PRONE TO COLLAPSE in a MODERATE EARTHQUAKE. PROVIDE a SECOND LAYER of PLYWOOD in the FALL ZONE where the BRICKS COULD FALL.

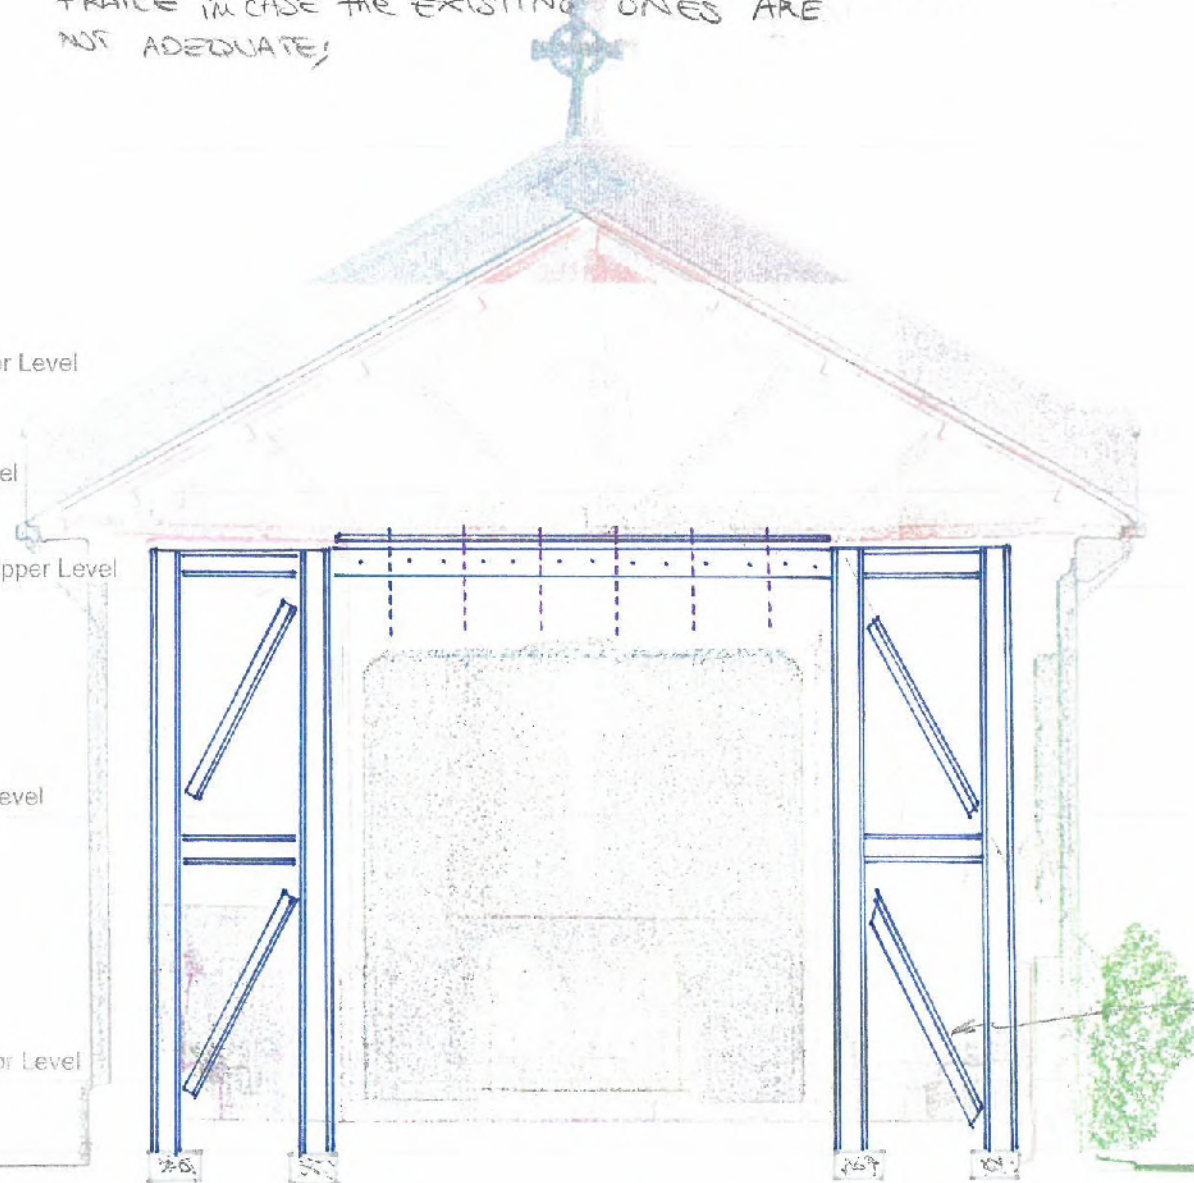
this brace conflicts with the back of the statue alcove.

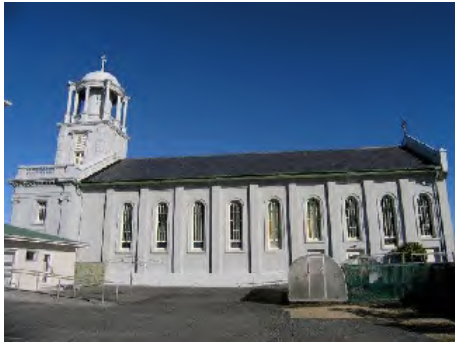
Painted plastered brickwork, tower, hf			
	Painted timber semi-circular headed windows with bottom hung casements at base, hf			
	Painted timber square headed windows, hf			
	Cast iron vents, hf			
East elevation

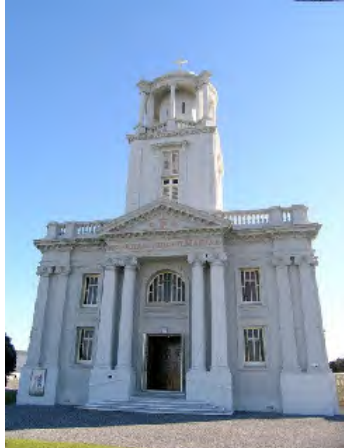
Painted plastered brickwork, tower, columned and plastered entry, hf			
	Painted timber square and semi-circular headed windows, hf			
	Painted timber entry doors, hf			
	Concrete steps, hf

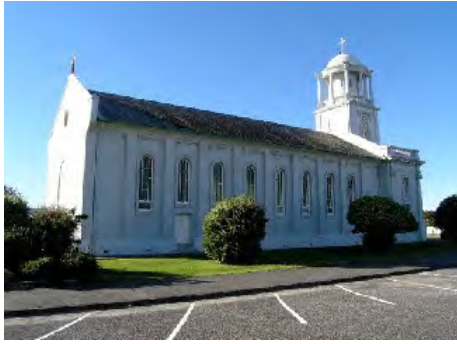
Painted plastered brickwork, tower, hf			
	Painted timber semi-circular headed windows with bottom hung casements at base, hf			
	Painted timber square headed windows, hf			
	Cast iron vents, hf			
	Concrete path, hf			
	Granite tablet, hf			
West elevation	E	E	E	E

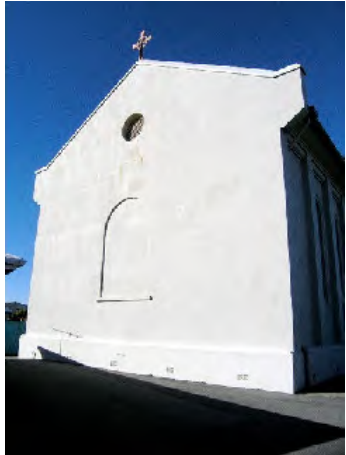
Painted plastered brickwork, hf			
	Painted timber vent, hf			
	Painted cast iron vents, hf			
	Concrete path, hf			
Interior				
Wind lobby	S	L	L	S

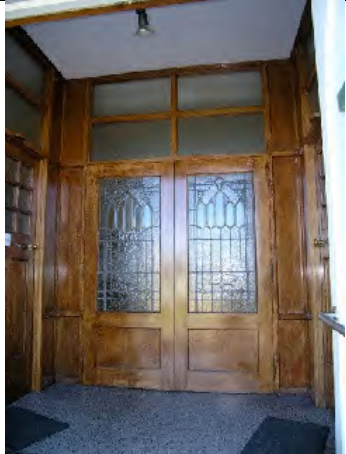
<u>Ceiling</u>			
	Painted plywood?, of?			
	Painted plastered cornice above entry door, hf			
	<u>Wall</u>			
	Clear coated timber panelling, of			
	Clear coated timber skirtings and architraves, of			
	<u>Floor</u>			
Terrazzo, hf

<u>Windows</u>
	-
	<u>Doors</u>
	1 x Clear coated timber double with leaded panels and toplights, of
	2 x Clear coated timber panelled and glazed with toplights, of
	1 x Painted timber panelled double entry, hf?
	<u>Fixtures and fittings</u>
-

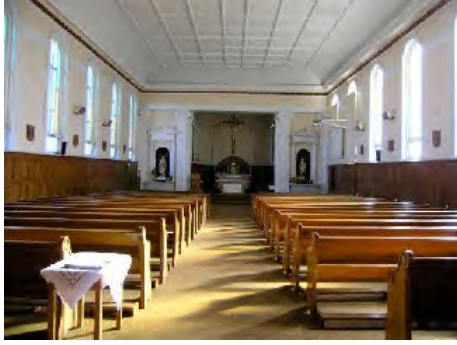
<u>Ceiling</u>
	Painted fibrous plaster with battens and ventilation panels, hf
	Painted plaster cornice, hf
	Painted plaster domed ceiling to sanctuary with plaster mouldings, hf
	<u>Wall</u>
	Painted plaster, hf
	Painted plaster string course in the style of art deco, hf
	Clear coated timber paneling, skirting, architraves and over doors, hf
	Painted plaster ionic pilasters to chancel/sanctuary with plaster niches, and pediments, hf
	Painted plaster Corinthian pilasters to sanctuary, hf
	Marble bases to niches for statue, hf
	<u>Floor</u>
	Carpet over timber strip, hf
	<u>Windows</u>
	12 x painted timber framed semi-circular headed windows with bottom hung casement at bottom, hf
	2 x clear coated timber semi-circular headed leaded and coloured glass windows to sanctuary, hf
	<u>Doors</u>
	2 x clear coated timber paneled double to east

wall, hf
	1 x painted timber double ledged and panelled, to north, hf
	<u>Fittings and fixtures</u>
	Clear coated timber pews, hf
	Timber stations of the cross, hf
	Wall mounted heaters, nhf
	Marble alter, hf
	Plaster statues, hf
	Clear coated timber lectern, hf
	Pulpit, hf
	Clear coated timber cross with painted plaster statue, hf
	Clear coated timber railings either side of sanctuary, hf
	Marble holy water fonts either side of entry, hf
	Brass plaques above fonts, hf
Sacristy (north west)	H E E S

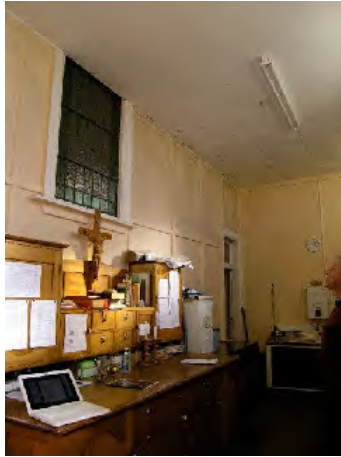
<u>Ceiling</u>
	Painted hardboard, hf
	<u>Wall</u>
	Painted asbestos sheet? With timber battens to south wall, hf?
	Painted hardboard to west and north walls, nhf
	Painted plaster to east wall, hf
	Painted softboard above panelling, hf?
	Painted timber panelling, skirtings and architraves, hf
	<u>Floor</u>
	Carpet on timber strip, hf

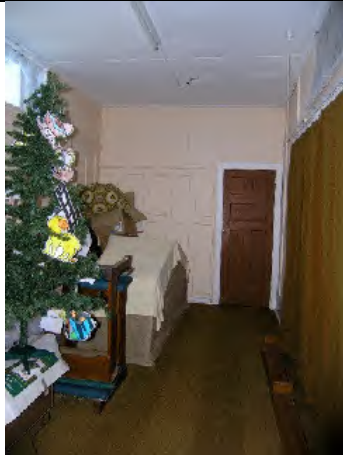
<u>Ceiling</u>			
	Painted softboard, nhf			
	<u>Wall</u>			
	Painted plywood with timber battens to north wall, hf?			
	Painted softboard above panelling, hf?			
	Painted timber panelling, skirtings and architraves, hf			
	<u>Floor</u>			
	Carpet on timber strip, hf			
	<u>Windows</u>			
	Painted timber bottom hung casement, hf			
	<u>Doors</u>			
	1 x clear coated timber paneled from sanctuary, hf			
	1 x painted timber paneled to west, hf			
	1 x painted timber double ledged and panelled to exterior south, hf			
	<u>Fixtures and fittings</u>			
-				
South west space	S	S	H	H

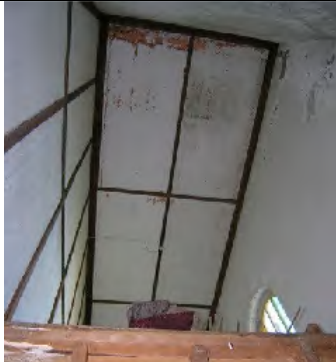
<u>Ceiling</u>			
	Painted asbestos sheet with clear coated timber battens, hf			
	<u>Wall</u>			
	Painted plaster, hf			
Uncoated asbestos sheet with clear coated

timber battens to north wall, hf
	Clear coated timber panelling to south and west, hf
	Painted softboard above panelling, hf?
	Painted timber panelling, skirtings and architraves, hf
	<u>Floor</u>
	Carpet on timber strip, hf
	<u>Windows</u>
	Pained timber bottom hung casement, hf
	<u>Doors</u>
	1 x clear coated timber paneled from sanctuary, hf
	1 x painted timber panelled to west, hf
	1 x pained timber double ledged and panelled to exterior south, hf
	<u>Fixtures and fittings</u>
	-
Confessional, north east corner	S L L L

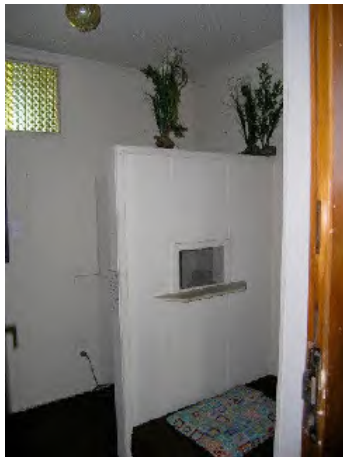
<u>Ceiling</u>
	Painted softboard tiles, nhf
	<u>Wall</u>
	Painted softboard tiles, nhf
	<u>Floor</u>
	Carpet over timber strip, hf
	<u>Windows</u>
	Sliding obscure, nhf
	<u>Doors</u>
Clear coated timber double paneled and glazed,

hf
	<u>Fixtures and fittings</u>
	Painted timber and softboard tiled lined partition, nhf
Stair, north east corner	S L L L

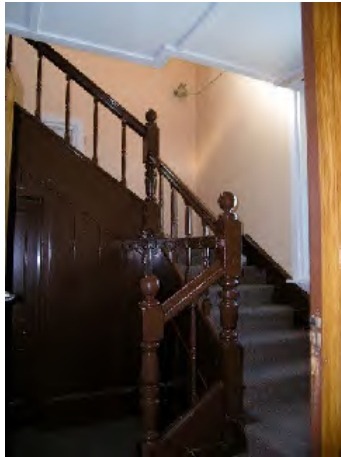
<u>Ceiling</u>
	Painted plasterboard with timber battens, hf
	<u>Wall</u>
	Painted plaster, hf
	Painted timber paneling with architraves and skirtings to stair, hf
	Painted timber architraves, hf
	<u>Floor</u>
	Carpet over timber strip, hf
	<u>Windows</u>
	Painted timber fixed with coloured glass, hf
	<u>Doors</u>
	Clear coated timber paneled, hf
	<u>Fixtures and fittings</u>
	Painted timber stair, newel posts, handrail, balusters, hf
First floor	
Stair, north east corner	S L L L
	<u>Ceiling</u>
	Painted plaster, hf
	<u>Wall</u>
	Painted plaster, hf
	Painted timber architraves, hf
