St Mary's Catholic Church, Hokitika

Partial Strengthening and Early Opening Scheme

Resource Consent Application to Westland District Council

**Consideration of strengthening options
to allow reoccupation**

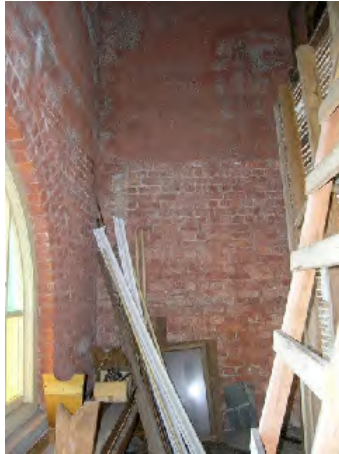
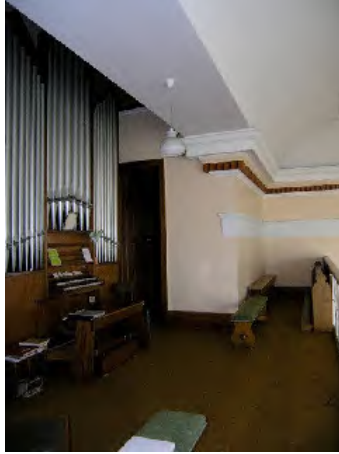
<u>Ceiling</u>			
	Painted plaster, hf			
	Painted plasterboard with timber battens, hf			
	Uncoated concrete, hf			
	<u>Wall</u>			
	Painted plaster, hf			
	Clear coated timber skirtings, hf

Uncoated brickwork, hf			
	Lath and plaster partition, hf			
	<u>Floor</u>			
	Carpet over timber strip, hf			
	Uncoated concrete, hf			
	<u>Windows</u>			
	Painted timber fixed semi-circular, hf			
	<u>Doors</u>			
	2 x clear coated timber paneled with south door boarded over toplight, hf			
	1 x clear coated timber panelled, hf

<u>Fixtures and fittings</u>				
	Organ, hf				
	Clear coated timber pews, hf				
	Light fittings, hf				
	Clear-coated timber and steel rail, hf				
Tower levels 2 and 3		H	H	H	E

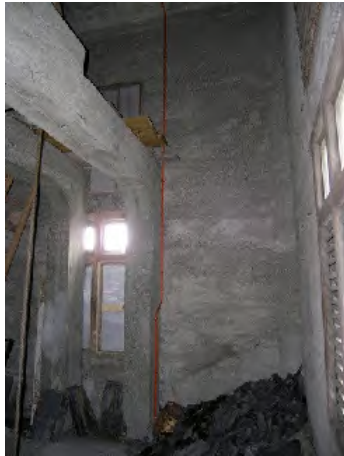
<u>Ceiling</u>				
	Uncoated concrete, hf				
	<u>Wall</u>				
	Uncoated concrete, hf				
	<u>Floor</u>				
	Uncoated concrete, hf				
	<u>Windows</u>				
	Painted timber, louvred, hf				
	<u>Doors</u>				
	Painted timber panelled, hf				
	<u>Fixtures and fittings</u>				
	Timber ladder, hf

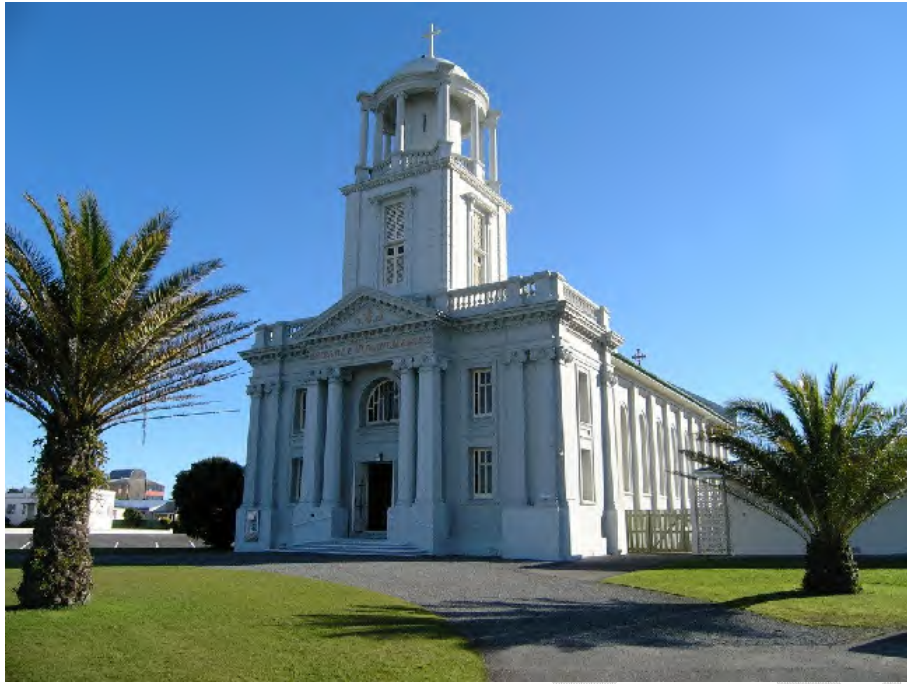
Temporary Protection Plan
St Mary's Church, Hokitika
November, 2015
